# Investigation, analysis and rehabilitation of the failures of St Dimitrios Bastion in the old city of Chania, Crete

M. Bardanis<sup>1</sup>, G. Dounias<sup>1</sup>

<sup>1</sup>EDAFOS Engineering Consultants S.A., Athens, Greece, email: mbardanis@edafos.gr, gdounias@edafos.gr

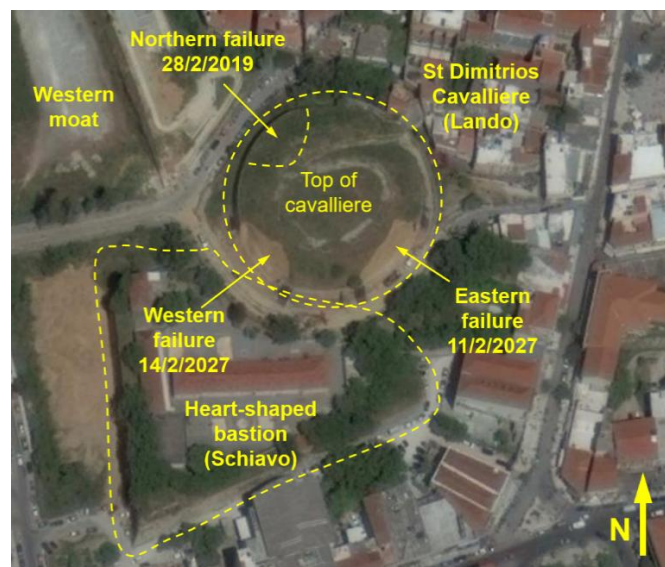
**Figure 2.** Close in on the area of the St Dimitrios Bastion indicated by the rectangle in the dashed yellow line in Fig. 1. The bastion itself, the cavaliere and the locations of the 2017 & 2019 failures are indicated.

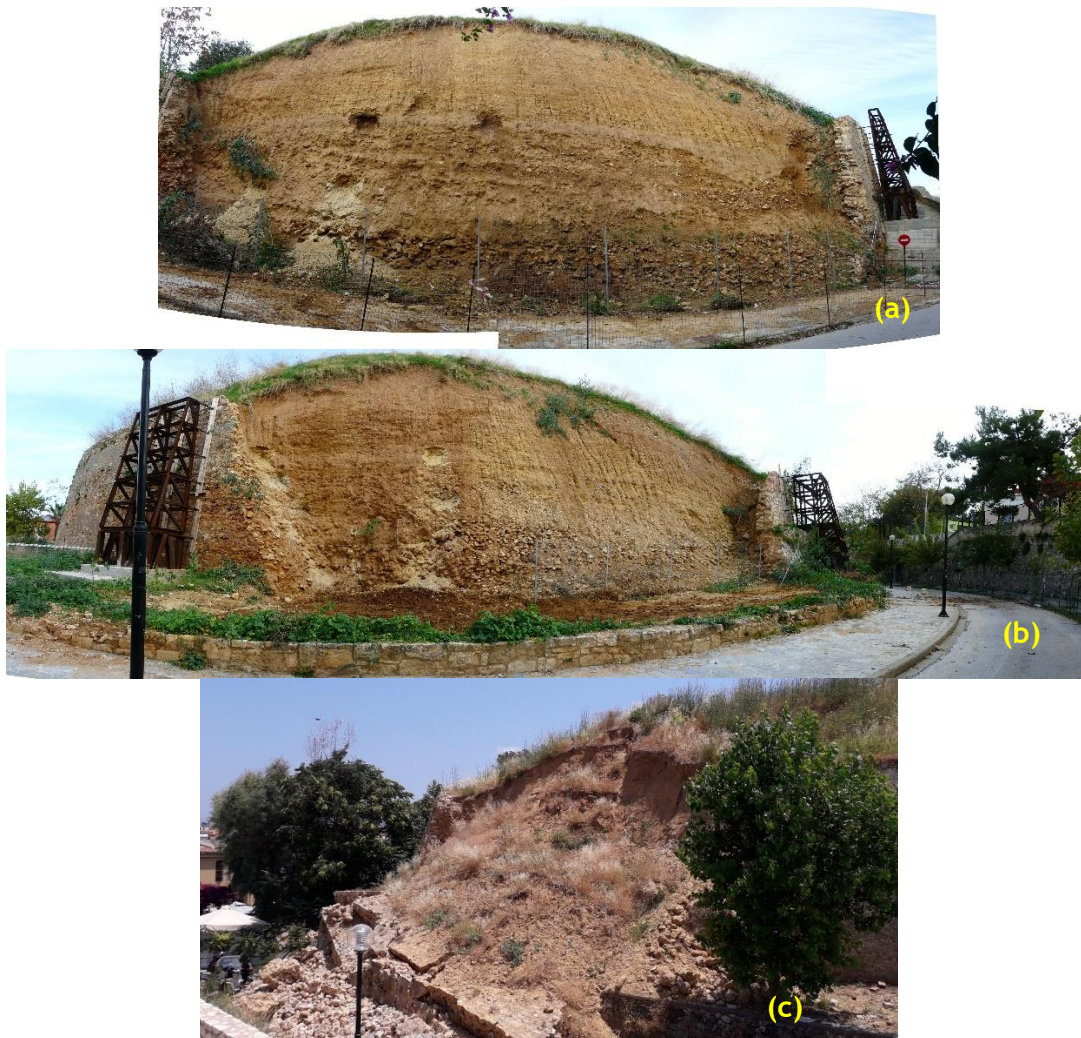
The failure at the south-eastern side was the first of the recent failures to occur during the night of 11/2/2017. It led to a major collapse of the toe wall of the cavalieri, closure of the street beyond the toe (Dounopapa st.) and destruction of several cars parked at the road side (Fig. 4a). Three days later,

during the night of the 14/2/2017 the failure at the south-western side occurred, leading again to a major collapse of the toe wall of the cavaliere (Fig. 4b), this time without any other destruction as Dounopapa st. had been closed for traffic and pedestrians after the failure on 11/2/2017. Rainfall measured in the centre of Chania for the 10<sup>th</sup> and 11<sup>th</sup> of February amounted to 90mm and cumulative rainfall from 1/12/2016 until 11/2/2017 amounted to 390mm. Both these failures were cleared of fallen debris and steel buttresses were designed and constructed by the Ephorate of Chania to ensure the protection of the rest of the cavaliere wall outside the boundaries of these two failures (Fig. 4a & 4b). Following these failures, on 28/2/2019 the failure at the north-western side occurred leading again to a major collapse of the toe wall of the cavaliere and closure of the street beyond the toe (Meletiou Piga st.). Rainfall measured in the centre of Chania for the 24<sup>th</sup> to 26<sup>th</sup> of February amounted to 160mm and cumulative rainfall from 1/12/2018 until 27/2/2019 amounted to 670mm (the 2018-2019 winter was one of the rainiest winters in Greece, and especially western Crete, over the past decades with catastrophic consequences in western Crete). Again, steel buttresses were designed and constructed as immediate measures to ensure the protection of the rest of the cavaliere wall outside the boundaries of this new failure. These were complemented by sub-horizontal drainage holes through the intact wall to relieve any excess pore water pressures that could develop as the culprit for the failures seemed to be increased pore water pressures following heavy rainfall. Following all these, extensive geotechnical investigation was carried out both for the materials used in the cavaliere and the ground below it and alternative solutions for reconstruction of the areas of the failure and strengthening of the rest of the cavaliere walls were investigated until the final solution was decided and designed.

**Figure 4.** View from the level of Dounopapa st in November 2017 a) of the eastern failure and b) of the western failure after removal of soil and wall debris and construction of the steel buttresses, and c) view of the northern failure in March 2019 before the removal of the debris. Small excavations on the slopes in Fig. 4a and 4b mark the locations of samples taken using an excavator from the various layers of the cavaliere materials.

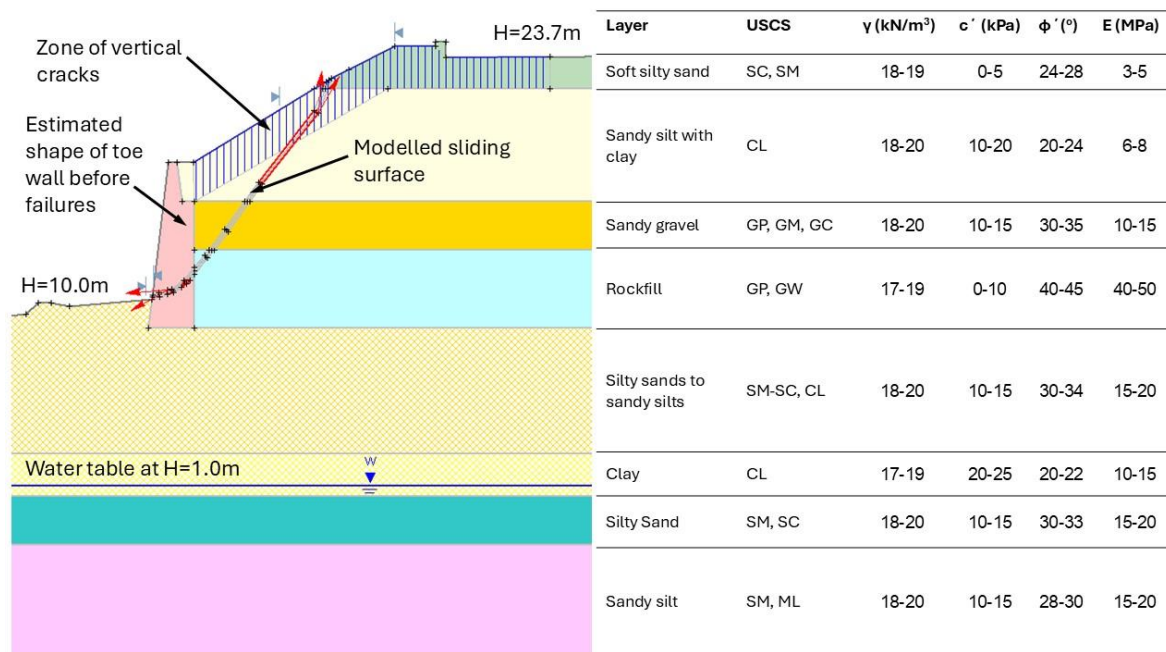
Based on these observations and the results of the geotechnical investigation, comprising boreholes, DCP tests and surface samples, the geotechnical model shown in Fig. 7 was adopted for the back analyses and the design of the reconstruction measures. Visual observations indicated that the sandy silt with clay forming the main upper part of the Cavaliere contained a network of vertical cracks extending to a depth of approximately 2 m. These cracks are also shown in Fig. 7, together with the estimated geometry of the toe wall before failure and the modelled sliding surface.

**Figure 7.** Geotechnical model as introduced in the slope stability analyses with the features modelled and the geotechnical parameters used (section shown is a typical section at the western failure).

The shear strength values introduced were the minimum ones of the range shown in Fig. 7. Parameter analyses with  $r_u$ , indicated that even without water slope stability is already marginal close to 1.1 to 1.15,

and reaches slightly below 1.0 as  $r_u$  becomes 0.45-0.5, a very large value indeed but rational for the magnitude of rainfall recorded before the failures and the presence of the cracks. Given the observations and limited laboratory data for the materials of the wall, it was modelled as a Mohr-Coulomb material with  $c=50$  kPa and  $\phi=30^\circ$ . Parametric analyses with values in that range indicated minimum effect on overall stability in comparison to the properties of the sand silt with clay layer or the value of  $r_u$ .

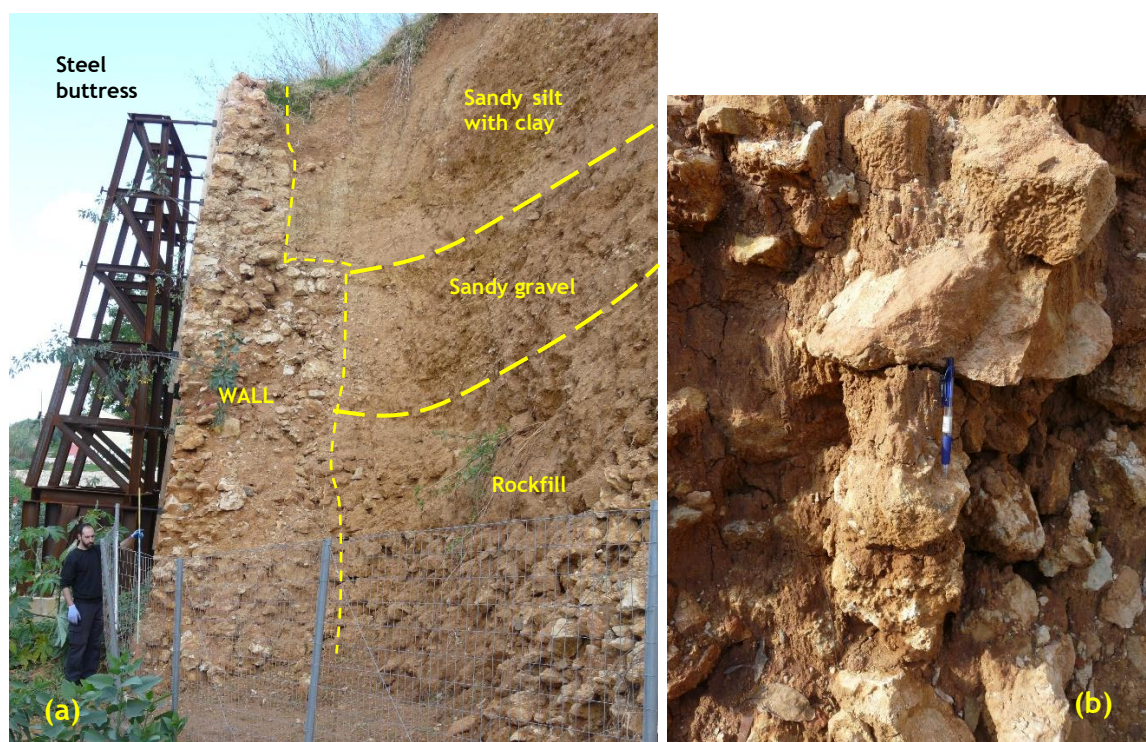
The principal observation regarding the toe wall itself was that its width was considerably smaller than would be expected in relation to both its own height and the height of the sloping ground retained behind it. Figure 8a shows the western section of the wall that remained after removal of the debris from the western failure. The wall is approximately 1.5 m wide at its base and approximately 0.8 m wide at the crest of its main body. Above this level, it continues as a much thinner, parapet-like extension, which also appears to retain sloping ground. A wall of these dimensions would clearly have had only a limited capacity to withstand the earth pressures acting upon it. Furthermore, although the stones used to construct the wall appeared to be reasonably competent, consisting of marly limestone and limestone with unconfined compressive strengths ranging from 8 to 47 MPa, the lime-based mortar exhibited poor mechanical properties. In some locations, the wall appeared to have been constructed using soil-based mortar composed of silty clay (Fig. 8b). Based on these observations, the toe wall was represented in the back analyses of the failures as a Mohr–Coulomb material with relatively low strength parameters.

**Figure 8.** a) Western section of the failed toe wall at the western failure after removal of the debris (human for scale). Boundary of the wall noted along with boundaries between soil layers in the cavaliere. b) Close-up photograph of the western section of the failed toe wall at the eastern failure after removal of the debris showing extensive use of thick soil-based mortar with the soil being of silty to clayey nature (pen for scale).
