# Preserving Historical Structures in Urban Tunneling: Diaphragm Walls Embedded in Bedrock

F. Capata<sup>1</sup>, M. Iacorossi<sup>2</sup>, F. De Santis<sup>3</sup>

<sup>1</sup>Engineer, SGS Studio Geotecnico Strutturale srl, Rome, Italy, email: [f.capata@studiosgsroma.com](mailto:f.capata@studiosgsroma.com)

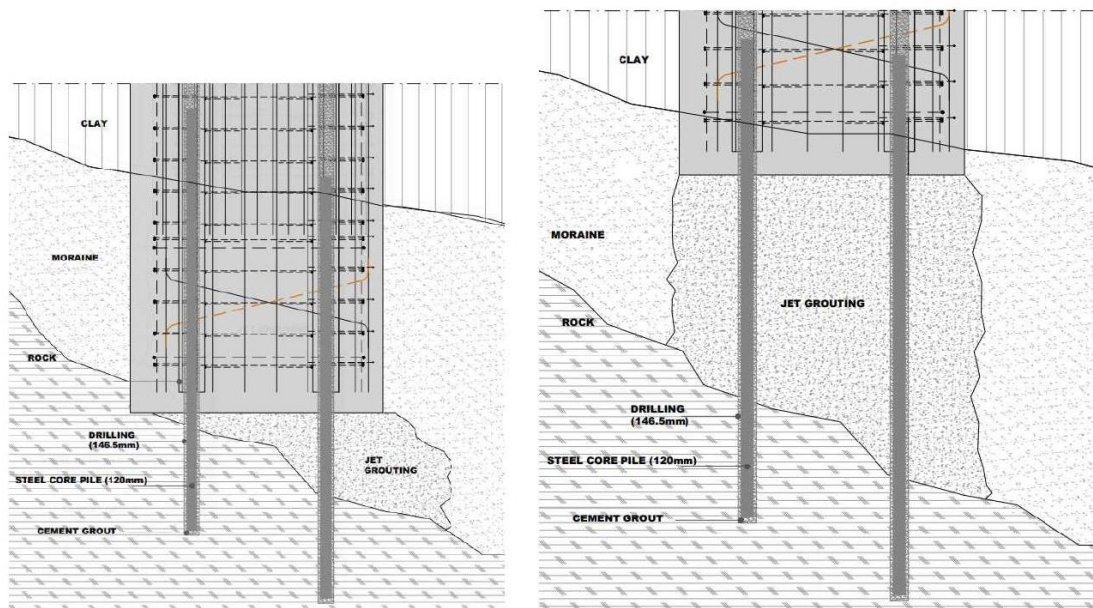
During field execution, starting in early 2021, the moraine layer proved substantially more resistant and heterogeneous than anticipated in the design phase and included frequent large boulders, in several cases exceeding 0.5 m in diameter. In multiple locations the excavation tools were unable to reliably penetrate the moraine layer down to the bedrock surface. As a consequence, the realized distance between the diaphragm wall toe and the bedrock increased significantly with respect to the design assumptions, from the expected value of less than 1 m to local values exceeding approximately 4 m, as schematically illustrated in Figure 3.

This geometrical deviation had important structural and execution implications. The steel piles intended to connect the diaphragm wall to the bedrock became longer than originally foreseen, increasing both their structural demand and their sensitivity to alignment accuracy and rock socket quality. At the same time, the initial design assumption that jet grouting would be required only to fill a limited toe gap was no longer valid, particularly under the prevailing pressurized groundwater conditions in the moraine layer.

The increased toe-to-rock gap also implied that a larger portion of the vertical load and bending effects had to be transferred through the combined pile–grout system rather than through direct wall–rock contact. This condition required additional verification of the structural capacity of the steel piles and of the global stiffness of the toe restraint system.

**Figure 3.** Comparison between design assumption (left) and as-built toe condition (right) showing increased wall toe–bedrock gap.

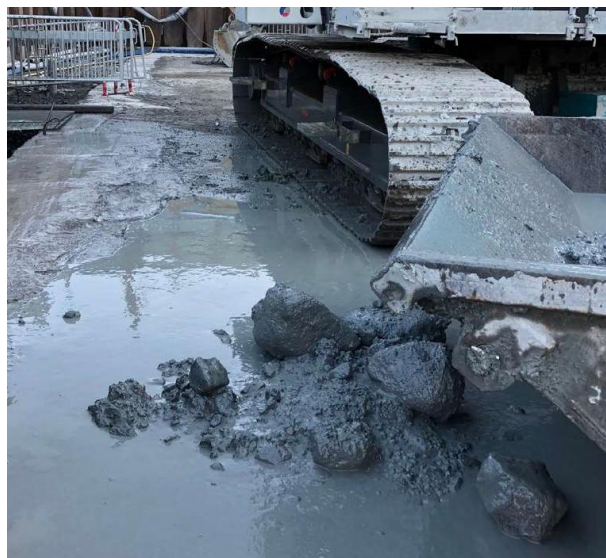
**Figure 4.** Example of large boulders extracted from the moraine layer during diaphragm wall excavation.

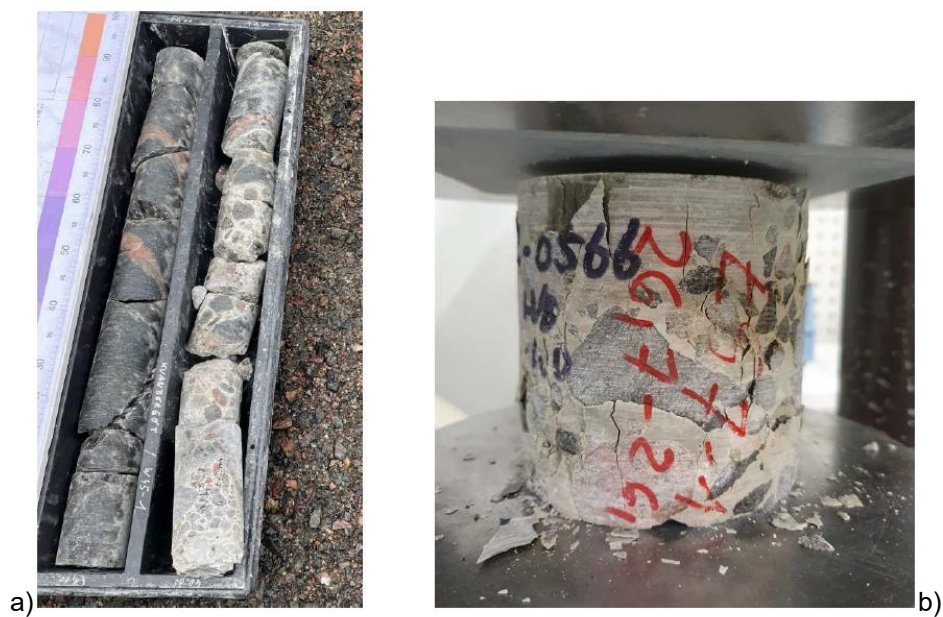
The initial jet grouting attempts beneath the diaphragm wall toe did not provide the intended continuity and material quality. Verification coring showed that the treated material was often discontinuous or poorly cemented, mainly due to the combined effects of high groundwater pressure, unfavourable soil fabric and non-optimized execution parameters.

Representative cores extracted from the treated zone, shown in Figure 5a, confirmed the continuity of the cemented mass and the effective incorporation of coarse moraine fragments within the grout matrix. Acoustic probes installed at radial distances between approximately 0.6 m and 1.0 m from the nominal column axis were used to estimate the resulting column diameter and verify the lateral extension of the treated volume. Unconfined compressive strength tests performed on selected specimens, as illustrated in Figure 5b, yielded strength values consistent with the project requirements for toe improvement and load transfer.

**Figure 5.** (a) Core samples from control drilling showing continuity of jet-grouted material; (b) specimen prepared for unconfined compressive strength testing.

A revised execution procedure was therefore adopted, including a preliminary pre-cutting phase performed at reduced pressures to condition the ground and decrease local permeability, followed by optimized injection parameters tailored to the heterogeneous moraine. Quality control was carried out through systematic control drilling and core recovery beneath selected panels.

Based on these results, the revised execution parameters were adopted for the production works beneath the diaphragm wall panels, ensuring continuous treated zones and improved contact conditions at the wall–rock interface.

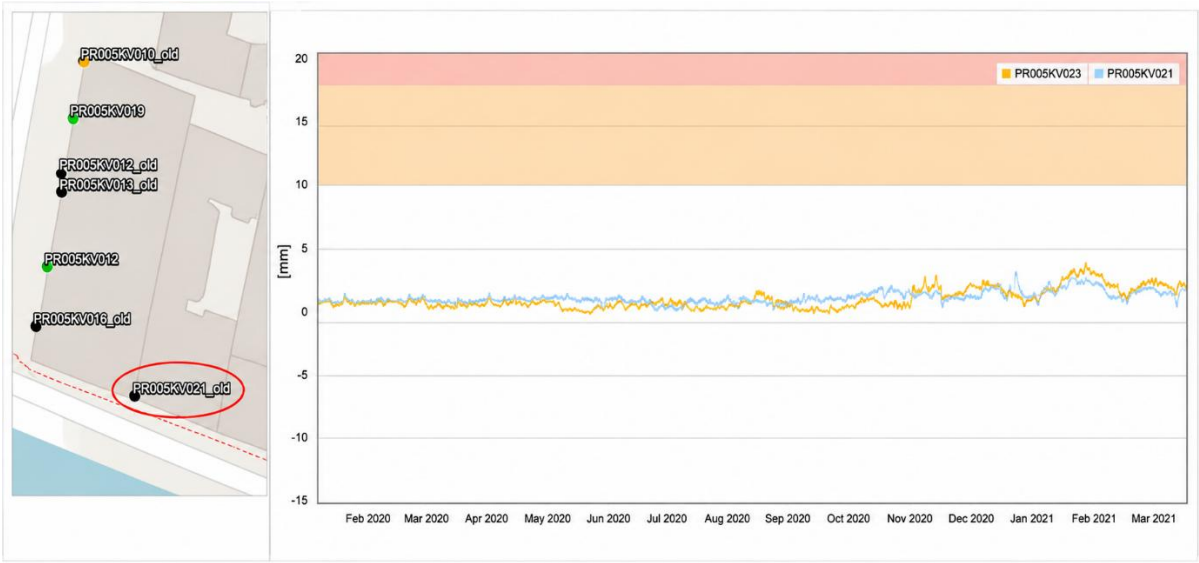
Historical levelling data indicate that both buildings experienced significant long-term settlements since their construction, exceeding approximately 30 mm for Building 13.12 and 55 mm for Building 13.7, with a progressive reduction of settlement rate in recent years. During the construction phases involving diaphragm wall installation, Deep Soil Mixing and early excavation works, additional vertical displacements recorded at Building 13.12 remained generally within  $\pm 2$  mm, while horizontal movements were typically limited to a few millimetres and always below 10 mm, as shown in Figure 9 and Figure 10.

Figure 9. Horizontal displacement of Building 13.12 versus construction progress.

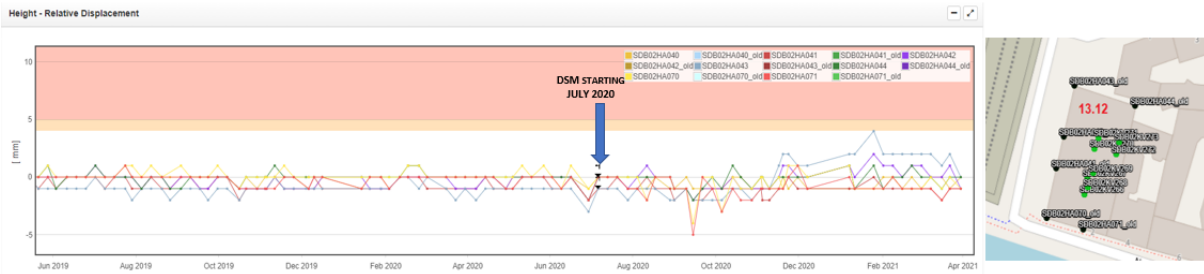
Figure 10. Vertical displacement of Building 13.12 versus construction progress.

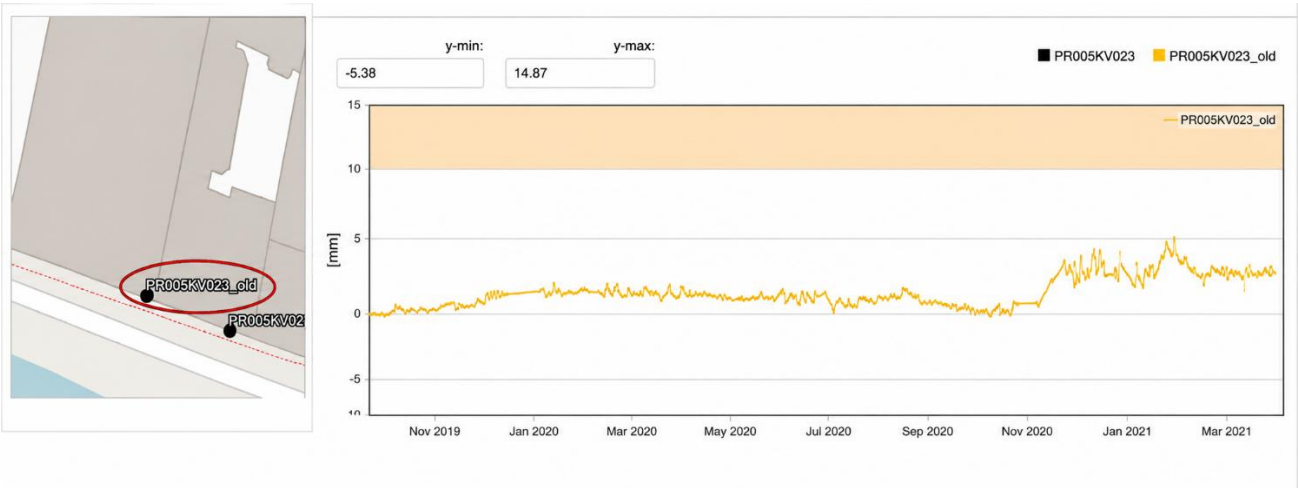
Similar trends were observed for Building 13.7, with vertical displacements within  $\pm 5$  mm and horizontal movements below 10 mm, as illustrated in Figure 11 and Figure 12.

Figure 11. Horizontal displacement of Building 13.7 versus construction progress.

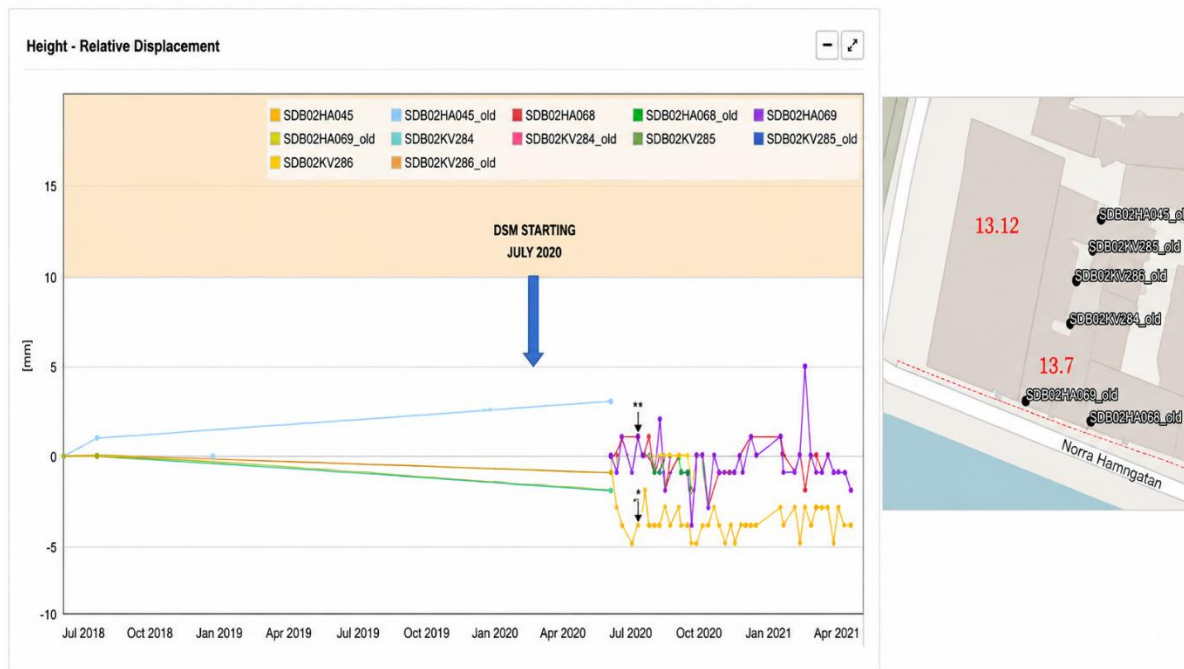
**Figure 12.** Vertical displacement of Building 13.7 versus construction progress.
