## Underground Church of Saint-Emilion : Geotechnical challenges in light of heritage issues

N. Carpentier<sup>1</sup>, E. Antoinet<sup>2</sup> and A. Esnault Filet<sup>3</sup>

<sup>1</sup>Senior geotechnical engineer in heritage structures, Antea Group, Bordeaux, France, email: [nicolas.carpentier@anteagroup.fr](mailto:nicolas.carpentier@anteagroup.fr)

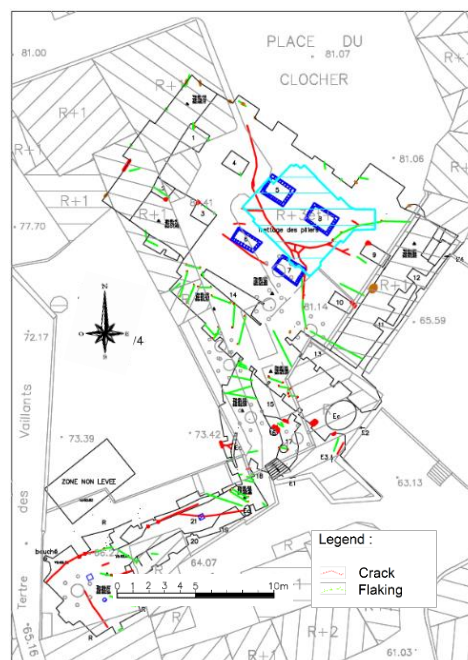
**Figure 3.** Plan view of the monolithic church of Saint-Emilion with cracking position (Antoinet, 2013)

The figure below (Figure 3) shows a plan view of the outline of the church and its pillars, and the outline of the bell tower (light blue outline) positioned just above. This bell tower rests mainly on 4 pillars (dark blue outline) which therefore support significant forces.

In addition, a crack survey was carried out, revealing mechanical cracking in the vault beneath the bell tower (red line on Figure 3) probably related to the overload of this construction.

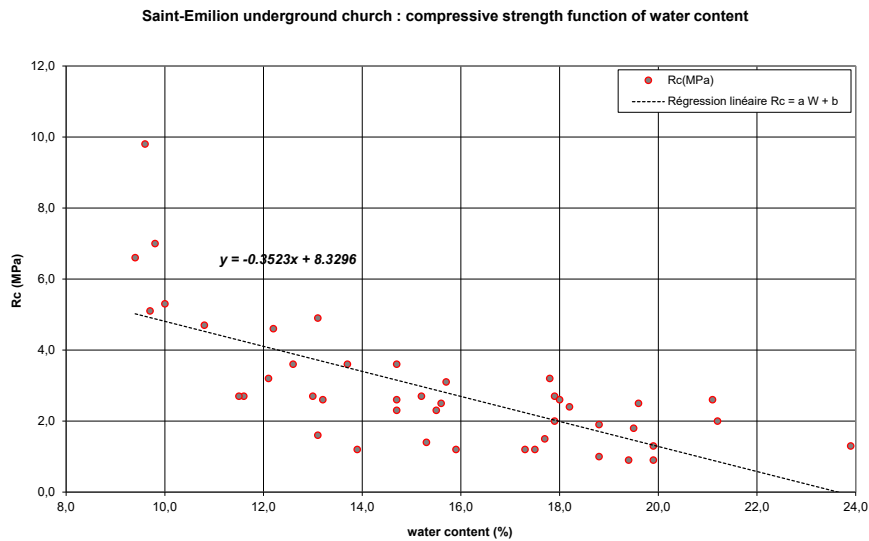
**Figure 4.** Compressive strength evolution according water content (Carpentier, 2015)

- a limestone with very low mechanical characteristics,
- an important influence of the saturation degree and water content on the rock's strength (see Figure 4), particularly linked to its high porosity (41%),
- the influence of sample orientation (strong  $R_c$  anisotropy).

Moreover, the tests showed lower mechanical characteristics at the base of the pillars, which also exhibited the highest saturation levels due to capillary rise from the floor, with the groundwater level less than 1.5 m below the church floor (see figure 4).

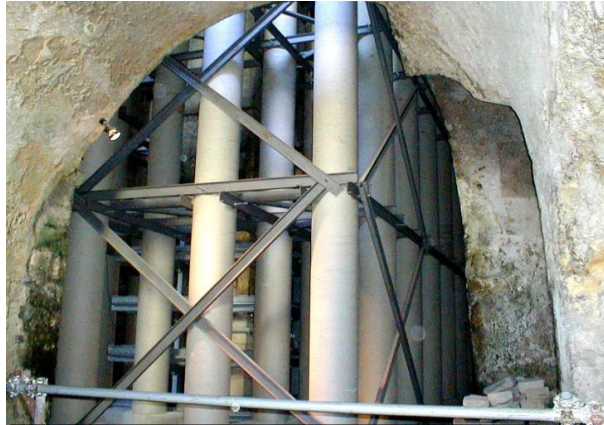
**Figure 5.** *Emergency reinforcement by concrete pillars (1991 – Pierre Regaldo Saint-Blancard)*

In 1986, a university hydrogeologist warned the Chief Architect of Historical Monuments of the building's instability, even though no structural damage had appeared inside the church, aside from water infiltration. Following this inspection, emergency reinforcement work was carried out between 1990 and 1991 without a proper stability study. This temporary shoring consisted of 38 steel columns, 60cm in diameter, supporting the vault around the four main pillars beneath the bell tower (see figure 5).

The concrete columns completely disfigured the church, prompting calls to remove these temporary supports and find more elegant, less visible permanent solutions, especially as the monument was about to be listed as a UNESCO World Heritage site (officially done in 1999).

Finally, it was decided to **replace the props with a provisional and reversible banding technique**, less harmful to the monument than the existing columns.

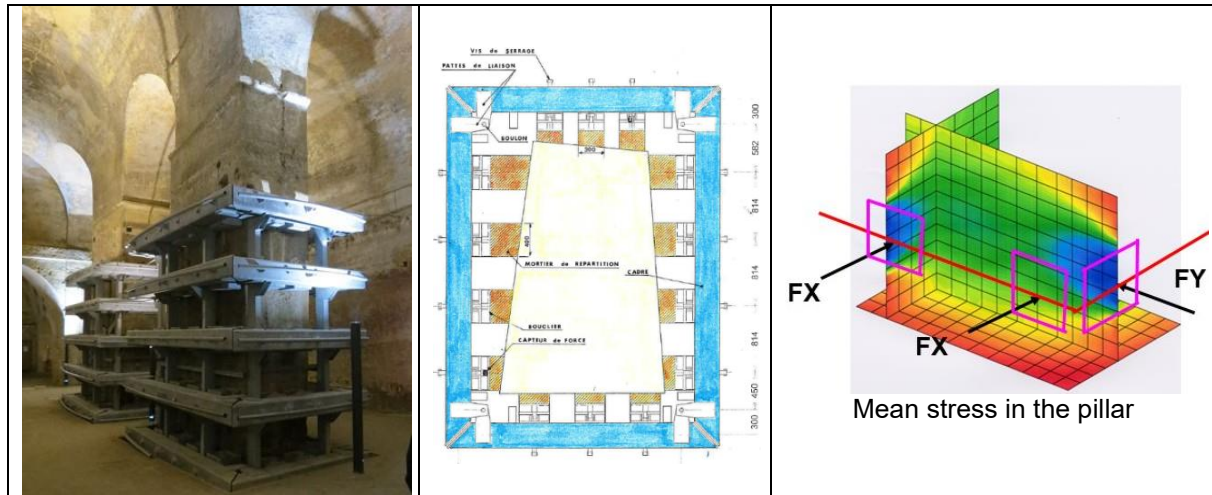
**Figure 6.** Photograph of the banding system (left), plan view of a metal frame (center) and 3D numerical model (right)

The metallic banding works, through the application of lateral confinement, was implemented in 2000, allowing the removal of the unaesthetic temporary props (Figure 6). The system consisted of metal frames encircling the pillars, fitted with mechanical screw jacks exerting calculated pressure on distribution plates. To prevent surface damage, a layer of lime mortar was inserted between each plate and the pillar. Each pillar had five frames spaced one meter apart, with 12 to 14 jacks per level, depending on pillar cross-section.

The applied stress on the plates ( $0.4 \times 0.4 \text{ m}^2$ ) ranged between 0.8 and 1 MPa. Force sensors on the adjustment screws allowed verification of the applied load. 3D modeling has been done to assess the behaviour of the pillar.

Due to the rigidity of the system and the pillars' geometry, it was difficult to apply a uniform force using mechanical jacks, so the nominal force was limited to **50%** of the initially targeted value.

Today, the instrumentation of the banding system is no longer operational (only 20% of the sensors are still in order), preventing assessment of the actual stresses in the pads and therefore of the system's efficiency (residual stress estimated less than 30% of initial stress after 15 years).

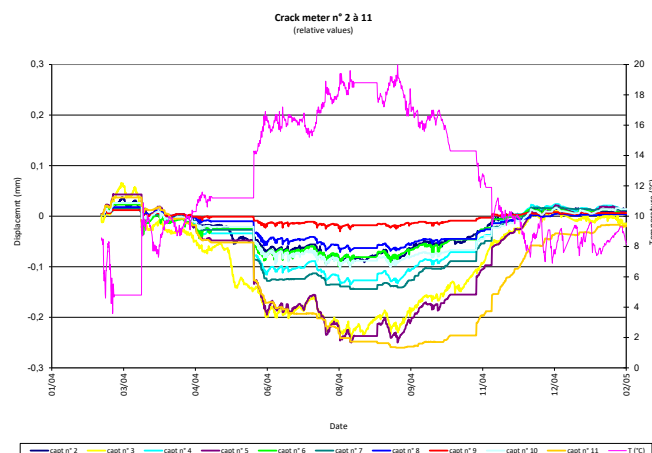
**Figure 7.** Cracks monitoring on one year (2002)

As part of the consolidation and restoration works, a monitoring system was installed, including 10 crack gauges fixed on the identified vault cracks. Monitoring showed small variations (less than 0.3 mm) correlated with temperature (pink line) changes (cf. figure 7):

- Cracks narrowing with higher temperatures,
- Cracks widening with lower temperatures.

Residual displacements over a yearly cycle were negligible (a natural “breathing” phenomenon of the rock mass), and no abnormal movement was observed. Therefore, the system was removed after two years of monitoring.

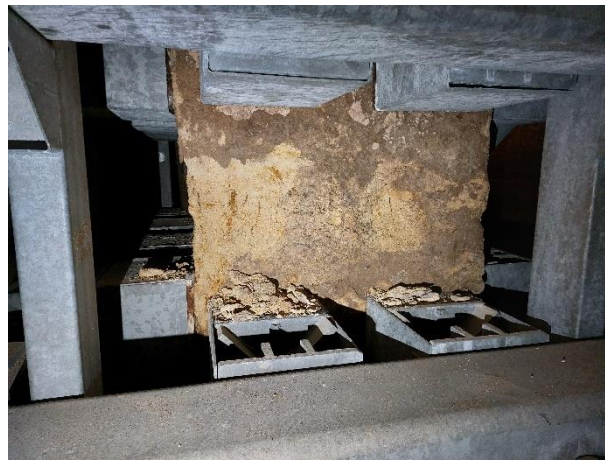
**Figure 8.** Pillars alteration at the base, between the metal frames (Carpentier, 2024)

Given the slow and continuous deterioration at the base of the pillars (see figure 8), partly due to capillary rise, and the reduction of banding stress, Antea Group explored new methods to improve the mechanical properties of limestone in depth. In this context, the Biocalcis process, developed by Soletanche Bachy, appeared as a potentially suitable solution.

To confirm these promising lab results and define in-situ implementation methods, it was recommended to conduct a trial treatment on a test pillar in a similar quarry to that forming the base of the Monolithic Church pillars.
