# A Multidisciplinary Approach to the Restoration of the Pyli Arch Bridge: Integrating Seismic, Geotechnical, and Hydraulic Analyses

D. Egglezos<sup>1</sup>, and C. Giannelos<sup>2</sup>

## ABSTRACT

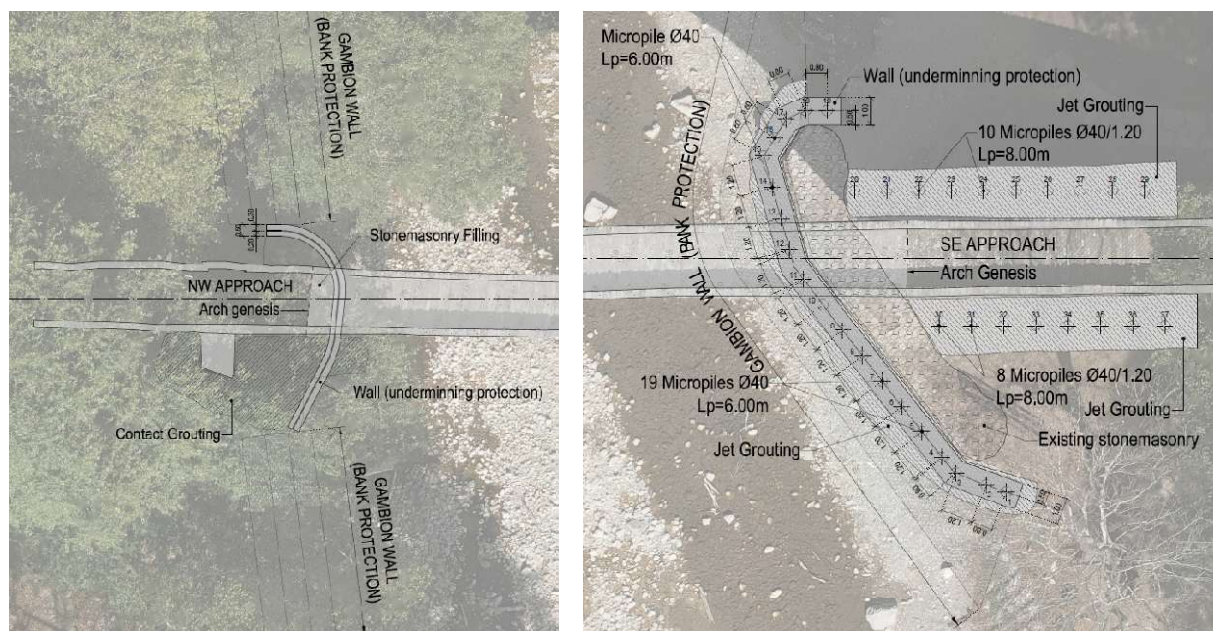
**Figure 9.** Plan view of the proposed geotechnical measures a) at the northeast abutment and b) at the southwest of the Pyli Bridge.

The proposed interventions to strengthen the foundation area (*Figures 9 and 10*) concern: cleaning of the foundation soil; deep jet grouting in the subsoil of the southern pedestal; contact grouting in the northern pedestal; micropiles around the perimeter of the southern pedestal; construction of walls/walls to protect against undermining; and shaping and strengthening the bank with gabions. These measures are reversible, minimally invasive, and designed to mitigate future scour phenomena while maintaining the visual and structural authenticity of the monument.

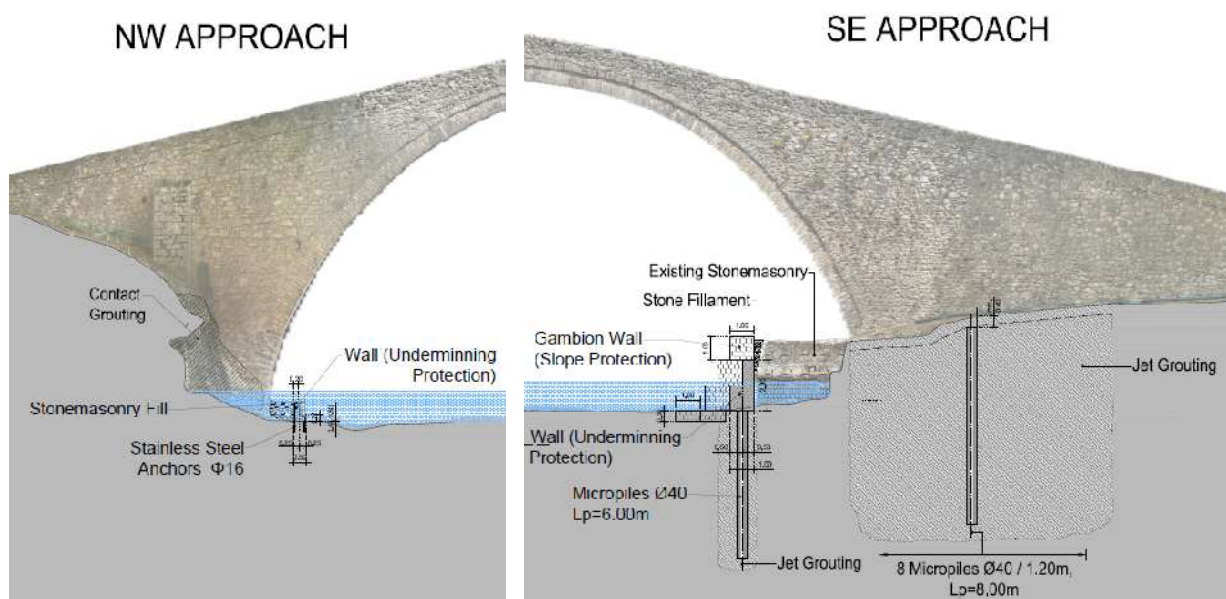
**Figure 10.** Upstream view of the proposed geotechnical measures. Left: at the northeast abutment. Right: at the southwest of the Pyli Bridge.
