# A Multidisciplinary Approach to the Restoration of the Pyli Arch Bridge: Integrating Seismic, Geotechnical, and Hydraulic Analyses

D. Egglezos<sup>1</sup>, and C. Giannelos<sup>2</sup>

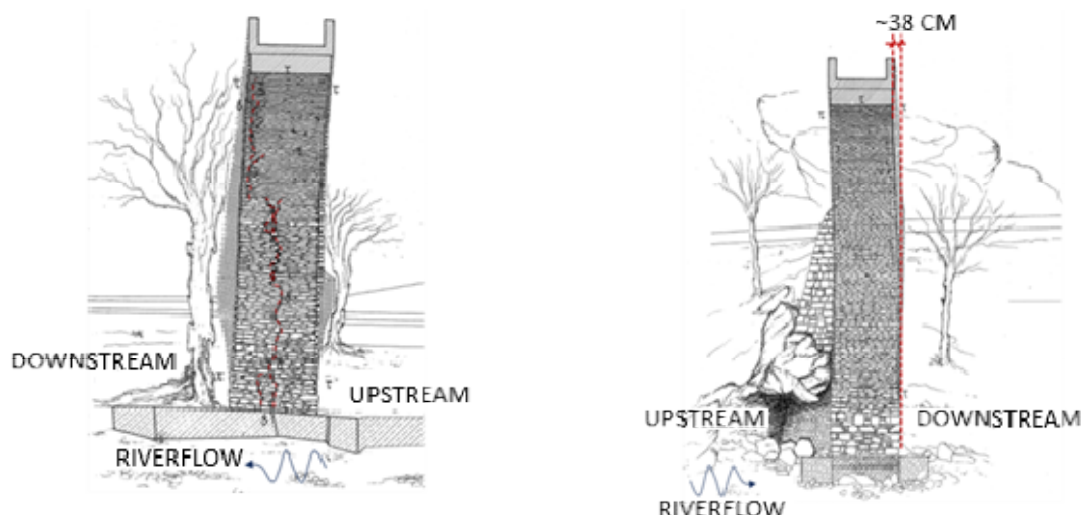
Additionally, at the crown of the arch (near the keystone region), a pronounced transverse deflection of approximately 35 cm is observed toward the upstream direction (Figure 2). This deformation, however, appears to correspond to the original geometric configuration of the bridge rather than a product of recent structural movement.

**Figure 2.** Transverse deflection – deformation of the arch. View of the Southern Abutment (Left). View of the (Northern Abutment (Right). Figures adapted from Karaveziroglou, 2004.

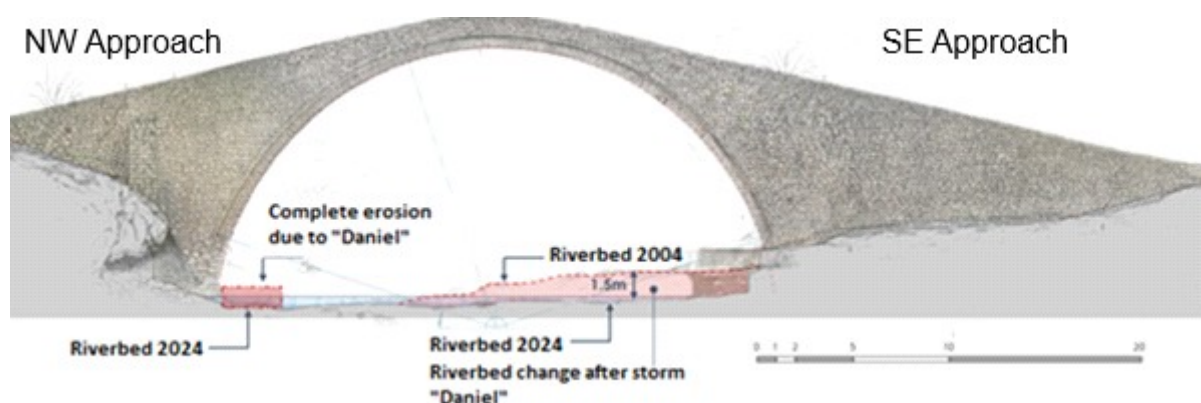
However, scour phenomena have been identified at the base of the southern abutment (Figure 3), posing a critical threat to the bearing capacity and overall stability of the monument. At the northern abutment, an ongoing process of localized detachment of the external stonework is observed, accompanied by vegetation growth, while the foundation rests on *hard rock outcrop* offering better resistance to erosion.

**Figure 3.** Overview (upstream view) of the scour zone on the southern abutment, following the storm Daniel (2023). Figure adapted from Structural Study (GEO.PER. S.A., 2024).

These hydraulic phenomena were identified as the primary cause of structural deterioration at the southern abutment. The absence of prior anti-scour protection measures allowed for progressive erosion of the foundation soils over time. The observed hydraulic impacts were integrated into the geotechnical and structural analyses, informing the design of targeted protective interventions aimed at ensuring the long-term stability and resilience of the monument.

The proposed interventions to strengthen the foundation area (*Figures 9 and 10*) concern: cleaning of the foundation soil; deep jet grouting in the subsoil of the southern pedestal; contact grouting in the northern pedestal; micropiles around the perimeter of the southern pedestal; construction of walls/walls to protect against undermining; and shaping and strengthening the bank with gabions. These measures are reversible, minimally invasive, and designed to mitigate future scour phenomena while maintaining the visual and structural authenticity of the monument.

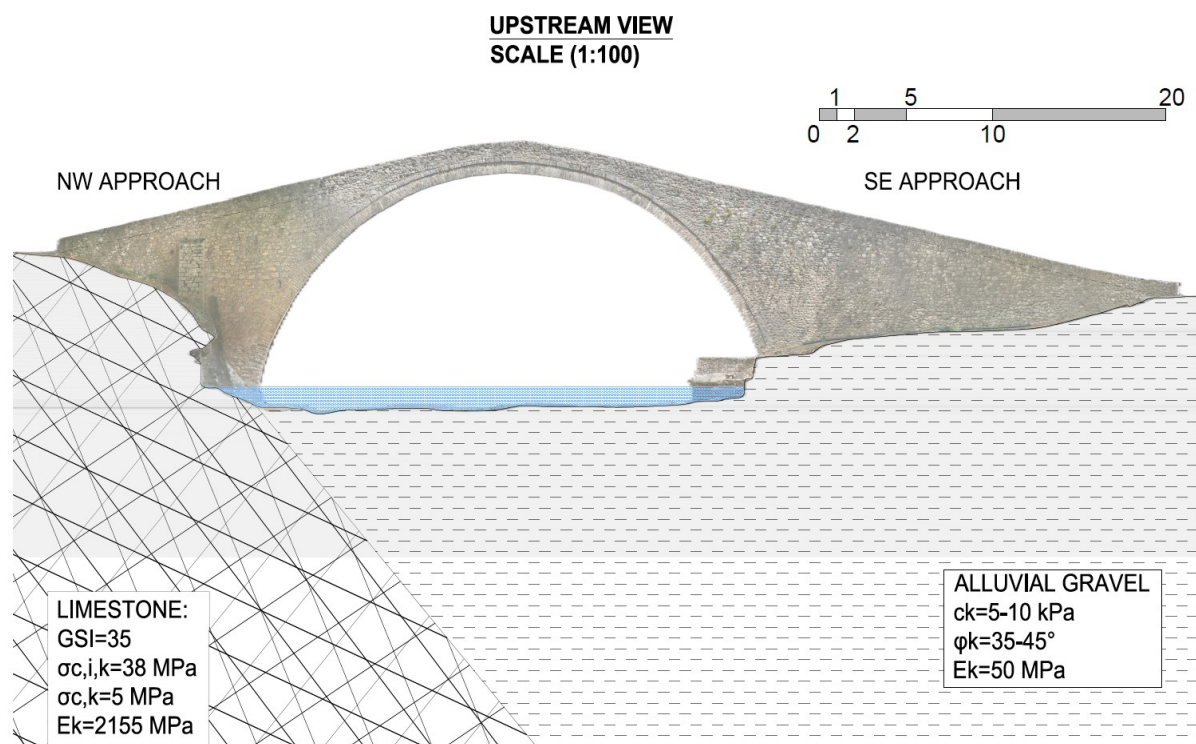
A key factor in understanding the structural response of the bridge is the contrast in geotechnical foundation conditions between the two abutments: the northern slope is characterized by competent rocky material, while the southern foundation consists of weaker, erosion-prone deposits. These findings, combined with the evidence of scour activity (Figure 3), confirm the necessity of targeted stabilization and conservation measures to ensure the long-term safety and preservation of the structure

**Figure 4.** Characteristic (longitudinal) geotechnical section in the area of Pyli Bridge (downstream view). Figure adapted from the drawings of Structural and Geotechnical Studies (GEO.PER. S.A., 2024; Egglezos, 2024).

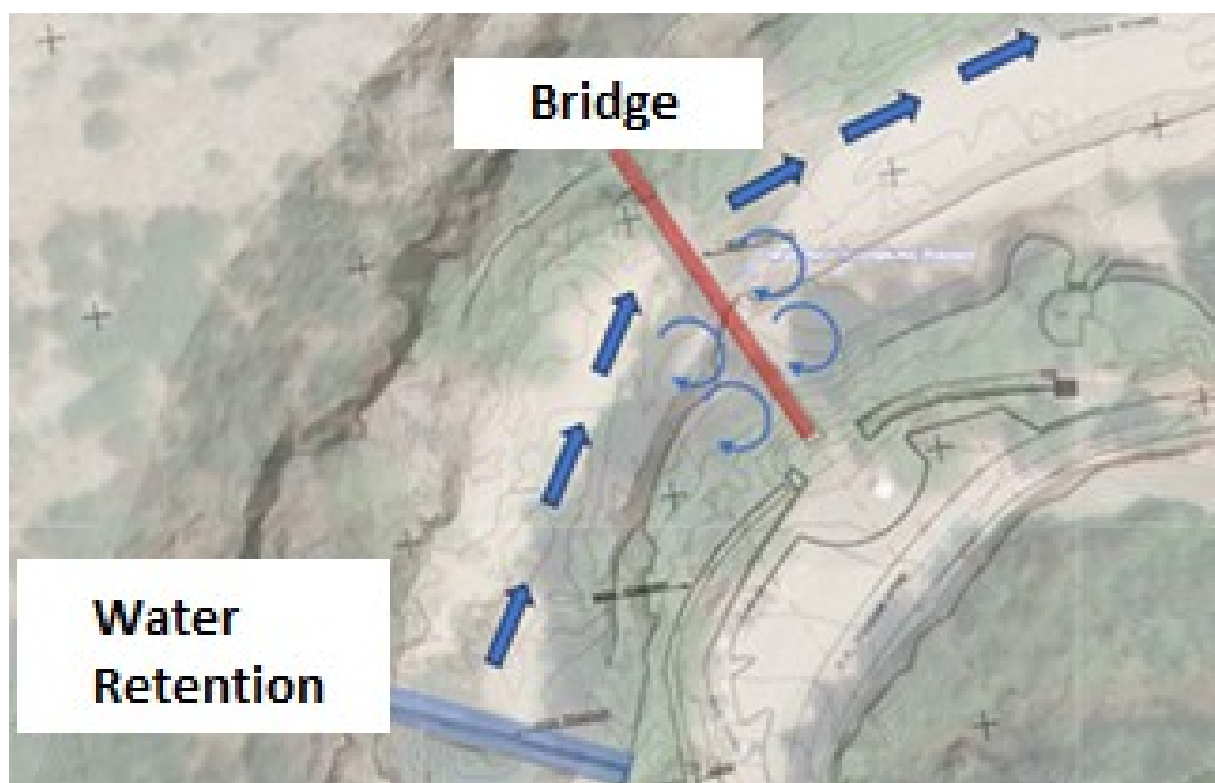
The Pyli Bridge spans the Portaikos River at a location characterized by a steep transverse bed slope and variable flow depth. Hydraulic loading has historically been a dominant factor influencing the pathology of the monument, particularly affecting the southern abutment (Figure 6).

**Figure 6.** Characteristics of hydraulic flow near the Pyli Bridge.

The extreme flood event of Storm “Daniel” (September 2023) caused river overflow and extensive scouring at the base of both abutments, accompanied by erosion of the surrounding slope material. At the southern abutment, substantial loss of soil mass and partial exposure of the foundation were recorded. The northern abutment, though founded on rock, experienced loss of fill material and partial detachment from the natural slope.

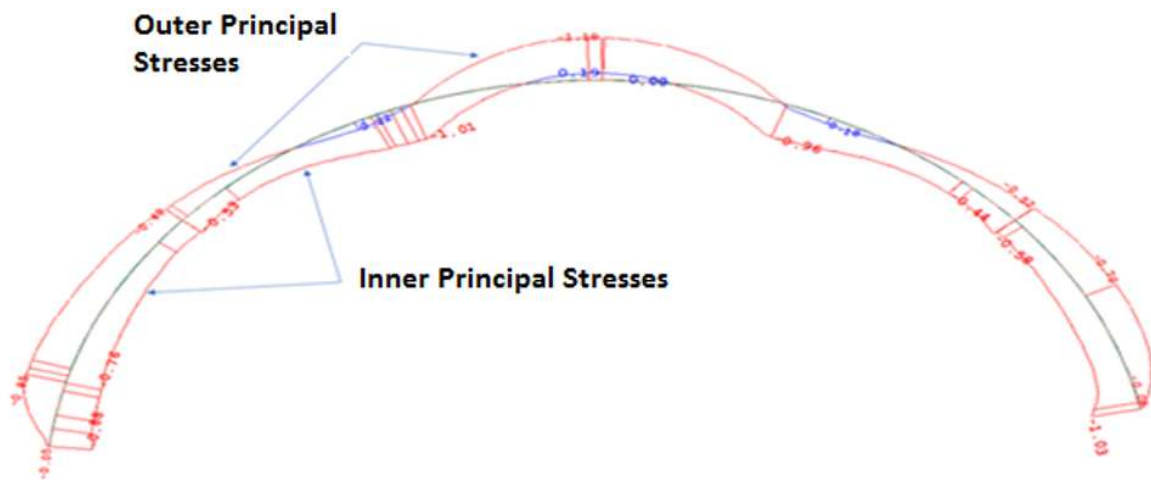
For static loads, the maximum compressive stress ( $\sigma_{c,max} = 2$  MPa) and tensile stress ( $\sigma_{t,max} = 0.19$  MPa) (Figure 6) remained below the corresponding strength limits in Table 2.

Localized tensile stress concentrations were observed in the 70°–110° arch sector, with tensile stresses of 0.95–1.95 MPa, where minor cracking is expected and considered acceptable.

**Figure 7.** Principal stresses developed at the intrados and extrados of the arch under gravity loading..

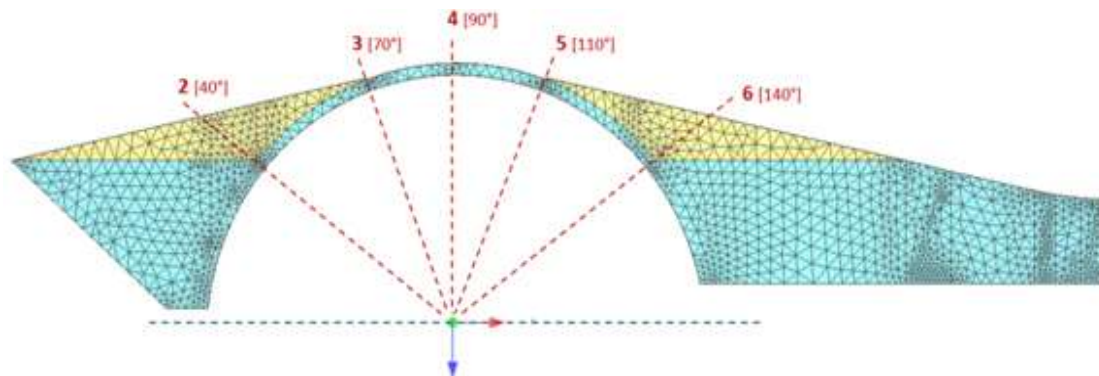
Using the force method, several characteristic cross-sections of the arch (Figure 7) were analyzed, assuming zero tensile strength. Results showed that most sections remain in compression, with Section 3 being the most critical. The mobilized friction coefficient ( $\mu_{mob} = 0.13$ , ratio of developed shear to axial force) is well below the maximum available ( $\mu_{max} = 0.30$  for cracked masonry).

The maximum compressive stress (8.07 MPa) occurs in Section 3, slightly exceeding the estimated compressive strength ( $f_{cw} = 7$  MPa).

**Figure 8.** Characteristic cross-sections of arch under examination

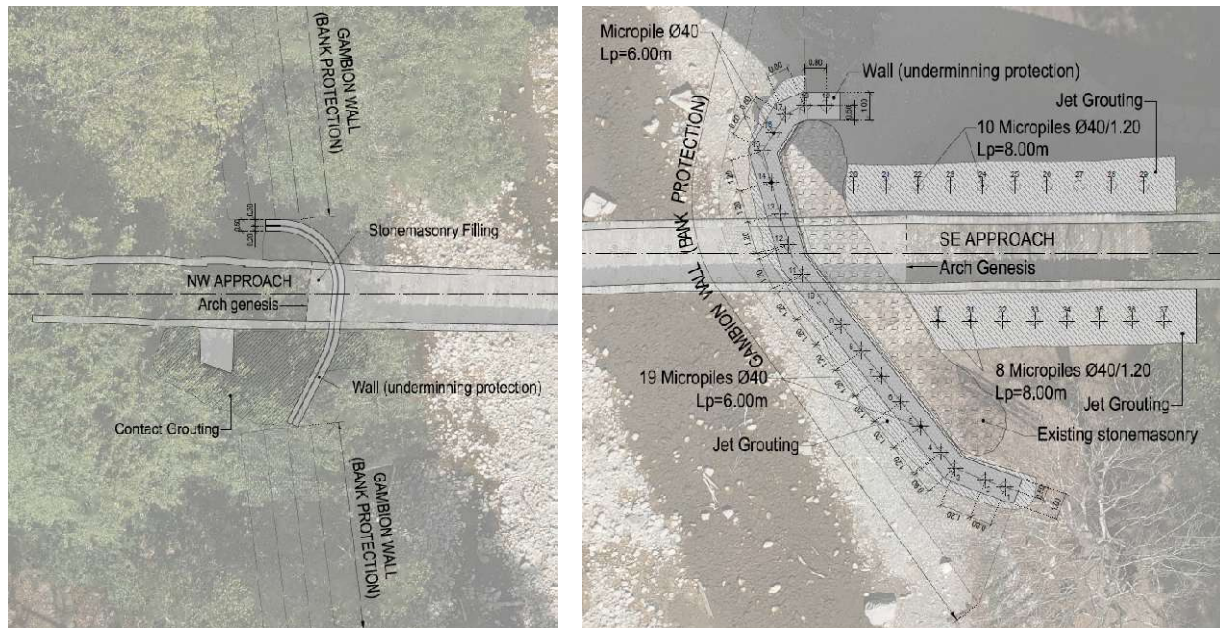
**Figure 9.** Plan view of the proposed geotechnical measures a) at the northeast abutment and b) at the southwest of the Pyli Bridge.

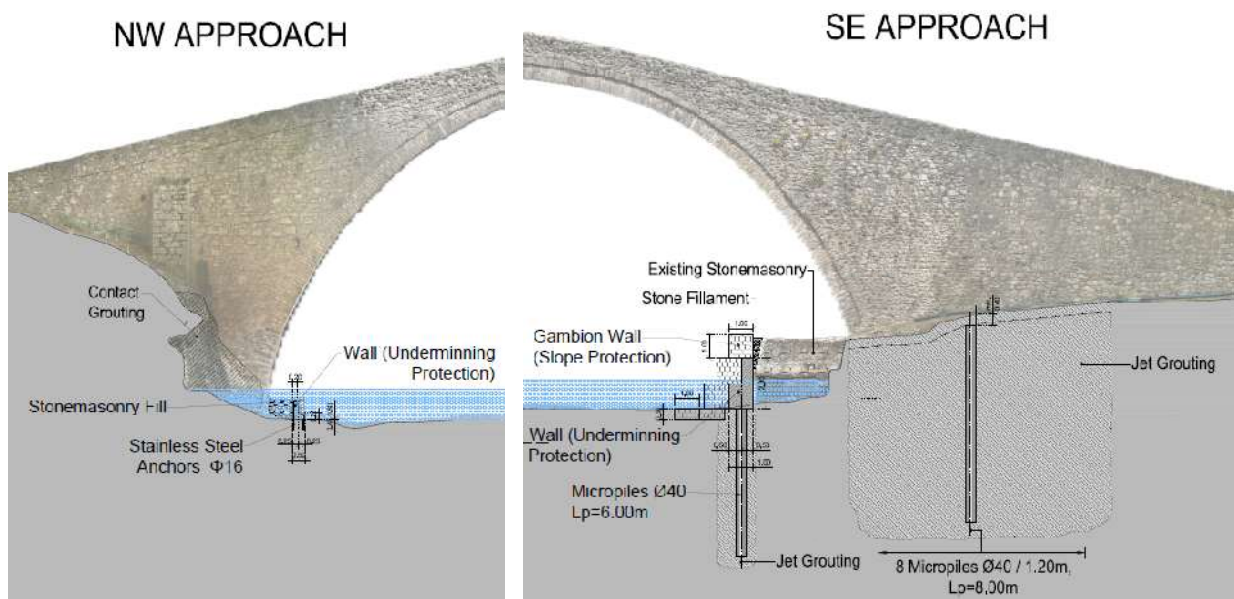
**Figure 10.** Upstream view of the proposed geotechnical measures. Left: at the northeast abutment. Right: at the southwest of the Pyli Bridge.
