# Case Study- Excavation Around Heritage Buildings in an Urban Environment

P. H. Lim<sup>1</sup>, J. J. Loo<sup>2</sup>, C. Y. Lim<sup>3</sup>

## ABSTRACT

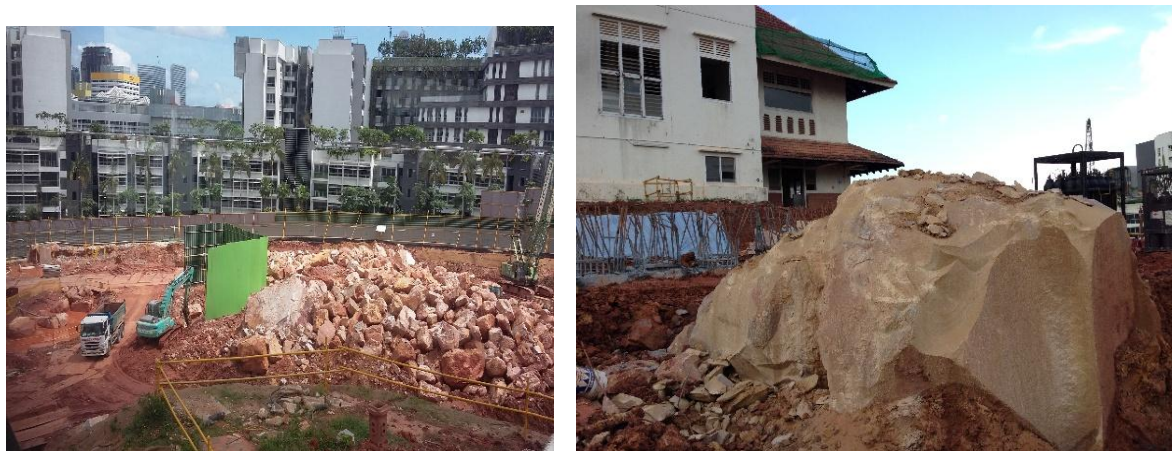
**Figure 6.** Sandstone boulders of various sizes exposed during excavation

An abundance of sandstone boulders of various sizes, some measuring up to 10m in diameter, was observed during excavation (see Figure 6). The boulders were embedded within the hard matrix of sandy silt or sandy clay.

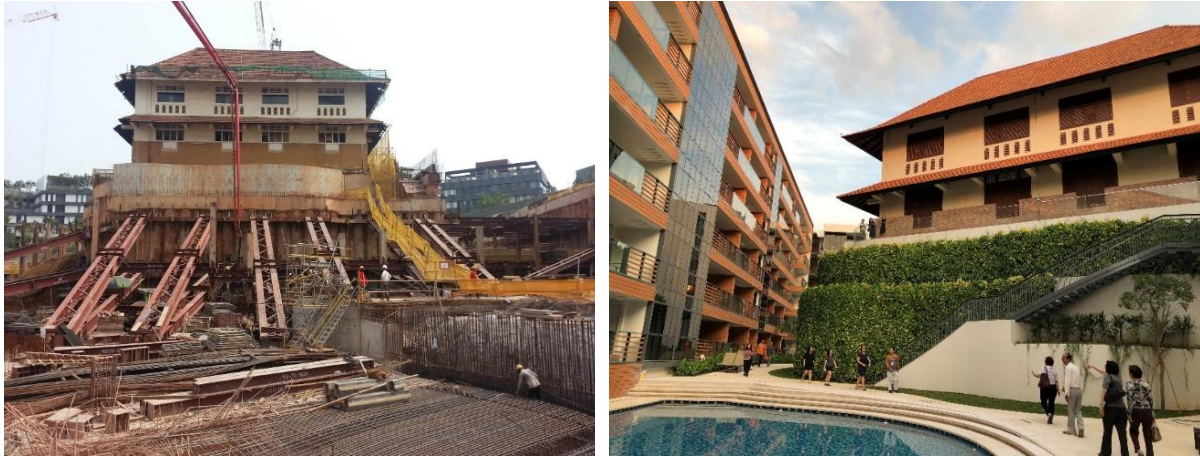
**Figure 9.** Site condition of the former Olson Building during construction (left) and after construction (right)

Before the commencement of engineering works, a detailed structural investigation was carried out on the conservation buildings and it was found that they were supported on reinforced concrete footings. Impact assessments on the conservation buildings were carried out during the design stage to evaluate the potential impacts arising from the excavation works. In addition, instrumentations such as tilt plates, building settlement markers, survey prisms, inclinometers and water standpipes were installed to monitor the performance of the ERSS and the conservation buildings. Figure 9 shows the site condition of the former Olson Building during and after construction.

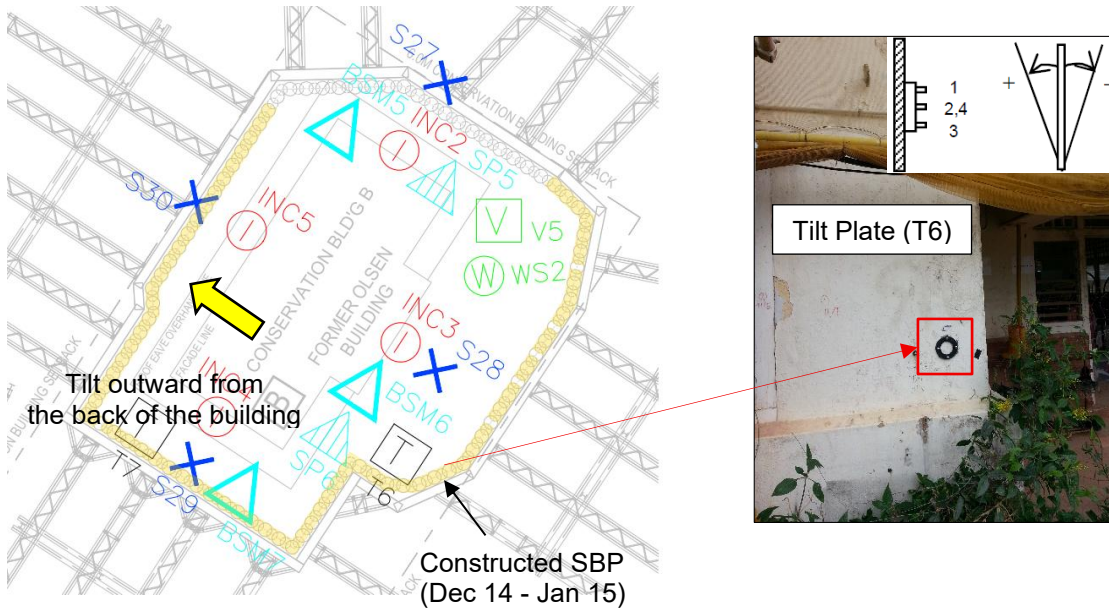
**Figure 10.** Instrumentation plan (left). Tilt plate (T6) installed on the former Olson Building (right)

During the construction stage, the tilt plate (T6) installed on the former Olson Building (refer to Figure 10) recorded a sudden increase in reading from  $0.003^{\circ}$  to  $0.043^{\circ}$  within a 10-day period even though no excavation works were being carried out during that time. The positive tilt plate reading indicated that the building was tilting outward from the back of the conservation building. The direction of movement was further verified by the nearby inclinometer (INC5), which showed a consistent ground displacement trend (refer to Figure 11).

An investigation was promptly carried out to assess the relationship between the construction activities and the instrumentation readings. Findings suggested that the tilt of the former Olson Building associated with the ongoing installation of the SBP wall. Due to the closer proximity of the SBP wall to the rear side of the building, greater ground displacement occurred in this area, resulting in differential movement of the building.

To minimize further disturbance to the building, the following mitigation measures were implemented:

1. The capping beam on the SBP wall was cast all around before the excavation works, providing structural continuity
2. Excavation works surrounding the building were carried out sequentially and in stages, progressing level by level to reduce the differential settlement.

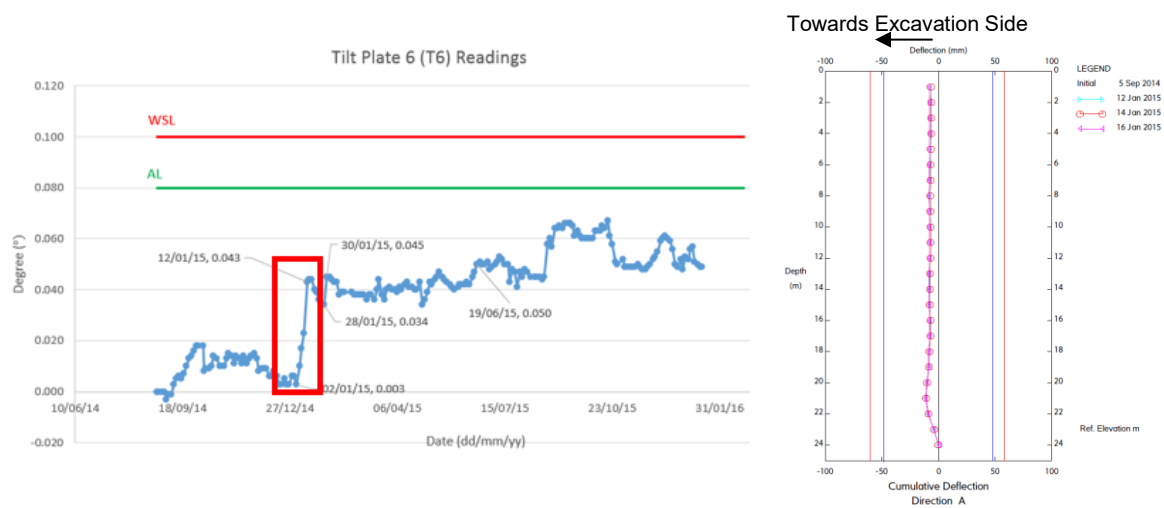
**Figure 11.** Tilt plate T6 readings (left). Inclinator INC5 readings (right)

During the subsequent excavation works, the former Olson Building recorded an additional backward tilt of about  $0.03^{\circ}$ , corresponding to a tilt ratio of approximately 1/1900. The total recorded building settlement is 7mm and is within the allowable limit of 10mm for conservation buildings (Building and Construction Authority, 2024). The measured tilt was consistent in direction with the predicted tilt of 1/1100 and was within the allowable limit, indicating that the proposed measures were effective in controlling the differential settlement throughout the excavation process.
