# The behavior of support measures applied to the Eupalineio tunnel, 10 years later

George Dounias<sup>1</sup>, Evryiadis Lyberis<sup>2</sup> and Vasileios Gkikas<sup>3</sup>

## ABSTRACT

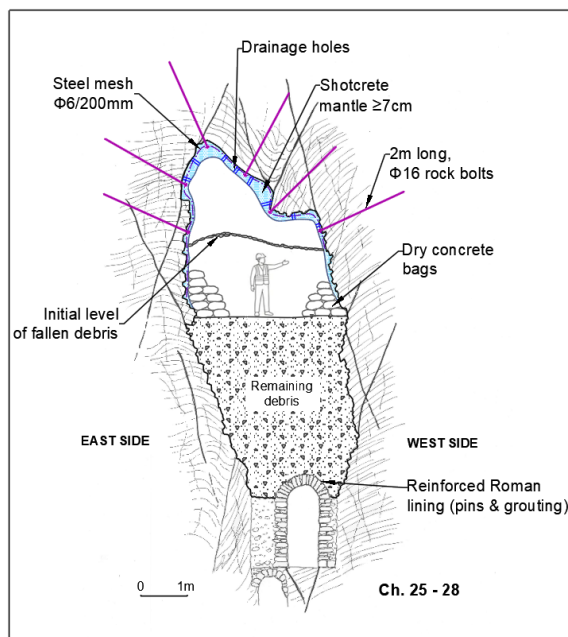
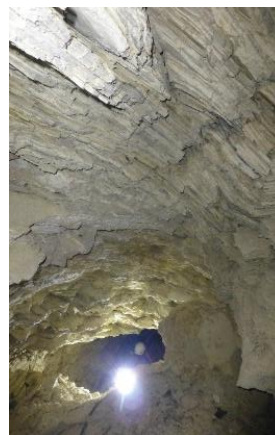
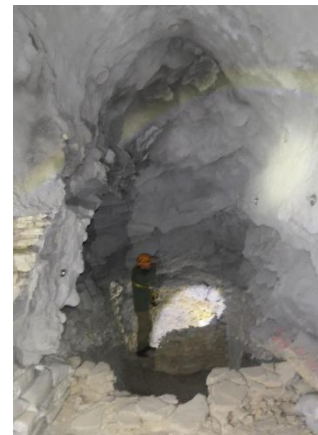
The collapse of a low-strength, thinly bedded rock mass, composed of platy, marly limestones alternating with marls, above the vault of the Roman lining formed an impressive cavern—a “chimney failure” in tunneling terminology—along this section of the Eupalinos Tunnel (see Figure 2). This failure

During the 2026 inspection, the interventions were found to be in pristine condition. There were no signs of deformation in the cavern roof or walls, such as shotcrete cracking or overloading of the anchor plates, while the light concrete bags remained intact (see Figure 2).

**Figure 2.** Cross section with the implemented support measures within the cavern above Roman lining (left). Pre-intervention rockmass condition in the cavern (middle). Post-intervention state during the 2016 inspection, displaying shotcrete, rock anchors, and dry concrete bags (right).

Considerable measures were applied comprised of: (a) rock scaling; (b) application of a shotcrete mantle (7–30 cm thick), reinforced with stainless steel mesh ( $\varnothing 6/200$  mm) and 2m-long,  $\varnothing 16$  mm stainless steel rock bolts installed in a nominal 1x1m grid pattern to enhance the stability of the cavern roof and walls; (c) partial unloading of the Roman lining through the removal of approximately 1.7 m of the 5m-thick collapsed debris; and (d) placement of bags filled with lightweight dry concrete to provide confinement and additional support to the lower part of the cavern sidewalls.

Finally, the protection of the area was supplemented by reinforcing the mortared, arched, stone masonry of the Roman lining—which bears the load of the remaining fallen debris—using pins and grout injections.

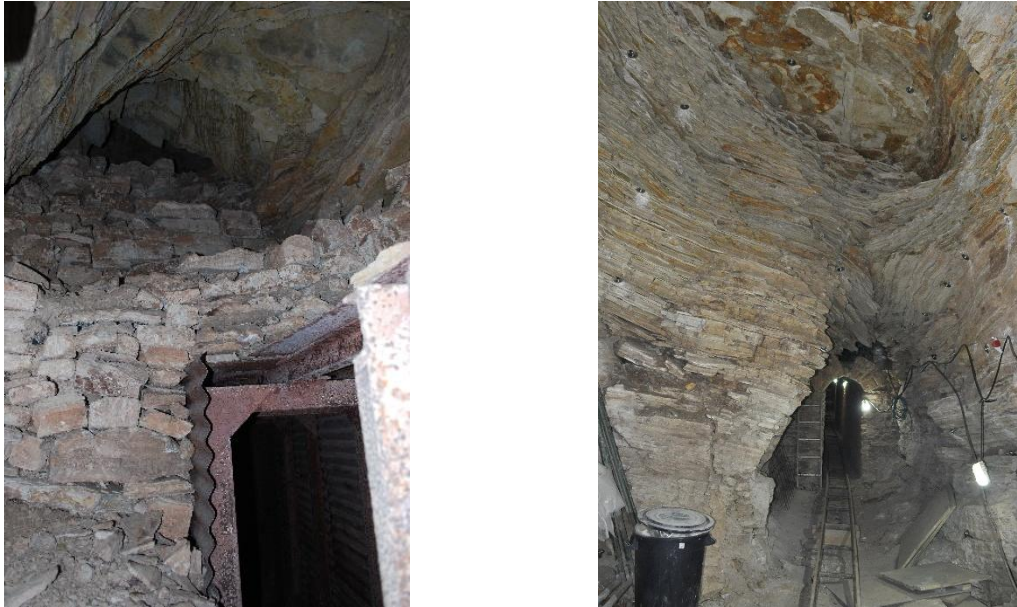
Figure 3 illustrates the canopy installed by the German Archaeological Institute (DAI) between Ch. 49 and Ch. 63.7, where the failure mechanism mirrored that observed between Ch. 15 and Ch. 50, resulting in a chimney failure with a crown extending more than 3 m above the original tunnel roof. The rusted canopy was removed, the area was cleared and the walls and roof of the opening were stabilized by an anchored netting (Figure 4). Then, a new stainless-steel canopy was installed. The canopy is 1.4 m wide and serves as an extra protection against roof collapses. Locally it was adopted to also act as support of partially detached rock wedges (Figure 4).

**Figure 3.** Pre-intervention sheltered walkway constructed by the DAI (left); the same location during installation of rock support measures after clearing (right).

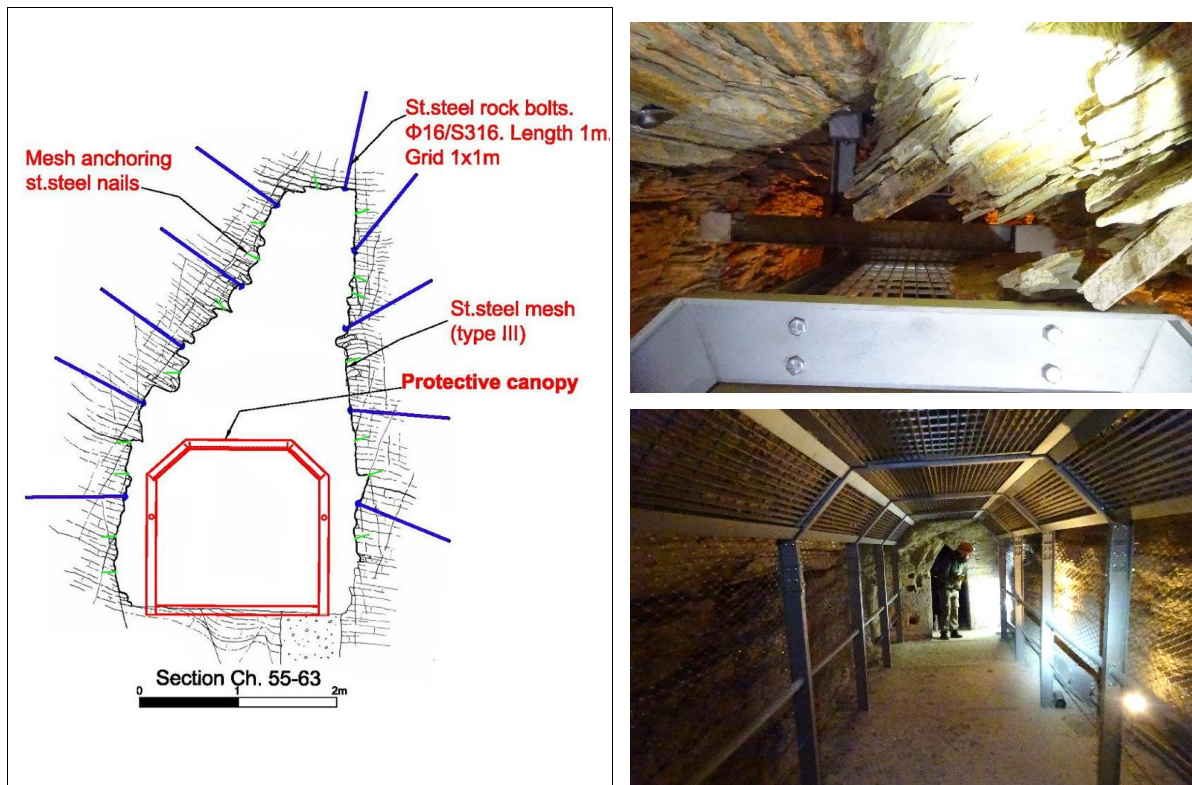
**Figure 4.** Cross section detailing the protective canopy and the rock support measures at the section between Ch. 49 and Ch. 63.7 (left). View of the installed canopy during the 2026 inspection (down right). Detail illustrating canopy protecting the visitor walkway from active rock falls (up right).

During the 2026 inspection, the canopy was found to be in perfect condition (Figure 4). Small, detached rock fragments were successfully retained by the anchored netting.

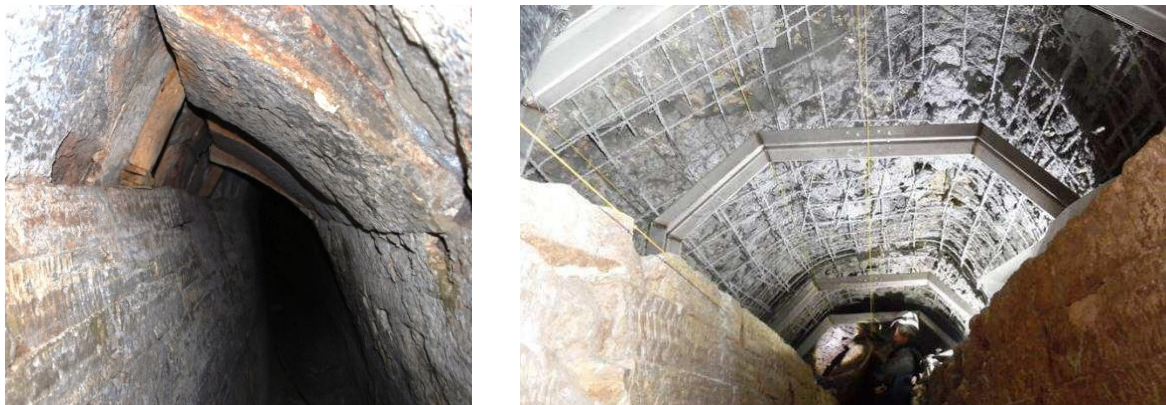
**Figure 5.** Distorted section between Ch. 130 and Ch. 136 prior to reconstruction (left). Representative view of the restoration process following the removal of the tholites (right).

Figures 5 and 6 illustrate the case between Ch. 130 and Ch. 136 of the archaic lining. Within this section, twelve pairs of tholites exhibited significant inward displacement—reaching up to 34 cm—accompanied by severe fracturing and the opening of construction joints. These deformations were driven by the gravitational collapse of a highly weak, thinly bedded to shaly rock mass. This lithology consists of platy, marly limestones, marls, and green tuffaceous alternations with sheared argillaceous shale intercalations. Structurally, the zone is characterized by a synclinal fold axis and conditions of increased moisture. After the dismantling of the tholites and the debris removal it was revealed that a cavern, up to approximately 1 m in height, had formed directly above the original tunnel crown.

The reconstruction of the archaic lining posed significant engineering challenges for both the Consultant and the Contractor. It required continuous adaptation of design during construction, as actual conditions of the rock were revealed. Critical factors included the structural condition of the existing lining, the quality of the surrounding rock mass, and the limited space available for the interventions.

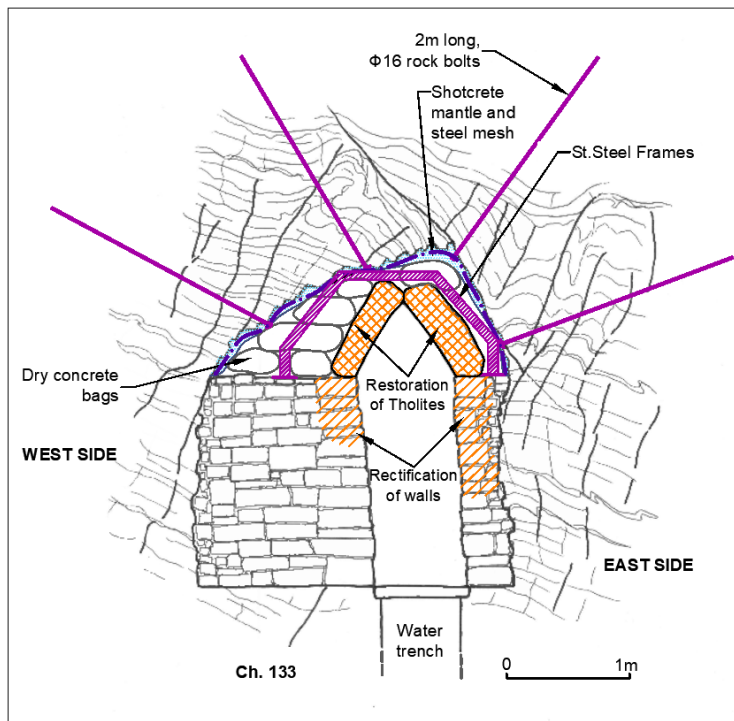
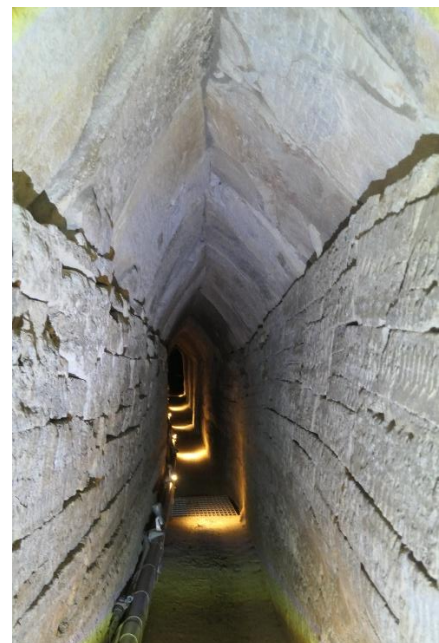
**Figure 6.** Cross section with the implemented support measures for the reconstruction of the archaic lining (left). Finalized view of the section during the 2026 inspection (right).

During the 2026 inspection, the restored Archaic lining was found to be in excellent condition, fitting seamlessly with the remaining lined sections (see Figure 6). No signs of visible deformation were observed.

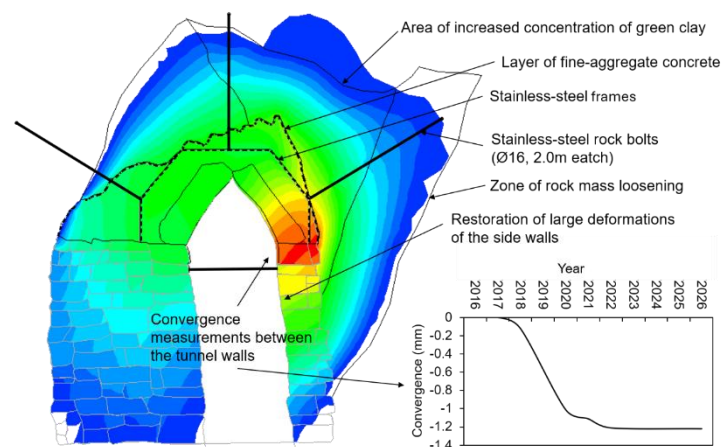
**Figure 7.** Performance of the restoration works, based on numerical simulation and field measurements.

Figure 7 presents the calculated displacement distribution after relaxation of the rock mass, calibrated to reproduce the final measured convergence of approximately 1.2 mm at the monitoring location. The performance of the restoration works appears to be satisfactory, as the loads transferred from the rock mass to the lining are significantly reduced compared with those that the lining had been required to withstand before the restoration measures.

The largest calculated displacements remain concentrated along the right-hand side of the section, owing both to the local geological particularity and to the structural configuration of the lining itself.

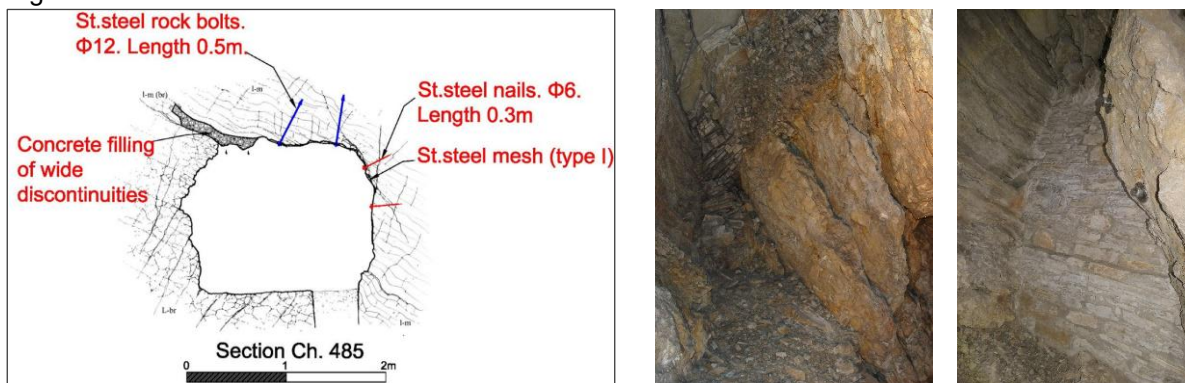
**Figure 8.** Design cross-section detailing the geological fault backfilling (left). Pre-intervention view (middle), and Post-intervention view during the 2026 inspection of the fault zone at Ch. 531 after infilling with mortared masonry (right).

During the 2026 inspection, the backfilled faults were found in pristine condition, fitting well with the surrounding rockmass. No signs of deformation or fracturing were found.

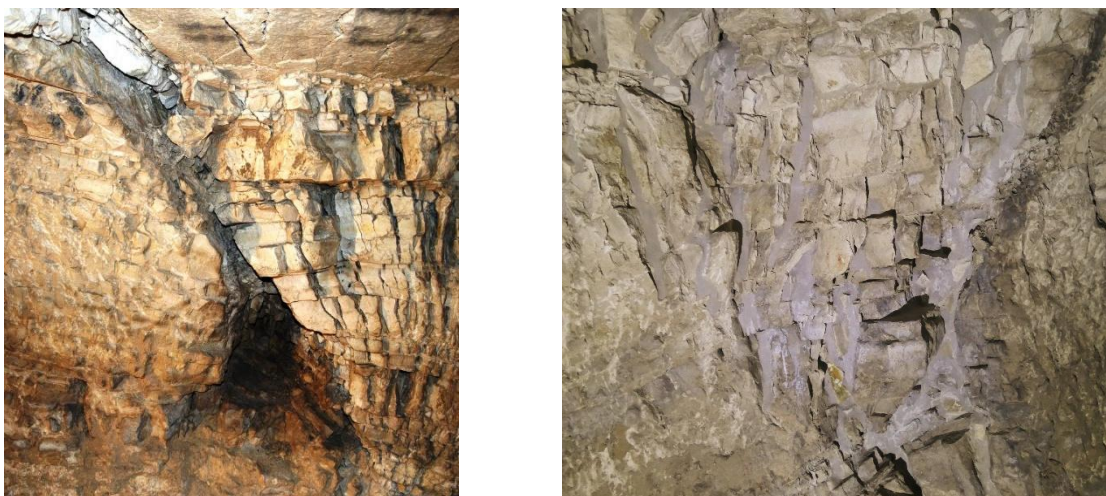
**Figure 9.** Pre-intervention view (left), and Post-intervention view during the 2026 inspection of the fault zone at Ch. 626 stabilized by pressure grouting (right).

While many of these zones were mitigated through the installation of anchored wire mesh (see below), many cases required pressure grouting (see Figure 9), whilst some larger voids necessitated backfilling with mortar (Ch. 621-625), or even the construction of a masonry wall (Ch. 509 and 531, see Figure 8). For these interventions—such as at Ch. 621-625—stones were sourced from the material stockpiled by the DAI between Ch. 49 and Ch. 63. These were bound using a color-tinted lime mortar, in full compliance with the provisions of the Conservation Study.

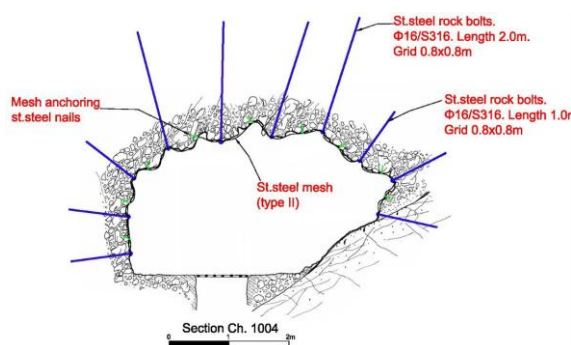
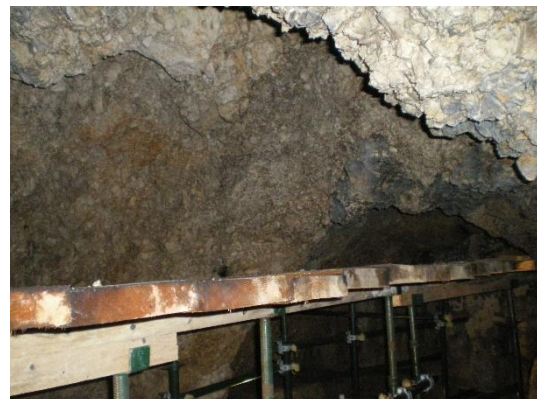
**Figure 10.** Design cross-section detailing the anchored stainless steel netting system between Ch. 999 and Ch. 1007. Pre-intervention view of the cataclastic rock mass of the section structure showing the temporary protection measures (right).

Figures 10 & 12 illustrate the tunnel section between Ch. 999 and Ch. 1007, which intersects a tectonic breccia zone developed within the limestone host rock along a major fault bounding the 'Kastro' hill (see also Figure 1). This zone is characterized by a highly irregular morphology resulting from previous roof collapses, intense fracturing, and structurally unstable rock masses. To protect this section, a Type II steel wire-rope net was deployed in combination with 1.0-m and 2.0-m-long Ø 16 mm rock anchors. In highly unstable zones, a double-layered net was installed. Mitigation measures also included the scaling of highly unstable blocks, selective grouting, and the sealing of wide discontinuities.

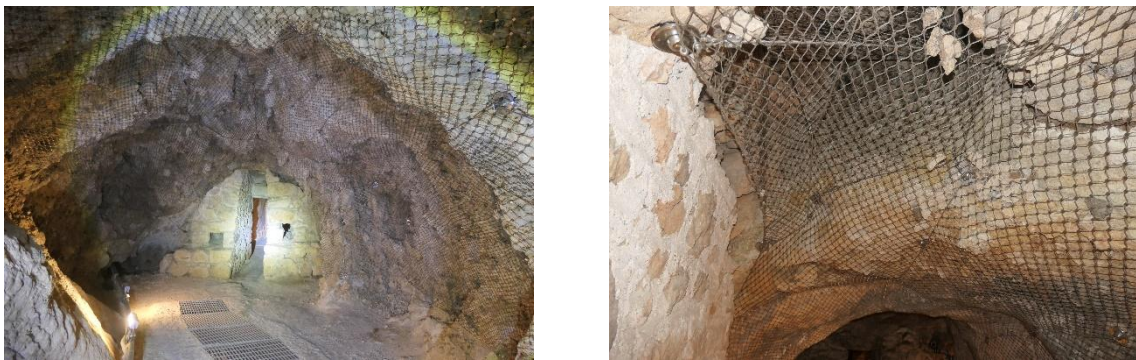
During macroscopic observations conducted in 2026, all rock bolts exhibited excellent structural integrity, showing no indications of plate deformation, loosening, or displacement. The wire-rope nets remained fully functional, effectively retaining detached fragments derived primarily from fault zones and weak shale–marl intercalations, though localized sections required minor clearing and retensioning.

**Figure 11.** View of the installation of the support system during the 2026 inspection (left). Close-up detail illustrating the wire netting retaining detached rock fragments (right).

To maintain the structural integrity of the monument and ensure visitor safety, continuous inspection and monitoring is recommended. Periodic clearing of debris accumulated behind the netting and occasional re-tensioning is required.

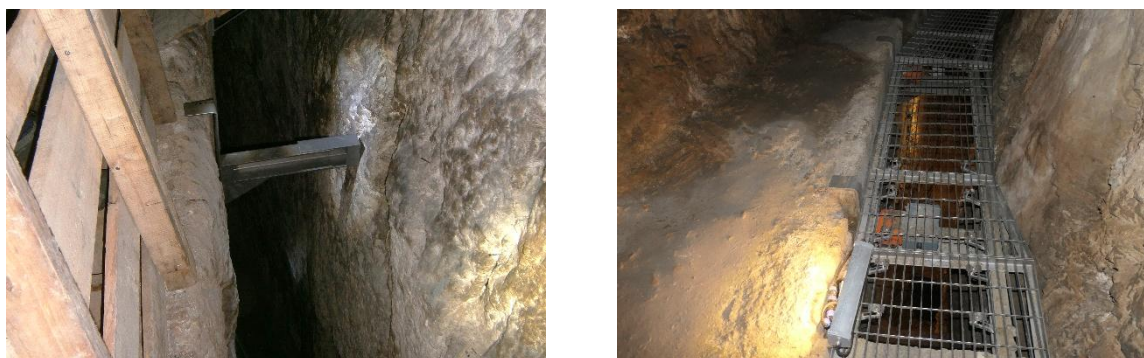
**Figure 12.** View during construction showing the installation of the transverse steel beams supporting the grates (left). Completed structural grates during the 2026 inspection at Ch. 945 (right).

During the 2026 inspection, the authors verified the robust and still flawless condition of the grates. Their installation has drastically improved both the overall appearance and functionality of the tunnel. Figure 12 illustrates a typical example of the grates application and Figure 13 compares the old trench protection with the new grates.

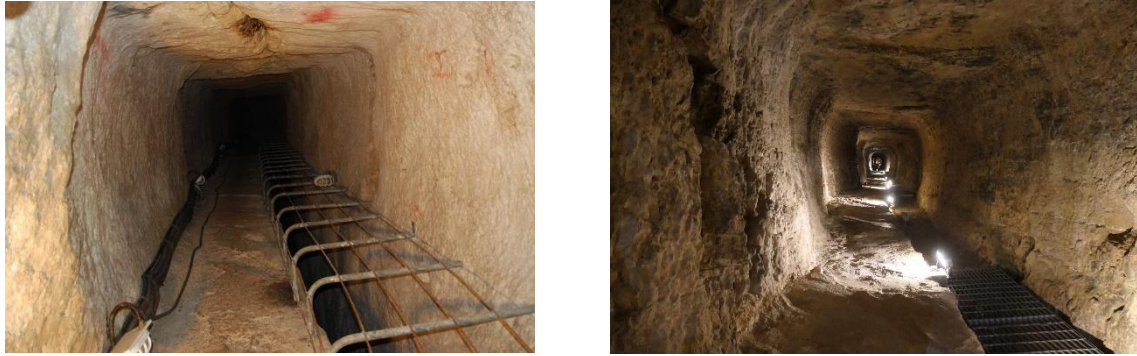
**Figure 13.** The pre-existing steel grill prior to the intervention at Ch. 568 (left). Installed structural grates during the 2026 inspection at Ch. 960 (right).
