Geotechnical properties of the Corinth Canal marls

A.G. ANAGNOSTOPOULOS, N. KALTEZIOTIS*, G.K. TSIAMBAOS*
and M. KAVVADAS

Geotechnical Department, National Technical University of Athens, Greece

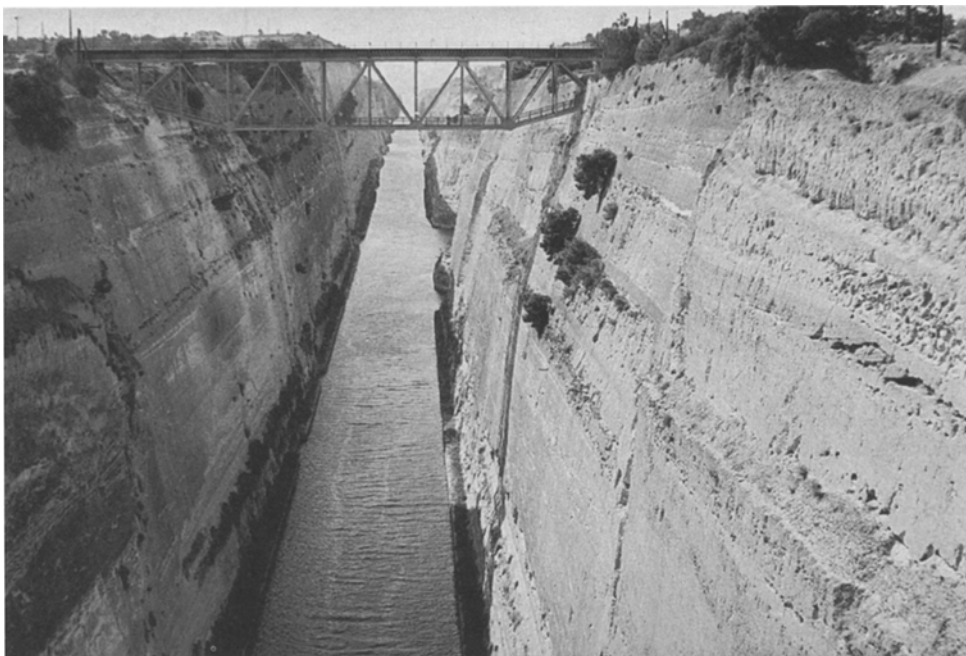
Fig. 1. A general view of the Corinth Canal

The Corinth Canal (Fig. 1) crosses the Isthmus of Corinth and is of great importance for Mediterranean navigation as well as the railroad and highway connections between southern and central Greece. It is 6.3 km long with a maximum height of 75 metres above sea level and 10 metres below sea level. The slopes have an average inclination of 4.5 to 1 (about 75 degrees) and show only minor falls, wedge-type dislocations and deformations, which developed mostly after severe earthquakes.

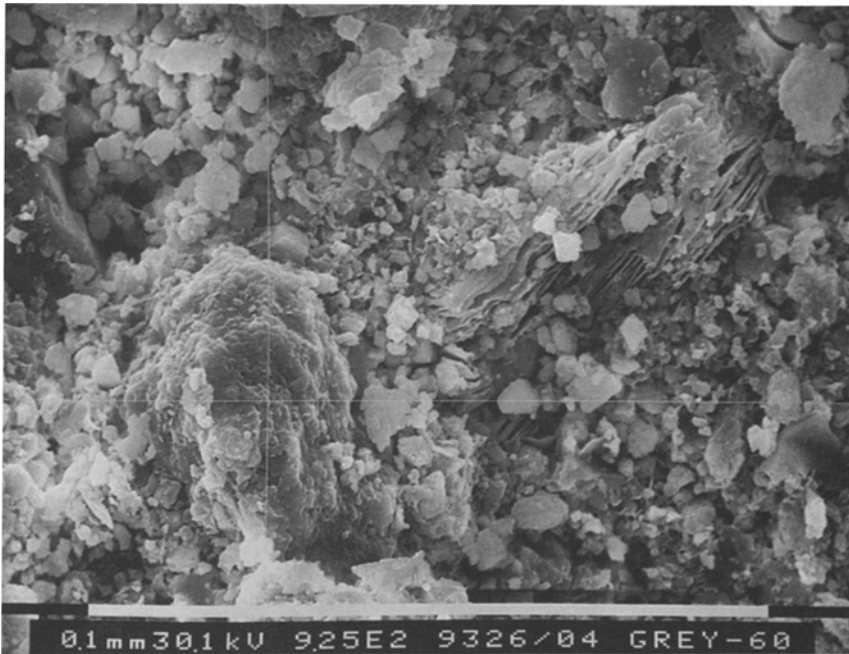
Fig. 4. s.e.m. microphoto showing platey clay minerals with a mica structure

The microstructure of the material was studied under the S.E.M. and using the EDAX technique. The grain size is very small with cryptocrystalline material of calcite as well as mixed material of clay particles and quartz (Fig. 4). The platy clay minerals with a mica structure are very altered, whereas some very well developed small automorphic crystals of quartz and calcite and well preserved diatom shells are present (Fig. 5).

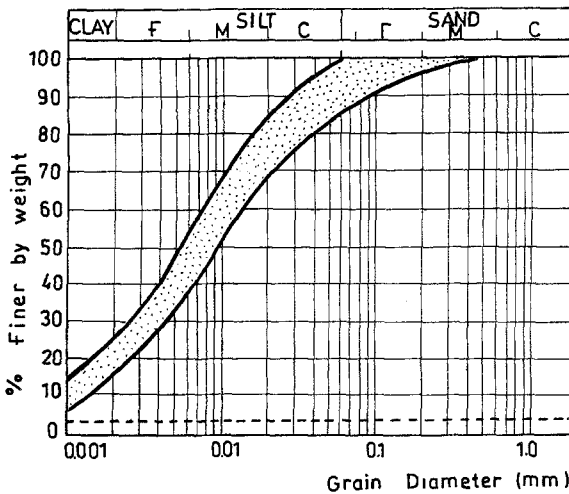
Fig. 6. Grain size distribution of the Corinth Canal marl

The grain size distribution of the marl was determined on oven-dried samples using sieve and hydrometer analysis. Envelopes of particle size curves are shown in Fig. 6. The sand content (>60 μm) is less than 12%, the silt-sized fraction ranges between 75 and 87% and the clay-sized fraction (<2 μm) between 13 and 24% (Anagnostopoulos *et al.*, 1989). The clay-sized fraction as determined by these sedimentation tests is much higher than the true clay content determined by the mineralogical analysis and can be attributed to the presence of micritic material (<4 μm in size) consisting mainly of calcite as it was detected in microphotos of the S.E.M. This feature has also been noted in other limey marls with low values of clay-sized fraction (Tsiambaos, 1988).

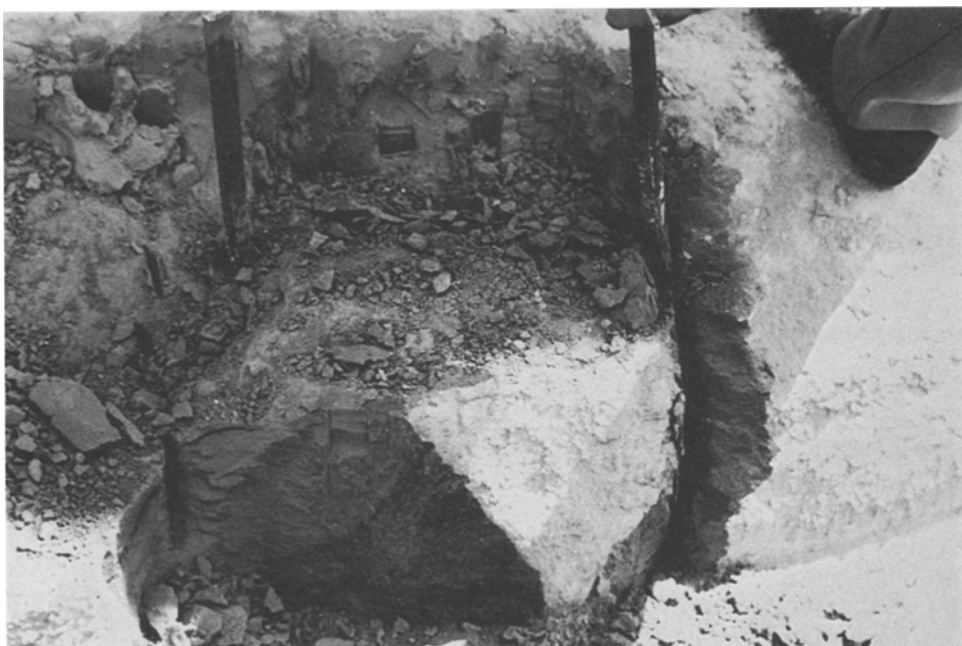
Fig. 10. Hand trimming of a block specimen

In order to minimize disturbance in the present investigation, large block samples (about 40 cm in size) were carefully hand trimmed from the toe of the slope 2 to 3 metres above sea level (Fig. 10). The blocks were then thoroughly sealed with paraffin wax, placed in double plastic bags and carefully transported to the laboratory.

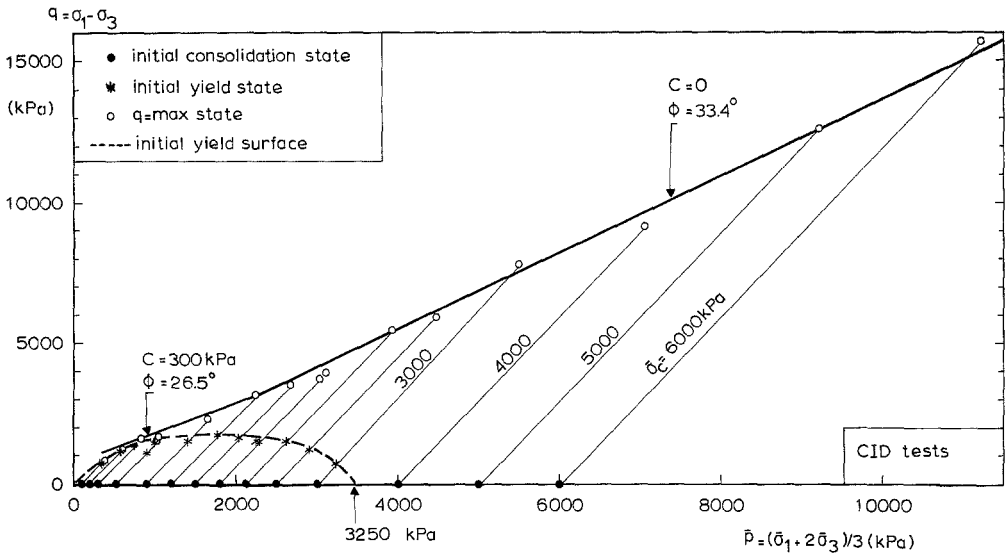
Fig. 12. Drained triaxial tests on the intact marl. Effective stress paths

Figure 12 shows the effective stress paths of the complete set of drained triaxial tests performed on the intact marl. The envelope of the initial yield states bounds the region of the pre-yield (bonded) response and defines the initial yield surface of the marl. Increasing isotropic and/or shear stress leads to states outside the initial yield surface which are associated with gradual bond degradation and reduced stiffness. The shape of the initial yield surface shows that initiation of bond degradation can be achieved more easily with the application of a shear stress rather than an isotropic stress of the same magnitude. However, even pure isotropic consolidation (at about 3250 kPa) leads to an initiation of bond degradation.
