## Analysis of slope instabilities in the Corinth Canal using UAV-enabled mapping

### ABSTRACT

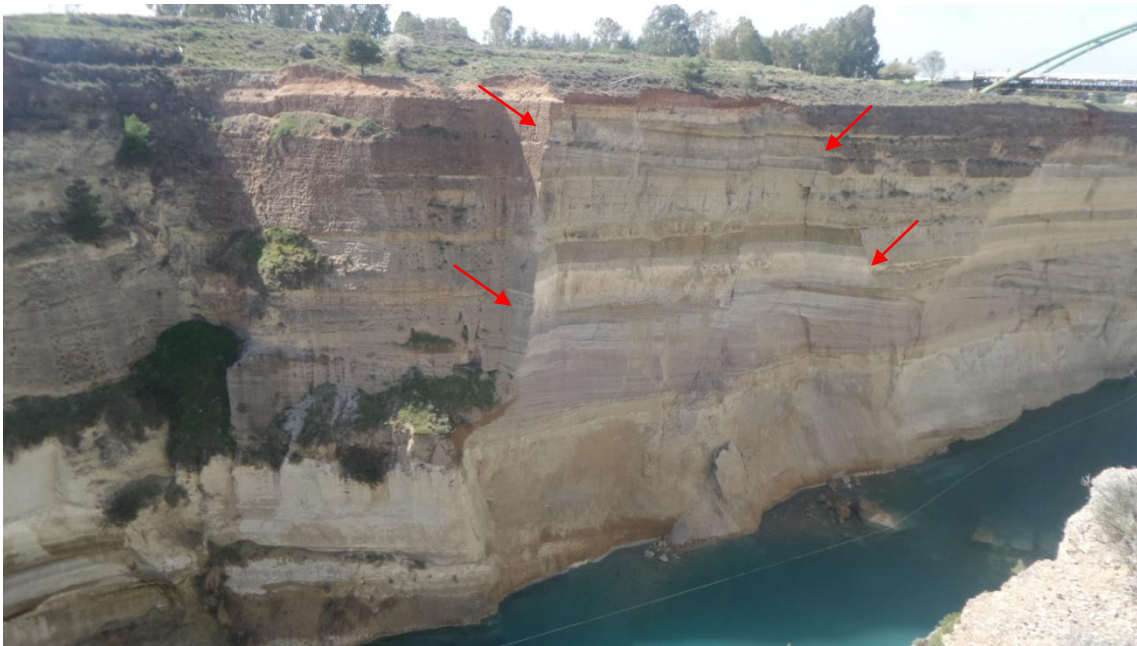
**Figure 1.** View of the slope failure, which occurred on February 26 2018 at the south slope of the Corinth Canal.

The risk of a large failure of the Canal slopes remains high, as demonstrated by the large failure that occurred on February 26 2018 and is shown in Figure 1. The safe operation of the canal may be endangered by the occurrence of slope failures and it is thus necessary to determine the risk from slope instabilities along the entire length of the canal and identify the higher risk areas. The use of new technologies, such as UAV-enabled mapping, in combination with field reconnaissance provides a very effective method of identifying the risk areas along the canal and calculating the slope stability conditions considering different loading scenarios, such as water pressure and seismic loading.

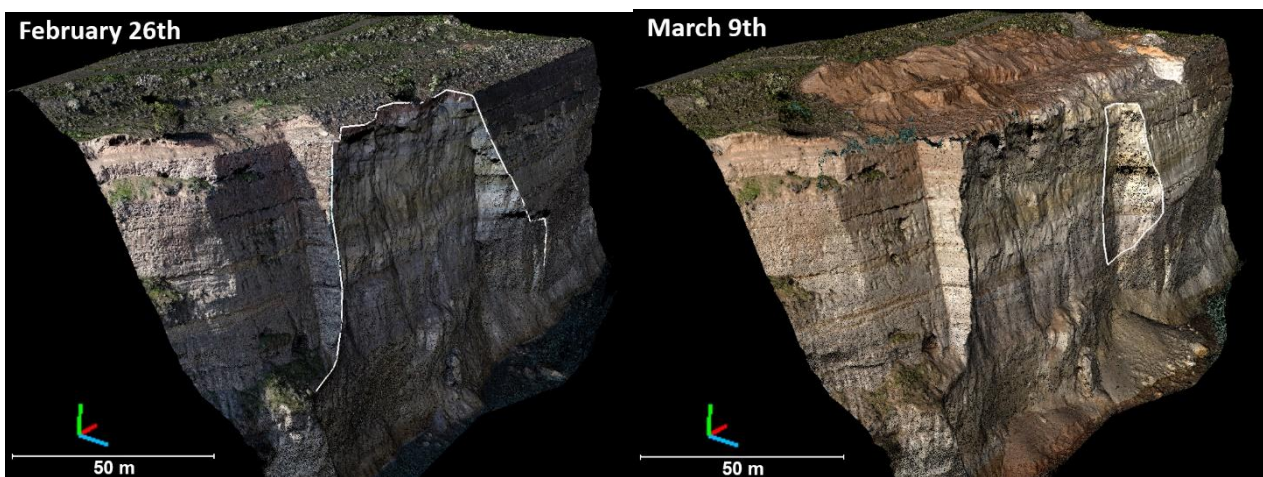
**Figure 3.** Point cloud of slope failure of Corinth Canal on February 26<sup>th</sup> and March 9<sup>th</sup> from Pix4D.

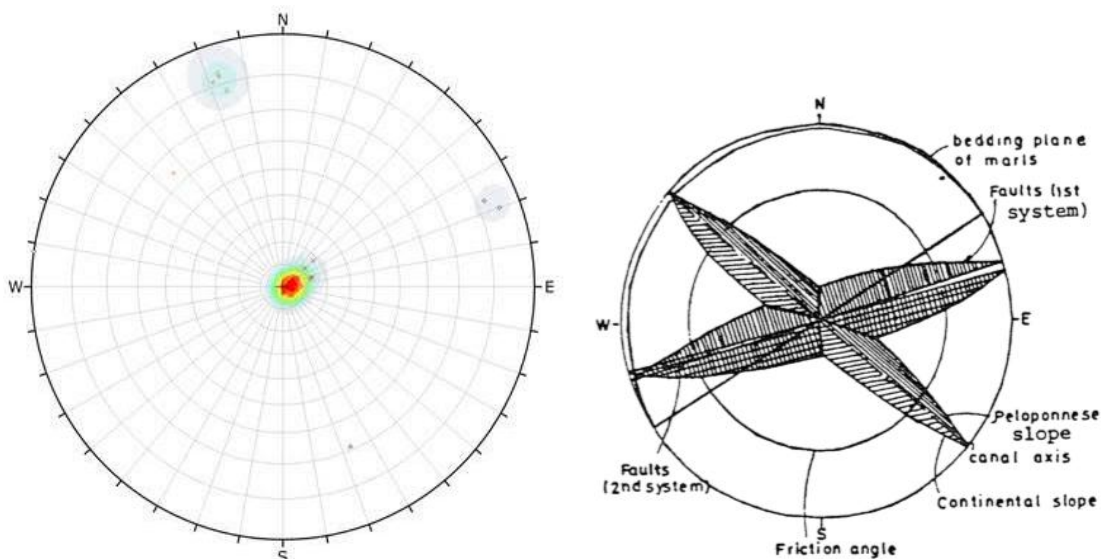
**Figure 4.** a) Lower hemisphere equal angle stereographic projection of main discontinuity surfaces controlling the slope failure. b) Structural data of the canal slopes (Andrikopoulou et al., 1988).

The geometry of the faults and main discontinuity sets were determined from the 3D photogrammetric models using photos captured from the UAV and the ShapeMetriX UAV (3GSM GmbH, Austria) software. Layers of marl and marly limestone were differentiated by mapping visibly different bands or beds of strata in three-dimensions. Similarly, other geological features, such as faults, joints and failure back scarps were also digitally mapped in 3D to identify the spatial location (X, Y and Z coordinates), the orientation of the planes (dip and dip direction), and the length or surface area of the planes. The identified discontinuities are presented in Figure 3. The Schmidt projection of the discontinuities is shown in Figure 4 and their mean orientations and geometrical characteristics are presented in Table 1.

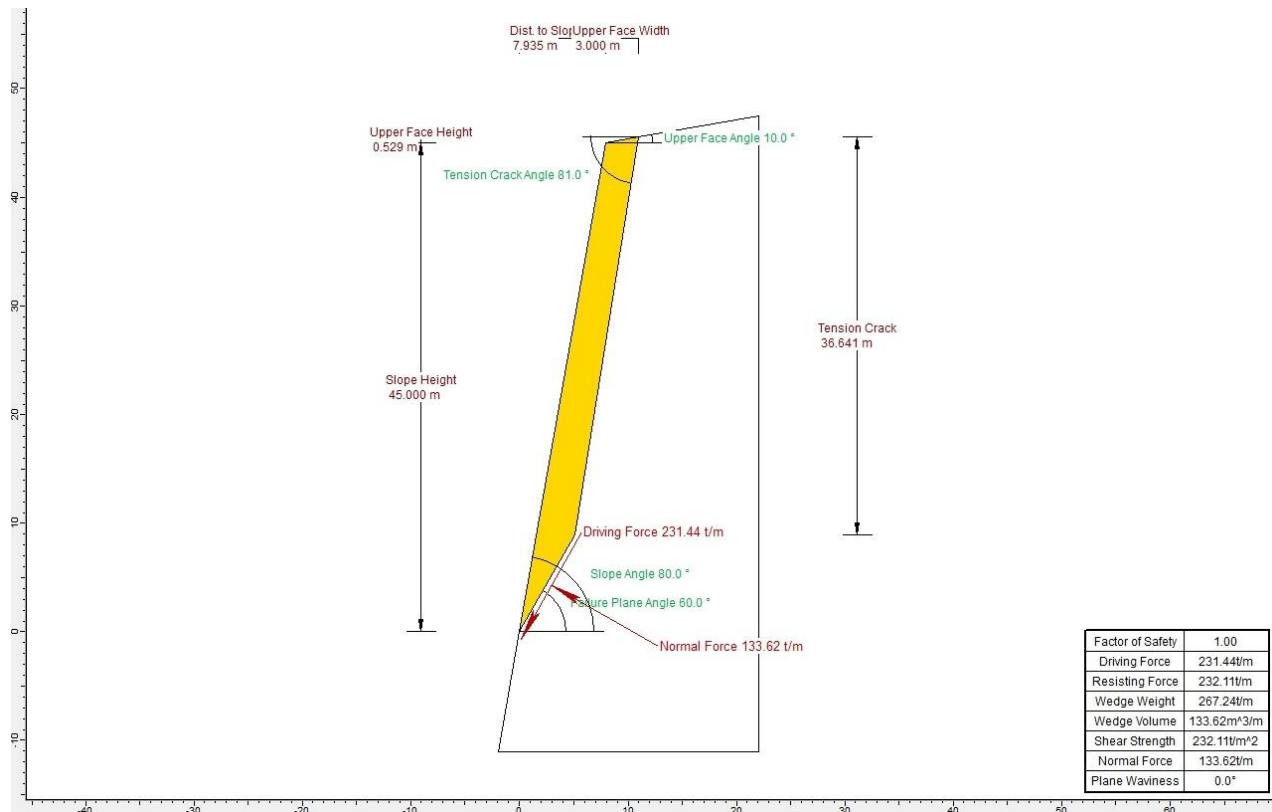
**Figure 5.** Planar stability analysis of the failure of 26<sup>th</sup> February 2018 failure.

Based on the geometry of the main discontinuity forming the scarp, and considering the initial slope geometry, a back-analysis of the February 26 failure, was performed. The back-analysis was conducted considering a planar slide of a block at the base of the slope with failure through the intact marl and a tensile crack at the back scarp of the failure.

The total height of the failed block was 45 m and the distance of the tensile crack from the slope face was 3 m. The shear strength of the marl at the base of the failed block was determined equal to  $c'=150$  kPa  $\phi=35^0$  while no strength was attributed to the back scarp tensile surface. The factor of safety was calculated equal to 1.0. Based on the planar stability analysis shown in Figure 5, and for an assumed total unit weight of 2.0  $\text{tn/m}^3$ , the wedge weight of the block was 267  $\text{tn/m}$ , resulting in a total weight of the failed block equal to 13350  $\text{tn}$ . This agrees well with the weight determined by surface differencing of the pre- and post-failure slope geometry in Cloudcompare, which was 6000  $\text{m}^3$  (equivalent to 12000  $\text{tn}$ ).
