# Mitigation of rock slope instabilities impacting Cultural Heritage sites

C. Saroglou<sup>1</sup>

## ABSTRACT

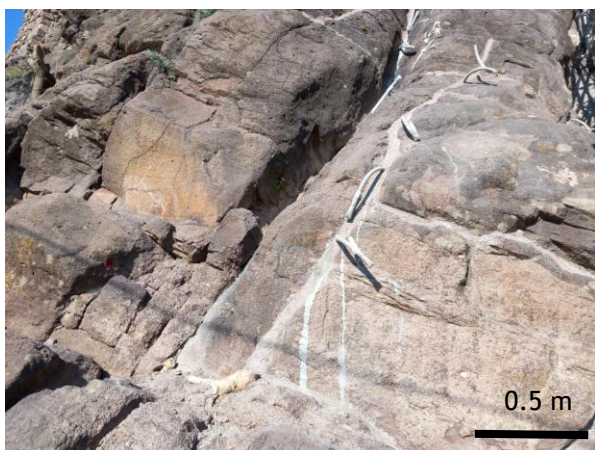
**Figure 3.** Sealing open joints in basaltic rock mass at Mythemna Castle, Lesvos Island.

An example of sealing open joints in a basaltic rock mass for the stabilisation of the rock slope at Mythemna Castle in Lesvos is shown in Figure 3. In this case, voids were encountered on the slope either due to the cooling of the basalt or due to previous slope movements, which undermined the stability of the slope. An effective stabilisation was implemented, through filling voids with concrete and constructing a stone wall facing. The concrete filling is bolted to the surrounding rock mass to achieve resistance to sliding (Figure 4).

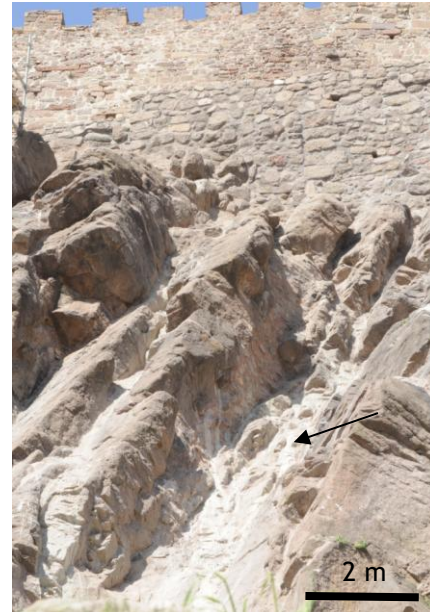
**Figure 4.** (a) Drawing detail of void filling with concrete and stone wall facing to support overhanging blocks. (b) constructed filling shown with arrow, example from Mythemna Castle.

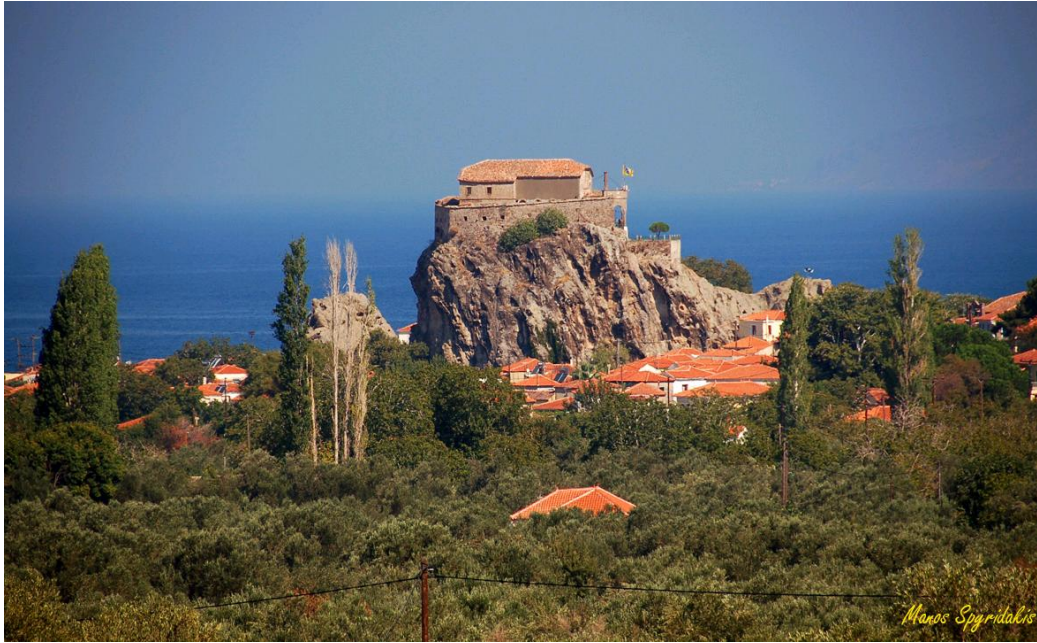
**Figure 5.** Volcanic rock cliff of Church of the Koimisi of Theotokos, Lesvos Island.

An interesting rock slope stability case is that of the volcanic rock cliff in the village of Petra in Lesvos Island, where the Church of the Koimisi of Theotokos is founded (Figure 5). The rock cliff has almost vertical slopes with height up to 40 m and is formed by an andesitic rock mass, fractured by four discontinuity sets. The predominant kinematic instability is wedge or toppling failures of medium-sized rock blocks. The problem of potential rock instability of the volcanic slope in Petra has been investigated in the past (Apostolopoulos & Koukis, 1979) and rock fall episodes have occurred mainly triggered by intense rainfall. Due to the weathering and deterioration of the andesitic rock mass, the risk of rock instability has increased in the last two decades and it was deemed necessary to protect the foundation of the monument as well as the surrounding settlement and visitors from potential rockfalls. Stabilisation measures were proposed to minimize the risk of rockfalls and protect the foundation of the Church (Saroglou et al. 2025).

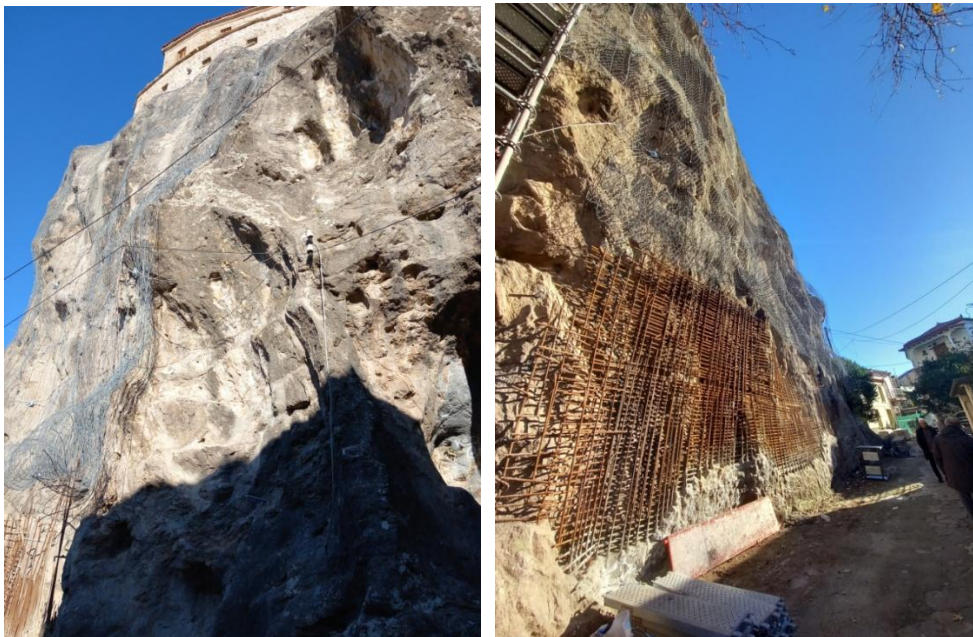
**Figure 8.** (a) Installation of anchored wire mesh, (b) filling of voids with cement at the base of slope in overhanging areas.

- Installation of spot bolts for anchoring individual relatively small rock blocks and pattern bolting for anchoring of larger blocks. The aim of this measure was to support potentially unstable blocks and improve the stability conditions of the upper part of the cliff below the foundation of the Church.
- Installation of a steel wire rope net, anchored with fully grouted bolts to control further loosening of the rock mass in fractured areas, as presented in Figure 7 and Figure 8a.
- Filling of voids in specific

locations with sprayed concrete, depending on their location, geometry and size to minimise the enlargement of voids due to weathering and support the overhanging slope areas (Figure 8).

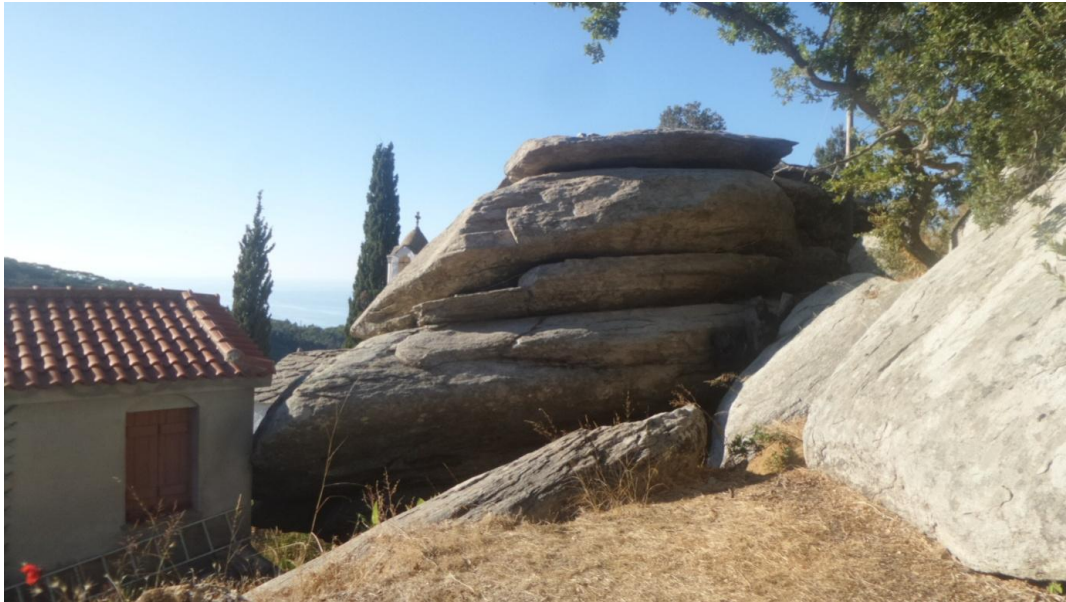
**Figure 9.** Gneiss rock mass sliding on foliation plane and impacting a historic church. The church is downslope behind the rock block.

An example of an unstable blocks due to instability of individual rock blocks is demonstrated by the case study of Theoktisti Church, which is impacted by the movement of a gneiss rock block, sliding on a gently dipping foliation plane (dip between  $16-25^\circ$ ) as shown in Figure 9. The block is detached from the rock mass as a tensile crack is formed on the backscarp of the block (Figure 10a). A backanalysis was performed to determine the shear strength of the sliding plane. A kinematic analysis under hydrostatic pressure (filled at 65% of the tensile crack height) and earthquake loading ( $a=0.112g$ ) was performed to determine the required support force (Figure 10b). The force was calculated equal to 262 kN per meter and the proposed anchor length was equal 8 m, inclined at  $65^\circ$  from horizontal.

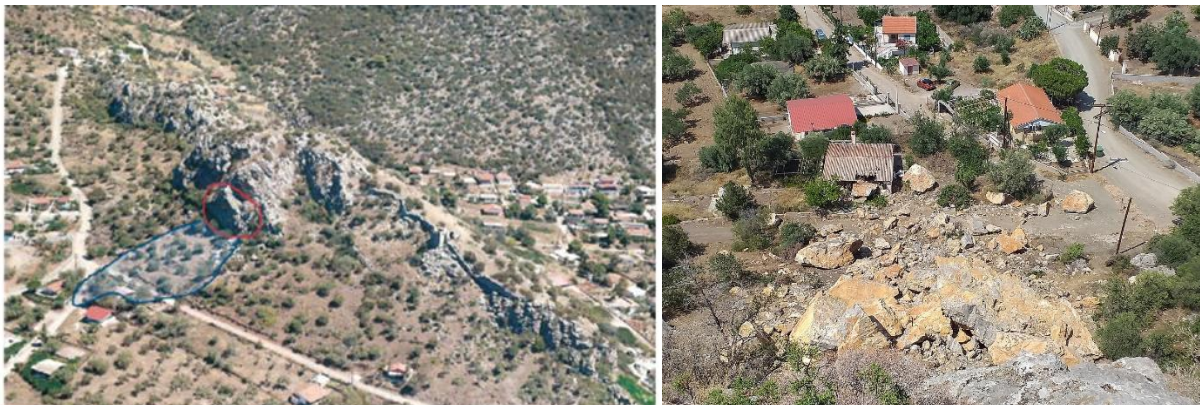
**Figure 12.** (a) Aerial photograph showing the location of the 2019 rockfall detachment and the area of rock blocks deposition b) Rockfall event impacting houses.

The case study refers to the Acropolis (4<sup>th</sup> century BC) situated at the crest of a limestone promontory in Alyki, Voiotia prefecture, central Greece. The Acropolis still preserves a 400 m long fortification that surrounds the north and east side of the promontory. The slopes on which the Acropolis is founded are steep and the area is prone to rockfalls due to the fracturing of the limestone rock mass and the presence of overhanging unstable blocks (Saroglou et al, 2019). In 2019, a rockfall event reaching a total volume of 1000 m<sup>3</sup> occurred after heavy rainfall and impacted the houses located at the base of the slope putting also into risk the integrity of the archaeological site (Figure 12). Mitigation of potential rockfall impacts on visitors of the Acropolis and surrounding houses was deemed necessary and a detailed assessment was commissioned.

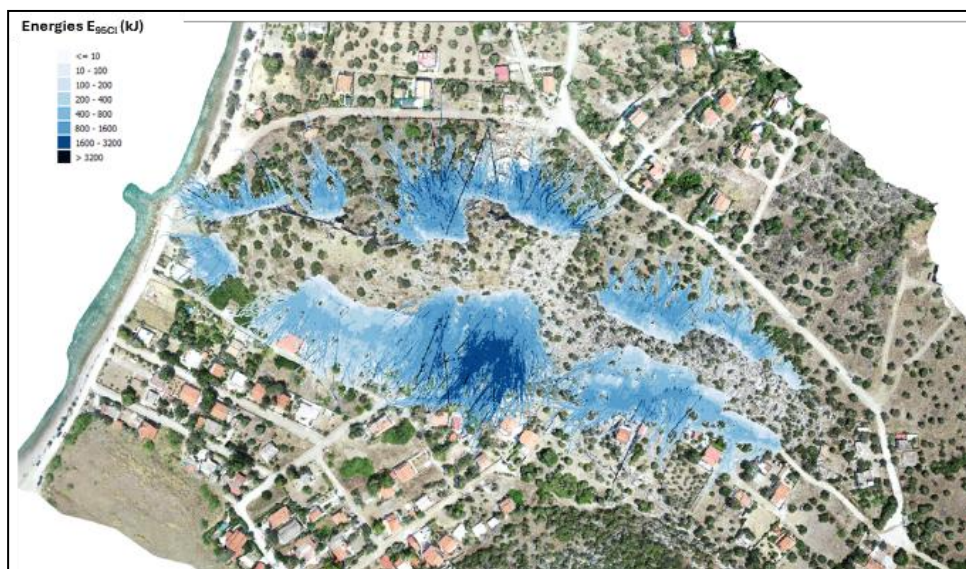
**Figure 13.** Distribution of kinetic Energies  $E_{95CI}$  in the surrounding area of the Acropolis of Voiotia.

The main results from 3D analysis are a) the trajectories of the simulated rock blocks, b) the reach probability (RP), c) the Kinetic Energy ( $E_{95CI}$ ) defined as the mean kinetic energy (kJ) of the falling rocks in a specific location increased by two standard deviations (95% confidence interval assuming a normal distribution of passing heights). An example from a 3D analysis with kinetic energy distribution of falling rocks from this site is presented in Figure 13.

The kinetic energy of the rocks, ranges between 200-1600 kJ in most areas, but in some places (especially in the central, southern part) they exceed 1600 kJ and in very few cases can reach up to 3200 kJ. To address the potential risk of rockfalls impacting the houses, it was proposed that rockfall barriers are installed at specific locations to intersect the trajectories. The barrier kinetic energy ranged between 500 kJ and 2000 kJ at maximum, dimensioned at the 95% percentile of kinetic energy distribution while their height was calculated equal to 5 m. The appropriate location of the rockfall barriers was calculated based on the 3D analyses as shown in Figure 14. Some outliers may exist (i.e., rock blocks that propagate above the protective barriers), but their impact on the barriers decreases their kinetic energy hence their trajectories will not reach the houses.
