# The Folkestone Warren landslides and the East Cliff Roman Villa

K. Parfitt<sup>1</sup> and E. N. Bromhead<sup>2</sup>

## ABSTRACT

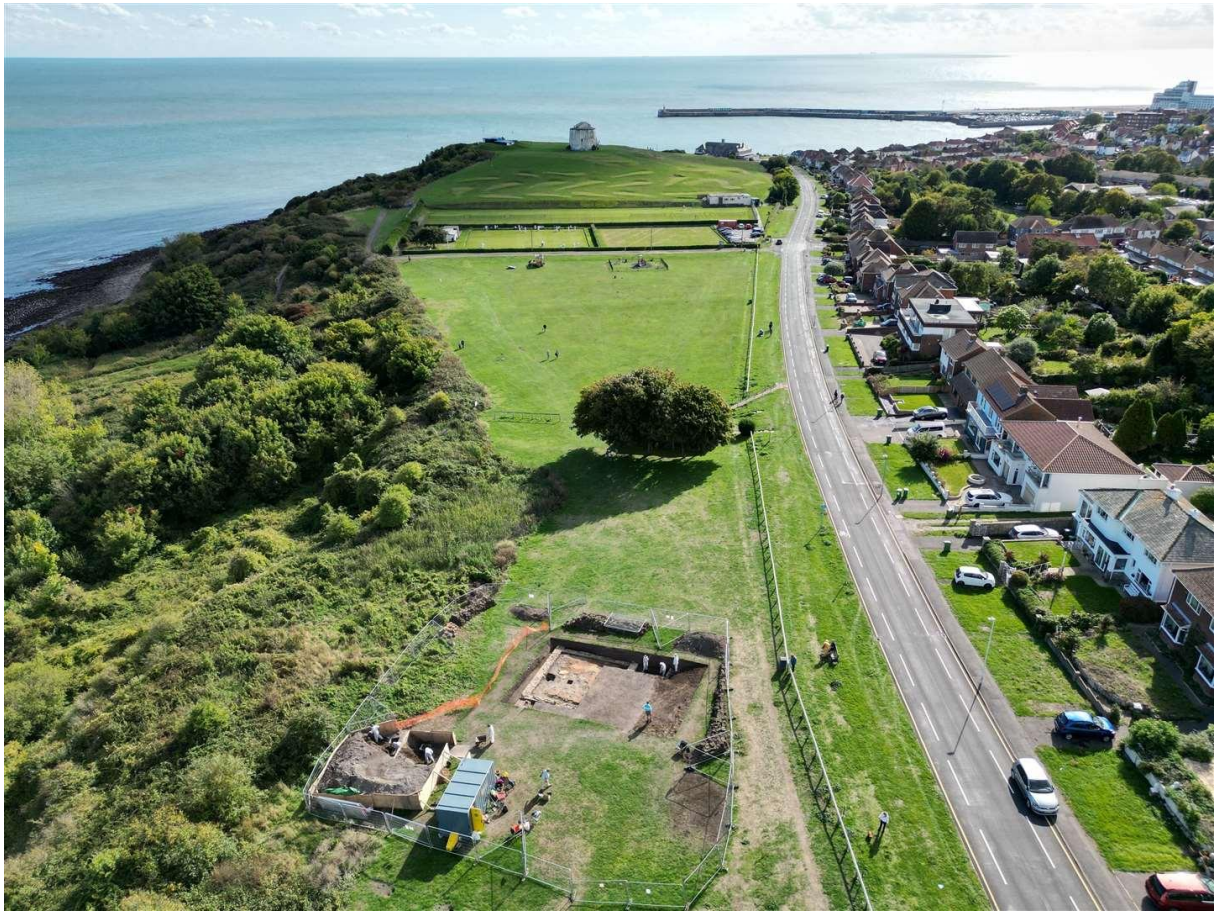
**Figure 4.** A view of the East Cliff with the modern excavations in the foreground, Copt Point, Martello Tower No 3 and the Folkestone Harbour breakwater arm in the distance.

Even in Winbolt's day it was apparent that the Roman villa site on East Cliff, along with the significant pre-Roman remains that underlie it, would ultimately be lost to the sea. Work on the cliff-edge bathhouse, Block C, by the Kent Archaeological Rescue Unit in 1989 showed that about 30ft (c.10m) of the structure had been lost since it was first excavated in 1924. Similarly, when Winbolt first exposed

the villa walls, there was around 30 metres of land between the north-east wing of the main house and the cliff edge. By 2009 this figure had been reduced to 2.25m.

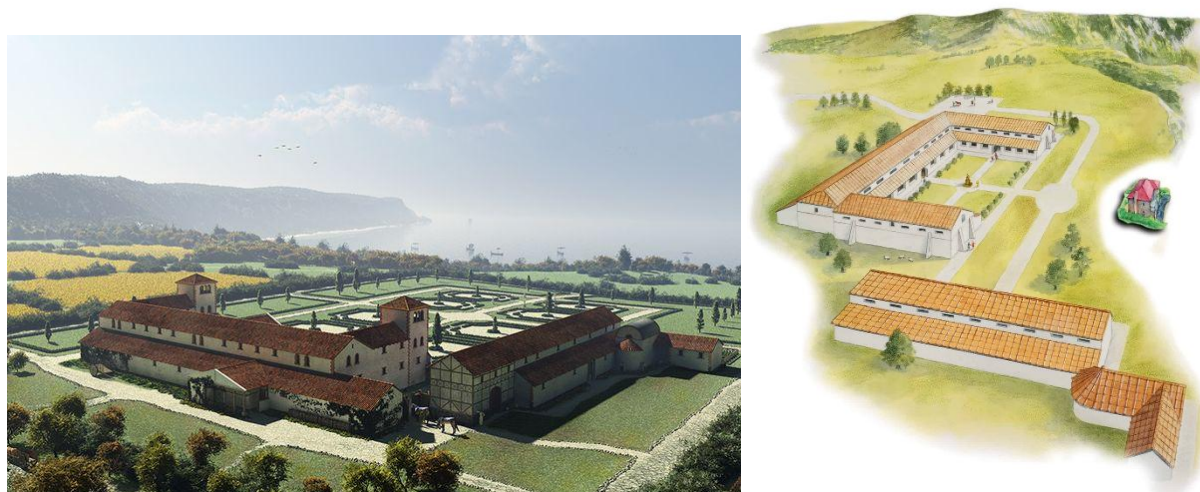
**Figure 5.** Artists' impressions of the villa. (a) A grand establishment with coastal views and elaborate gardens (left). A more modest, and perhaps more industrial establishment (right: image [www.arccreative design.com](http://www.arccreative design.com) and White Cliffs Countryside Partnership).

Alternatively, in keeping with a Victorian era meme of a grand house with sweeping sea views, then the reconstruction with elaborate gardens of Figure 5 (left) – which incidentally lacks access to the shore – might be a solution.
