## Winter Road Maintenance as a Threat to Our Built Heritage

T. DiLorenzo<sup>1</sup>

<sup>1</sup>Graduate Engineer, Aperture Consultants Bryant, Carrollton, United States, email: taryn.dilorenzo@aperturellc.com

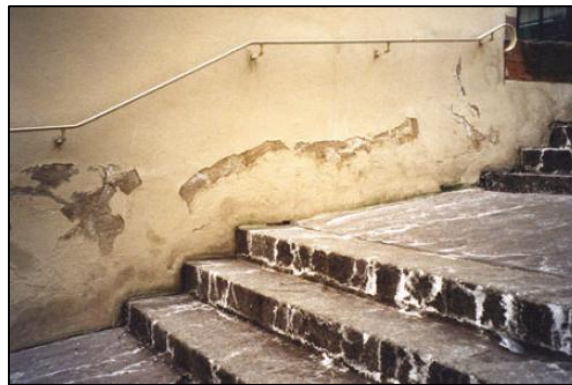
Deicing salts have been found to be a major contributor to chlorides accumulating at the ground level of masonry. Figure 2 shows the effects of de-icing salts on urban masonry. It can be observed from the figure below, that efflorescence from de-icing salts has accumulated on the stairs and impacted the masonry.

**Figure 2.** Accumulated efflorescence from dried deicing salts (From Steiger et al., 2010)

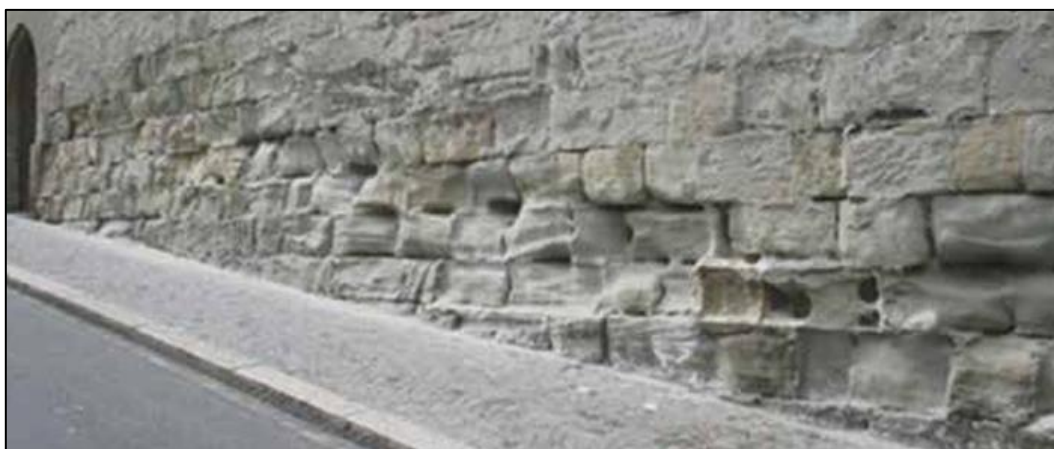
Rising damp is caused by deicing salts present in the soil that then travel to the base or foundation of a structure via capillary rise (Steigler et al., 2010). Older structures are particularly vulnerable to this phenomenon due to insufficient insulation from ground moisture. During capillary rise, moisture travels from the subsurface soils to the foundation of base of the structure and then through the structure allowing the salt in the water to travel further from the base. The ultimate height of this capillary rise is given as the height where the evaporation rate is equal to the supply of moisture from below. Because the rate of evaporation will vary based on the amount of salt present and the porosity of the material, the deterioration of the material will vary significantly. Figure 3 below illustrates the effects of capillary rise on masonry. Here, the damage sustained to the wall from NaCl is over 2 meters above the ground level.

**Figure 3.** Salt weathering in upper portion of structure (From Charola et al., 2017)

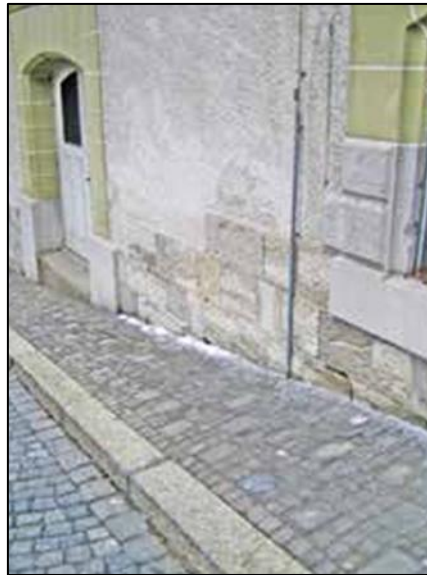
Dry winter weather does not prevent the risk of damage. Porous materials absorb moisture from the atmosphere; this moisture can mobilize and deposit salt into cracks and pores of the structure, becoming a major source of salt contamination. Remaining salts on pavements crystallize and these particles are dispersed by vehicles and pedestrians, allowing them to become airborne. A study of European air quality showed PM air levels contained enough NaCl for inland areas to be considered as sea salt air (Charola et al., 2017). Salt damage is not limited to the outside of monuments. Morabito 2013 found chloride deposits in the entrance of St. Mark's Basilica. The levels of chloride decreased further into the chapel, indicating the source of contamination was from outside the structure. The figure below illustrates the accumulation of residual deicing salts on the base of the structure during a dry winter period. These residual salts can be mobilized and then enter the pores of the structure through absorption (Charola et al. 2017).

**Figure 4.** Accumulated salts at the base of the structure (From Charola et al., 2017)

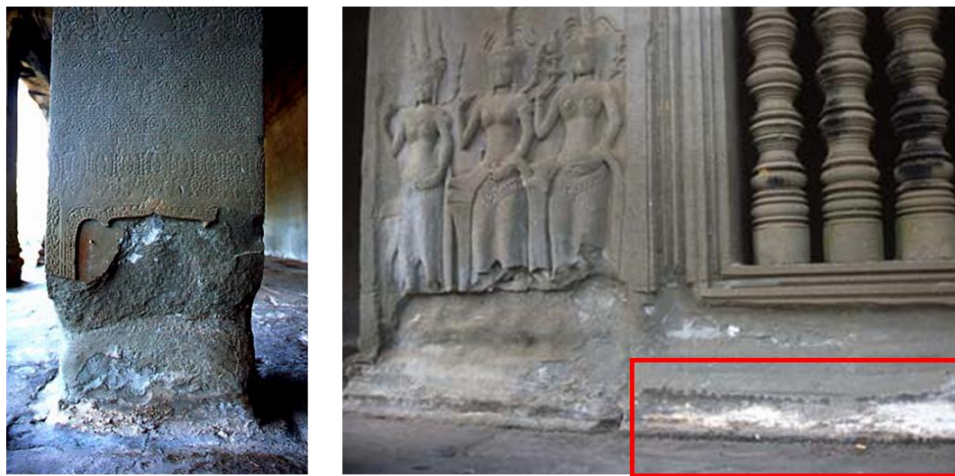
The 12<sup>th</sup> century temple of Angkor Wat, located in Cambodia, is part of the UNESCO World Cultural Heritage. The deterioration of the monument due to salt load has been extensively studied (Hosono et al., 2006; Siedel et al., 2008; Waragai & Hiki, 2019). The superficial degradation here is characterized by scaling and flaking. Siedel et al., 2008 found that structural damage to the stone occurred in areas that are not exposed to prolonged high surface temperatures. The higher surface temperatures allow the stone to dry, illustrating the requirement of moisture in any form for salt crystallization to occur and thus cause pore expansion and degradation of the material's structure.

**Figure 5.** Damage to a pillar (left). Example of scaling on the carvings and salt efflorescence, in boxed area (right). (From Siedel et al., 2008)
