## **LANDSLIDES TRIGGERED BY INTENSE RAINFALL: NUMERICAL SIMULATION USING FLAC AND PRELIMINARY RISK CONSIDERATIONS FOR CULTURAL MONUMENTS**

This study investigates landslides in Zagora (Pelion, Greece) due to extreme rainfall of Storm Daniel (2023). More specifically, it deals with the failure mechanisms and their indirect impacts on nearby cultural monuments. Based on field observations, it appears that rapid saturation near the surface of the slopes increased water pressures in the pores and reduced the shear strength, causing their instability. The simulation was carried out through the FLAC 2D program, and it was shown that the results agree largely with the field observations. In this case, that is, that heavy rainfall destabilizes the slopes and disrupts access to cultural sites. In conclusion, the need for monitoring and achieving targeted stabilization measures in areas of high vulnerability is emphasized.

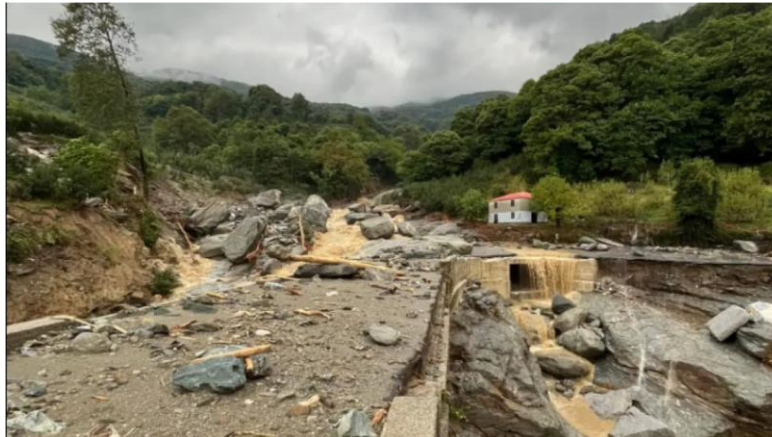
***Figure 1: Damage caused in Zagora by landslides due to heavy rainfall***

In Zagora, the damage affected both the natural environment and the local infrastructure. The landslides caused landslides, leading to rock falls, the transport of debris and the deposition of large volumes of mud and worn material on roads, residential areas and agricultural lands. Consequently, significant sections of the road network were damaged or remained inaccessible for long periods of time. At the same time, small bridges and other technical structures were destroyed due to the strong hydraulic action and erosion caused by the flowing water. subsequent slope failure modeled in this study.

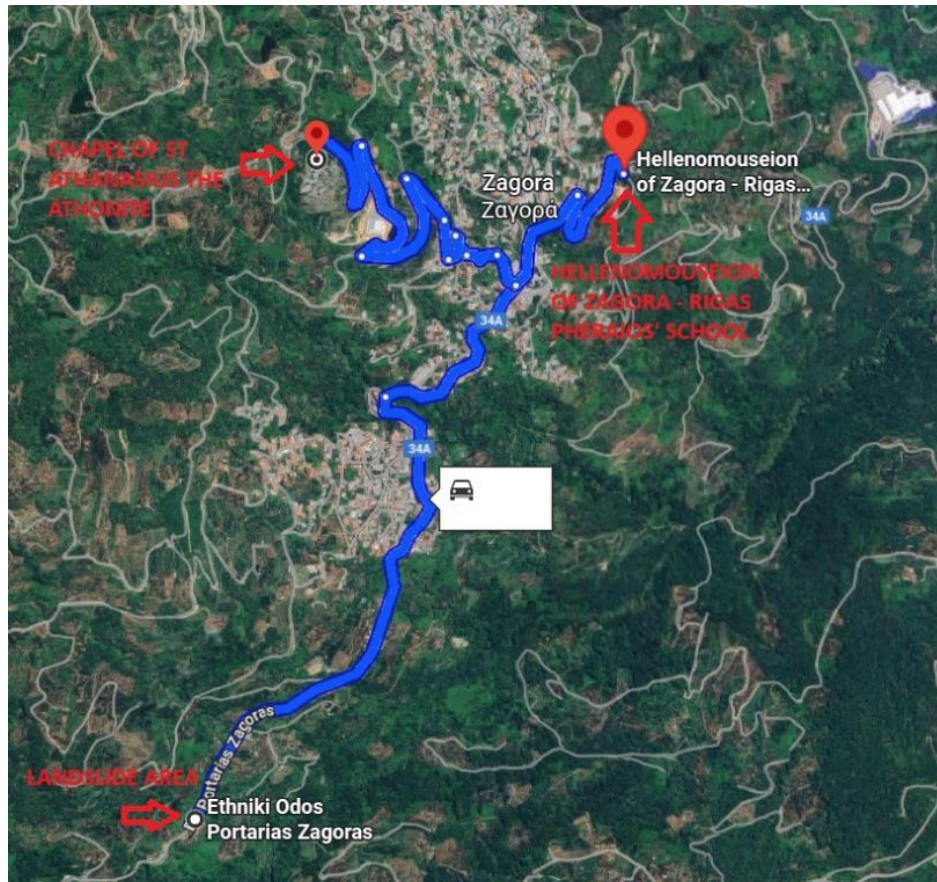
**Figure 3:** Distances of the landslide area with the church of Saint Athanasius Athonitis (4 km) & Rigas Feraios School (3 km)

The effects of Storm Daniel affected two important cultural monuments in Zagora - the historic Rigas Feraios School and the Monastery of Agios Athanasios Athonites. The damage was indirect, and related to the loss of access to these sites. For this reason, the slope stability assessment is being carried out on a critical section of the main road network related to these sites.
