# Restoring the foundation of a historic Viennese building using injections of expanding polyurethane resins

*Keywords: Vienna, foundations, polyurethane resins, injection, timber piles*

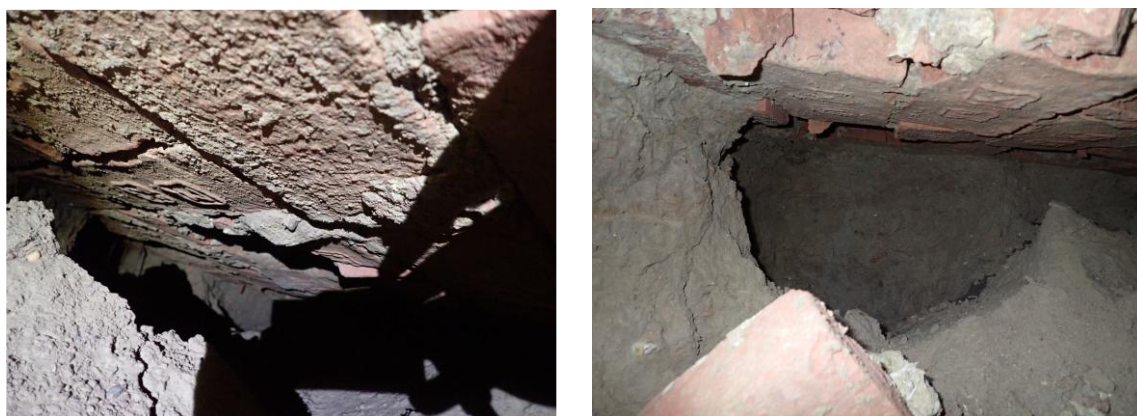
**Figure 3.** Trial excavation S13 highlighting a large void beneath the masonry building foundation

Among all the trial excavations and foundation exposures within the WUK site, a sandy silt classified as loess-derived loam was encountered at the foundation level. Within this stratum, evidence of the former pile foundation comprising timber piles was also observed. In most of the shallow excavations located in Figure 1 that provided meaningful results, problems with the pile foundations and the overlying timber grillage were identified. On the other hand, the excavations located in the stairwells (S04, S05, S11 in Figure 1) did not yield conclusive information; test pits S16 and S17 could not be executed and in the exterior test pits (S15, S20, S21) it was not possible to investigate the piles. Point-based investigations always have the risk that conclusions drawn by analogy may lead to misinterpretations. Nevertheless, based on the excavations results, it can be assumed that the entire building complex is founded on timber piles which are not only damaged but they are completely decomposed and now detectable only through the remaining voids. Similar considerations can be done for the beam grillages, that were often embedded into the foundation to distribute the building loads. In most cases, the foundation masonry is intersected by voids running longitudinally and transversely at various elevations, with only the soil (loess loam) between these voids able to carry the building loads. The situation in the excavation S13 may be cited as an extreme example. Here, the foundation appeared to be constructed on a full-area timber structure. Due to its complete decomposition, a continuous void with a height of approximately 30 cm was found beneath the foundation. Above this void, the entire foundation base was exposed (Figure 3). Beneath this void lied the soil material in an extremely loose state.

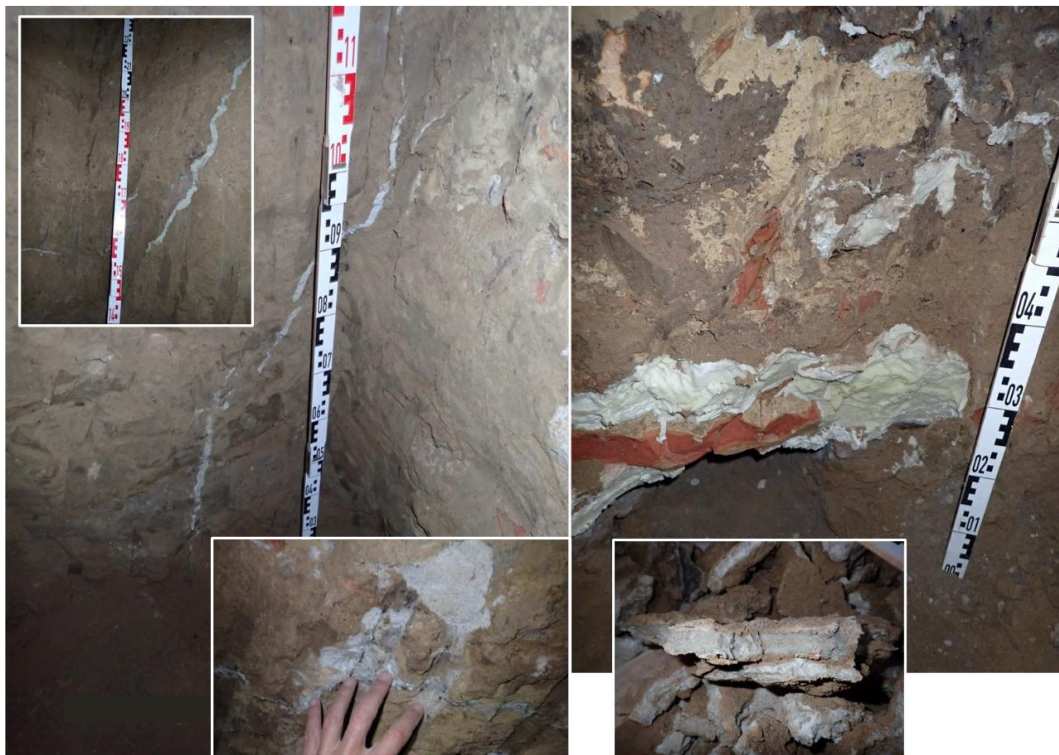
**Figure 5.** Images of the soil beneath the building foundation after the injection of expanding polyurethane resin

After the trial injections, shallow excavations were carried out at the two testing points where large amounts of resin were injected. These excavations highlighted the success of the treatment, as the injected material reached and completely filled the voids beneath the foundation, thanks to the expansion capability of the resin (Figure 5). Around the injection points, the resin migrated through available soil pathways (mainly fissures) and created a branched treated area. This evidence demonstrated that the resin could find preferential pathways adjacent to the voids and even create its own pathways due to its swelling capacity (Figure 5). It was also evident that the injection material expanded and formed a substantial injection body where voids were encountered. In the branched veins, expansion occurred only in isolated spots; elsewhere, the injected material remained as compact resin sheets (Figure 5).

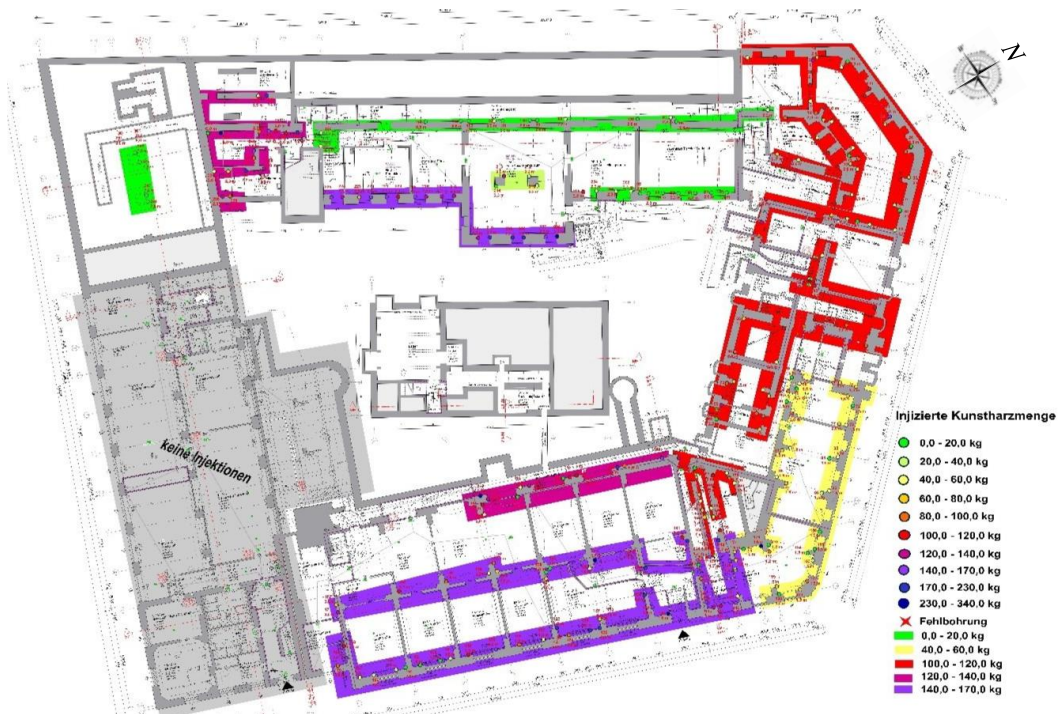
**Figure 6.** Overview of the building plan showing, for each treatment zone, the range of resin mass injected beneath the foundations and the corresponding resin mass per borehole

A more systematic method to assess the outcome of the treatment is represented by the locally varying quantities of injected resin, illustrated in Figure 6. The color-coded overview plan shows injection quantities ranging from less than 20 kg (green) to over 230 kg (purple) per injection point, providing a clear visualization of the foundation conditions throughout the building. This heterogeneous distribution of the amount of injected resin, showing a more critical condition for the east wing of the building, might be related to a lower level of the groundwater table, a lower relative density of the foundation soil, and, eventually, a different configuration of timber foundations (piles and grillages) with respect to the other wings of the building. However, the geotechnical investigations performed were insufficient to confirm these assumptions, and, given the shallow excavations carried out, more invasive investigations could not be conducted to preserve the serviceability of the building.
