# Development of methodologies and protocols for the analysis of the geotechnical and structural safety of archaeological monuments from the pre-Nuragic age in Sardinia

Within the framework of the nomination for UNESCO recognition of the serial site '*Funerary Tradition in the Prehistory of Sardinia – The domus de janas*', a detailed analytical study was carried out on the monumental sites included in the nomination list.

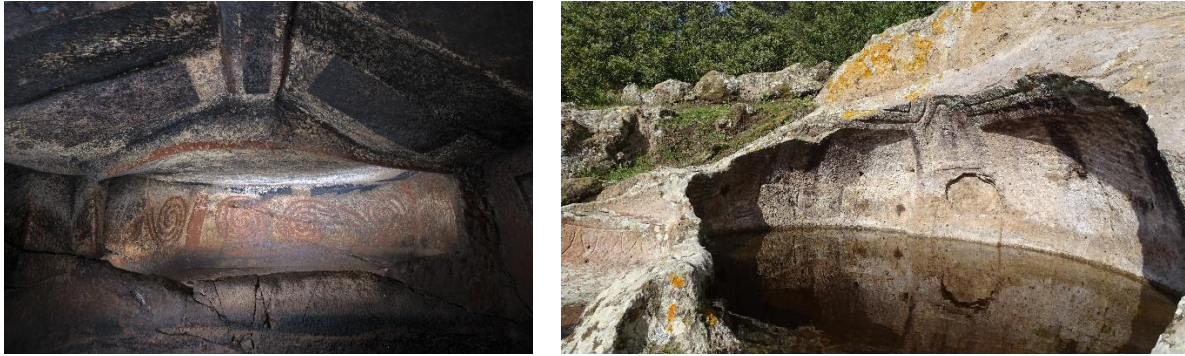
**Figure 1.** Necropolis of “Sa Pala Larga”, Bonorva (SS) (left). Necropolis of “Montessu”, Villaperuccio (SI) (right).

The 'Domus de Janas' (Fairy Houses) are hypogeal burial sites and necropolises located in Sardinia (Italy). They were created between the 5th and 3rd millennia BCE (Lilliu, 1988). These rock-cut tombs feature complex layouts, symbolic decorations and figurative motifs (Figure 1) (Melis, 2014). They represent the most extensive and richest manifestation of hypogeal funerary architecture in the western Mediterranean (Tanda & Usai, 2005) and exemplify a phenomenon attested by around 3,500 tombs spread across the entire island.

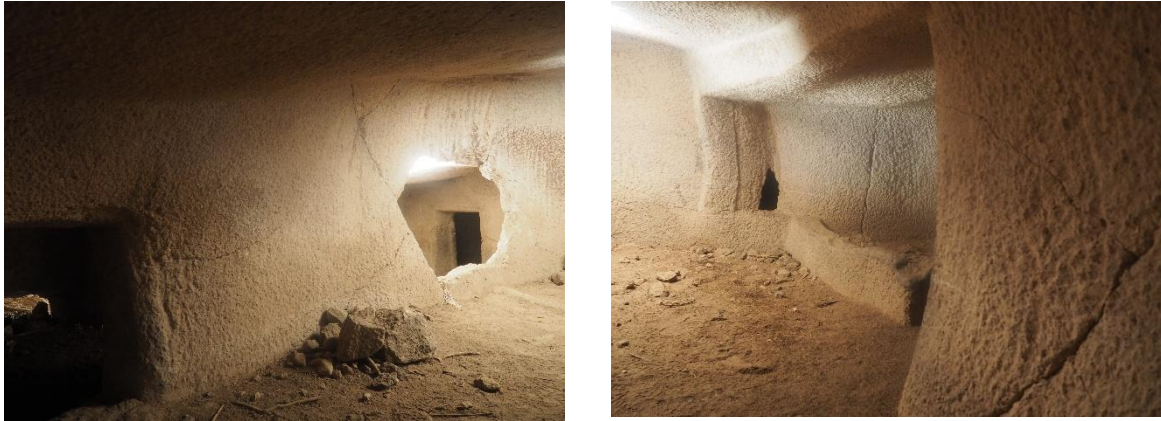
**Figure 4.** Observed damage of Tomb I, “Iloi Ispiluncas”, Sedilo (OR): passing crack (left) crack pattern (right).
