# Anastylosis of the northeastern tower of the ancient fortress of Aegosthena in Attica: construction analysis, collapse mechanism and interventions for the improvement of the foundation conditions

El-E. E. Toumbakari<sup>1</sup>, and D. N. Egglezos<sup>2</sup>

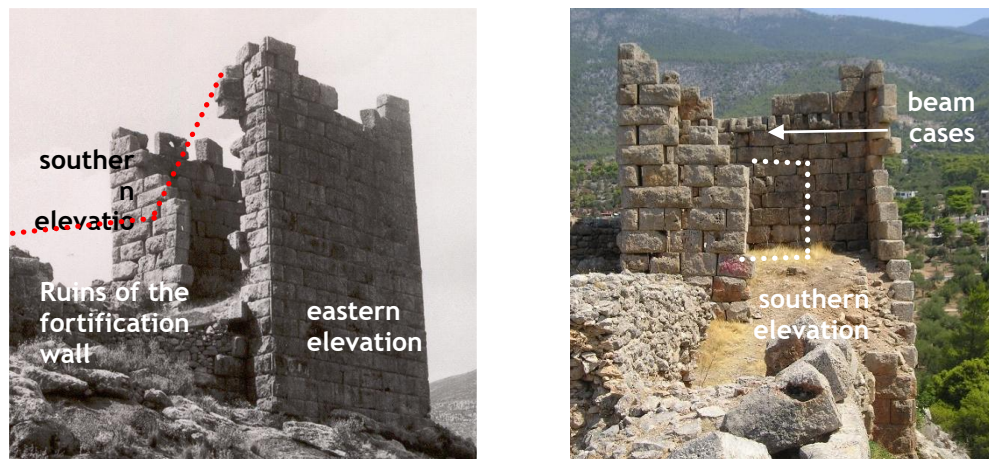
**Figure 1.** The southern & eastern elevations of the tower in 1933 (courtesy of the German Archaeol. Inst., Athens). In dotted line: the missing fortification wall (left). The tower after collapse of the S.E. corner and eastern elevation (1981)-in white dotted line the entrance to the first level is shown (right)

The tower was standing as shown in Figure 1 (left) until February 24<sup>th</sup>, 1981. This day, the eastern Corinthian Gulf earthquake (Papazachos & Papazachou (1997), Ambraseys (2009)) has struck the building, resulting mainly in the collapse of the free-standing southeastern corner and a big part of the eastern elevation (Figure 1 right). The pathology of the remaining structure was extremely severe and further collapse in case of a future, even low intensity, earthquake was certain. In addition, the foundations of the western and southern elevations had gradually settled due to the deformability of the filling material, resulting in block subsidence up to 40 cm in the middle of the western elevation. Sliding of the blocks of the still standing southern elevation was evident by the opening of the joints (Figure 1 right). Moreover, the N.E. corner top blocks (on the upper right of Figure 1 right) were in an extremely unstable situation due to the severe opening of joints, the rotation of the remaining blocks outwards and the subsequent loosening of the corner connection.

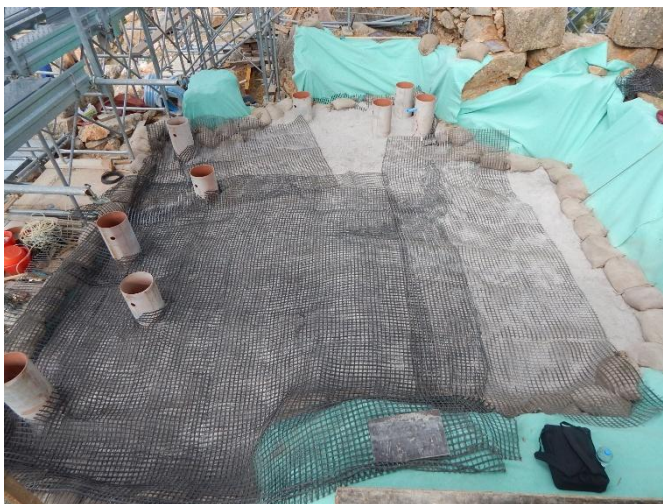
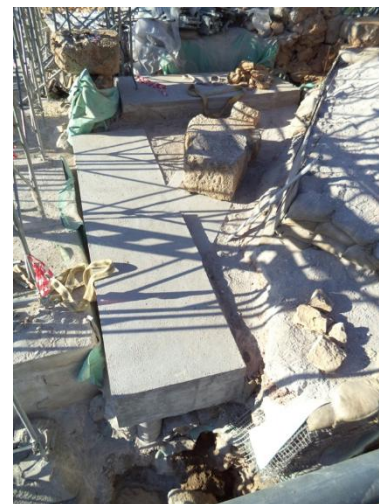
**Figure 11.** The deep foundation under construction (view from the east) (left). The pile cap of the eastern elevation before the anastylosis and, in the background the western one (right).

The study was approved by the Central Archaeological Council and subsequently implemented (Figure 11). The anastylosis of the tower (Figure 12) was completed in 2016. From the outset of the project, particular emphasis was placed on the significance of the internal fill, which constitutes valuable evidence of ancient construction technology. Its preservation, to the greatest extent possible, was adopted as a key criterion guiding the design of the proposed interventions, with the geotechnical study proving to be a critical tool in achieving this objective. The internal fill yielded important archaeological and technical insights, shedding light on construction methods, material selection, and building practices employed during the original erection of the tower. Its conservation therefore contributes not only to the structural integrity of the monument, but also to the documentation and broader understanding of ancient engineering knowledge.

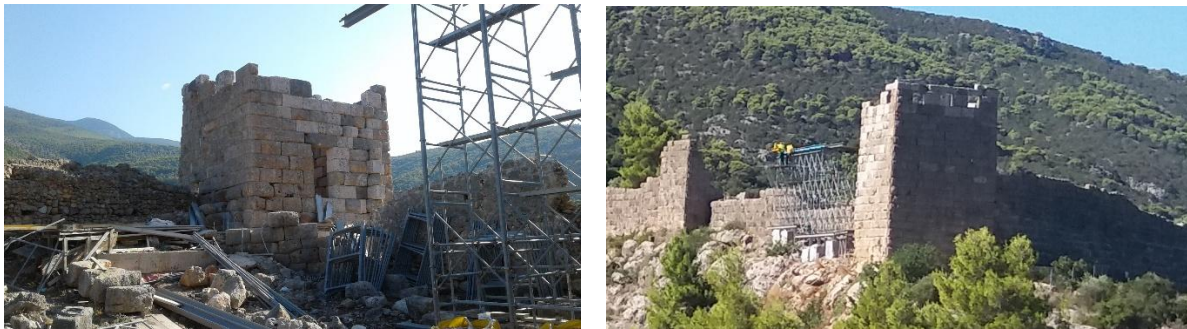
**Figure 12.** *The restored south and western elevations from the interior of the acropolis (left). The restored eastern and northern elevations (right)*
