# Anastylosis of the Western Stoa of the Gymnasium of Ancient Messene: Engineering Insights into an Archaeological Monument

A.Alexandris<sup>1</sup>, and C.Papantonopoulos<sup>2</sup>

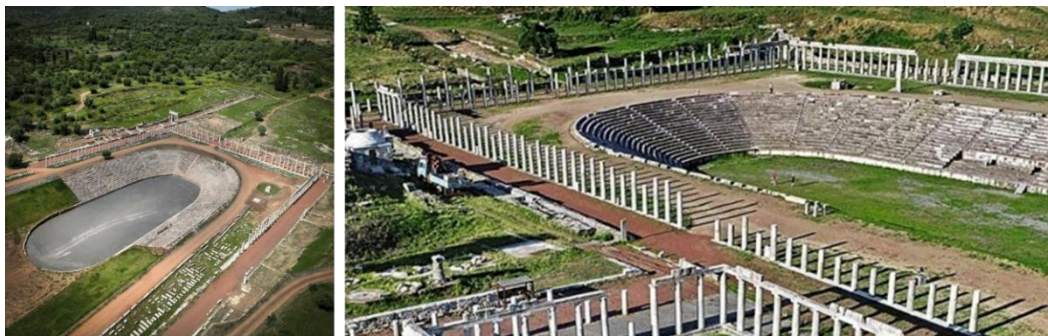
**Figure 1.** *The Stadium and Gymnasium of Ancient Messene after the completion of the archaeological excavations and the anastylosis program.*

The ancient city of Ancient Messene was founded in 369 BC and quickly developed into an important Hellenistic and Roman urban centre. The construction of the Stadium and Gymnasium, which are the subject of the present study, is dated to the late third or early second century BC (Themélis P., 2009). The Stadium served as a principal public space of the city and today stands as one of the most impressive architectural complexes of the site, in terms of both its scale and state of preservation. The northern, horseshoe-shaped section of the Stadium comprises 18 tiers of seating, arranged in 18 rows and separated by stairways. The Gymnasium is built around the Stadium and consists of Π-shaped stoas, supported by single or double colonnades. Collectively, the stoas and the Stadium form a unified architectural complex, representing a distinctive feature among ancient stadia. The substantial quantity of building material from both the Stadium and the stoa colonnades, unearthed during excavations, enabled an extensive anastylosis programme, which today allows visitors to gain a clear understanding of the structure's size and appearance in antiquity. The current state of the site is illustrated in Figure 1.

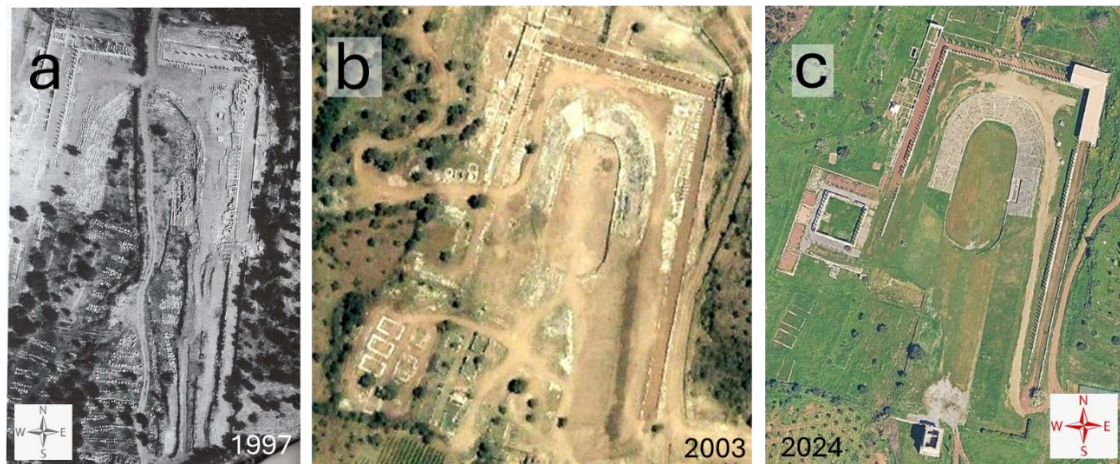
**Figure 3.** Aerial photographs of the Stadium: (a) in 1997, prior to the start of archaeological excavations; (b) in 2003, during the anastylosis programme; and (c) in 2024, following the completion of the anastylosis.

itself, had been fully unearthed and documented, thereby clarifying the architectural layout of the complex, as illustrated in the aerial photographs in Figure 3. While some columns of the Gymnasium were uncovered in a partially standing and backfilled condition, many others were found toppled from their original positions in front of the stylobate, while others were completely disassembled and scattered along the original axis of the colonnade. In particular, the lower portions of most columns of the western and northern stoas remained standing in situ. In contrast, the eastern colonnade had collapsed, together with its entablature, and was found lying in front of its stylobate, to the west. A further observation from the aerial photographs in Figure 3 is the slightly divergent alignment of the western and eastern stoas, which gradually separate towards the south. This condition is also reflected in the architectural mapping of the remains (Figure 5).
