# Monuments of Greece classified according to seismic behavior and case study for seismic vulnerability index

The classification of the Greek monuments is based mainly on the geometry of the shells. First-degree-pre-earthquake assessment data sheets were developed for several structural typologies, while a representative structure of type A2 is selected and evaluated using the sheets.

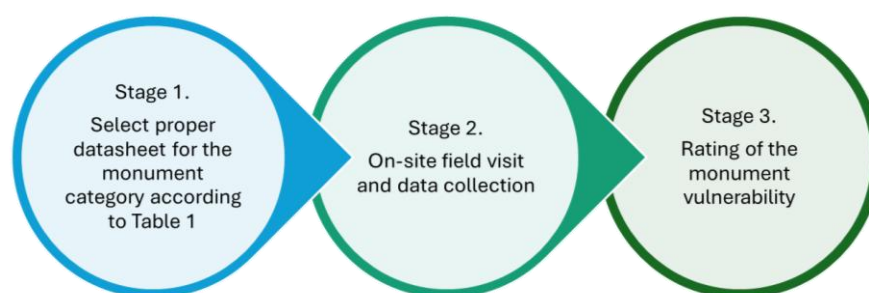
Figure 1: Flowchart methodology for first degree vulnerability assessment.

The purpose of this research is to present the methodology of the first degree vulnerability assessment and implement it for a case study. The methodology consists of three stages, according to the flowchart of Figure 1. In the first stage, the proper monument category is selected according to Table 1. The second stage contains an on-site visit and completion of the datasheet. The last stage, which is presented in this paper in detail, contains the rating of the monument vulnerability according to the datasheet. The output is the vulnerability index. The secondary assessment procedures are not included in this paper.

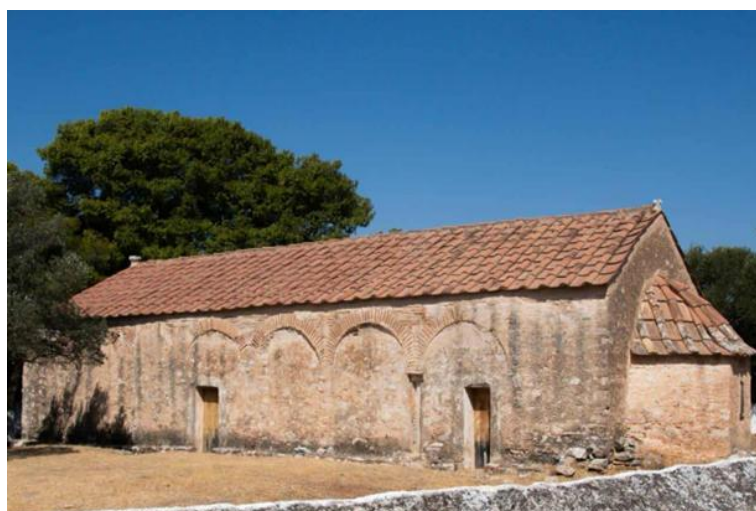
**Figure 2.** Location (left) and general view (right) of the monument

The good present condition of the church and the preservation of murals of 3 different historical periods, prove that the church has been seismically resistant due to the continuous care and maintenance of the villagers.

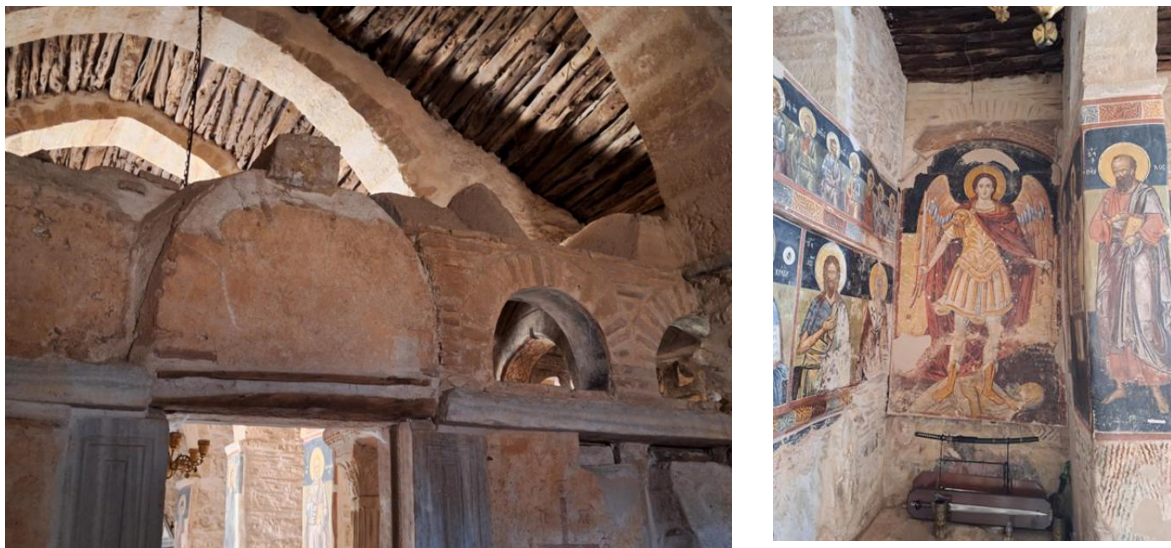
**Figure 4.** Interior of the monument with visible timber roof (left) and painted decoration with frescoes of the 18th century, from the school of Georgios Markos (right).

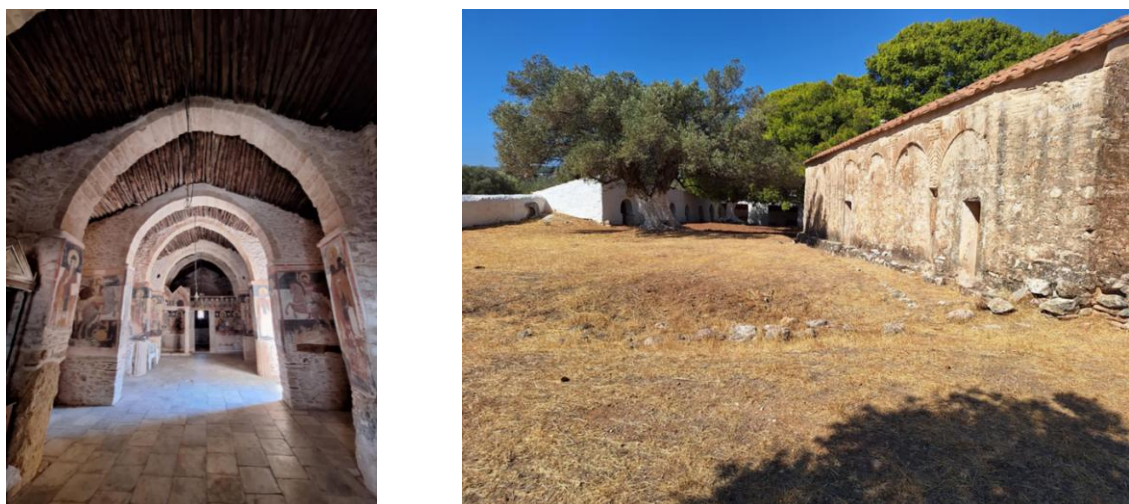
**Figure 5.** Interior apses of the church (left). External view of the arcades and the remnant of the large semi-circular apse (right)
