## Vertical connectors between successive drums in ancient columns: literature and in-situ investigation

### ABSTRACT

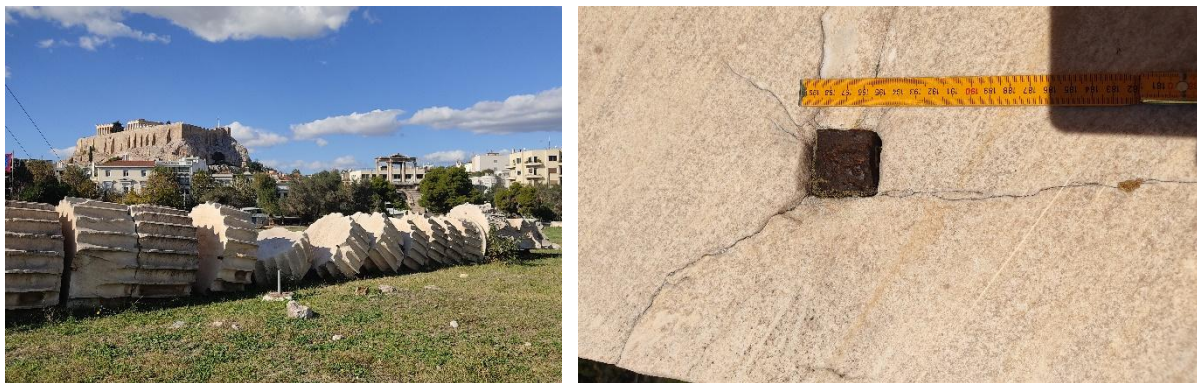
**Figure 3.** *Measuring the main dimensions of interest, in the Temple of Olympian Zeus, Athens.*

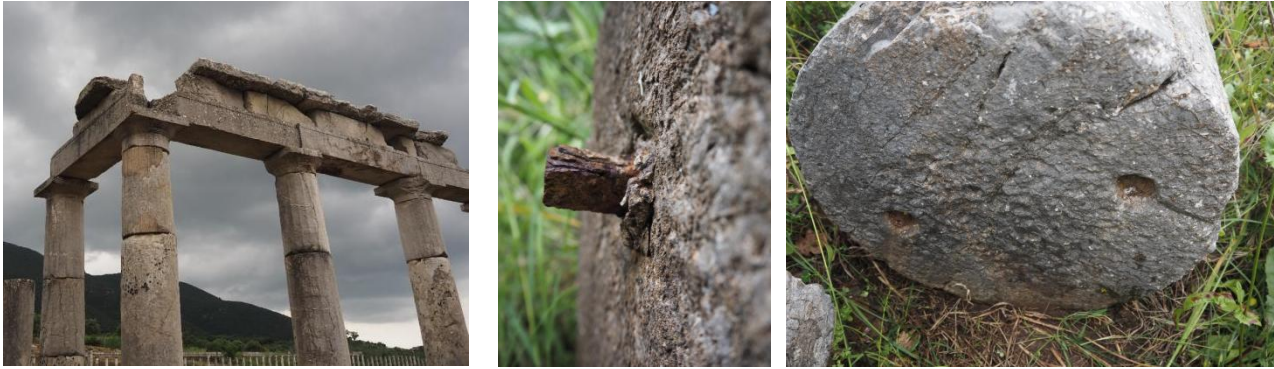
**Figure 5.** *The Gymnasium, in the archeological site of Ancient Messene: The construction of the corner and the form of the epistyles (left); Drum, the iron connector can be seen (middle); Drum with grooves and channel for the lead pouring (right).*

Another important monument in which vertical connectors between successive drums are located is the gymnasium in Ancient Messene. In the gymnasium, columns consisting of several drums exhibit between two and four connectors between courses. Measured groove dimensions are of the order of 4cm on a side, and positions are typically near the perimeter of the drums. The literature and field observations suggest a combination of bronze and iron connectors, with bronze more frequent in lower drums and iron in upper ones, although detailed confirmation of this distribution would require selective opening of joints (Figure 5). The observable pathology is relatively moderate and includes some cracking in upper drums, mild deformation of joints and local degradation of the stone, which may be attributed to a combination of corrosion, environmental action and human intervention, rather than to a single cause. The gymnasium thus provides an example of a many-drum colonnade in which vertical connectors were evidently used as a regular construction element.

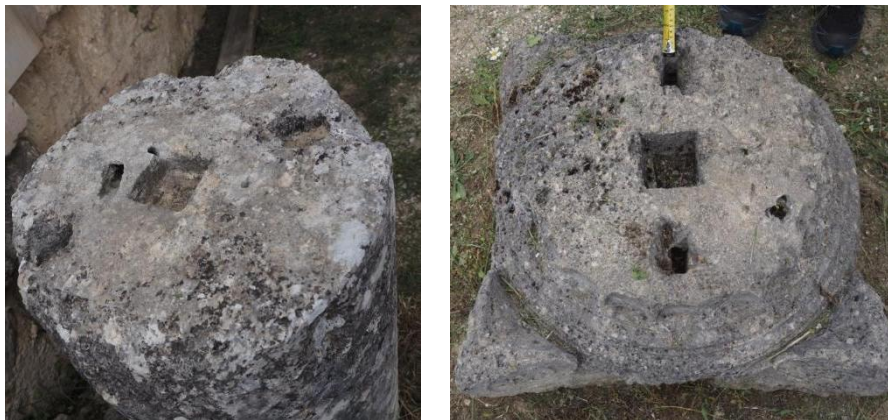
**Figure 6.** *Epidavros, photo of one of the drums (left) and one of the capitals of the Avaton (right).*

At Epidavros, the sanctuary of Asclepius comprises several buildings with columnar elements in which vertical connectors have been documented (Figure 6). The Ceremonial Restaurant, the Temple of Artemis, the Avaton and the Stoa Kotyos all show evidence of connector's use between drums, with two connectors in most cases and four in at least one building. Many of the drums lie on the ground and can be examined closely, revealing grooves in the bedding surfaces and, occasionally, remnants of metal or lead within them. The generally good state of preservation of these columns, combined with the clearly visible provision for connectors, indicates that this technique was considered appropriate and effective in this context and was applied consistently across different structures within the sanctuary.
