# Laboratory and field investigation of the backfill behind the ancient walls of the Acropolis, Athens

M. Bardanis<sup>1</sup>, N. Ninis<sup>2</sup>, D. Michalopoulou<sup>3</sup>

## ABSTRACT

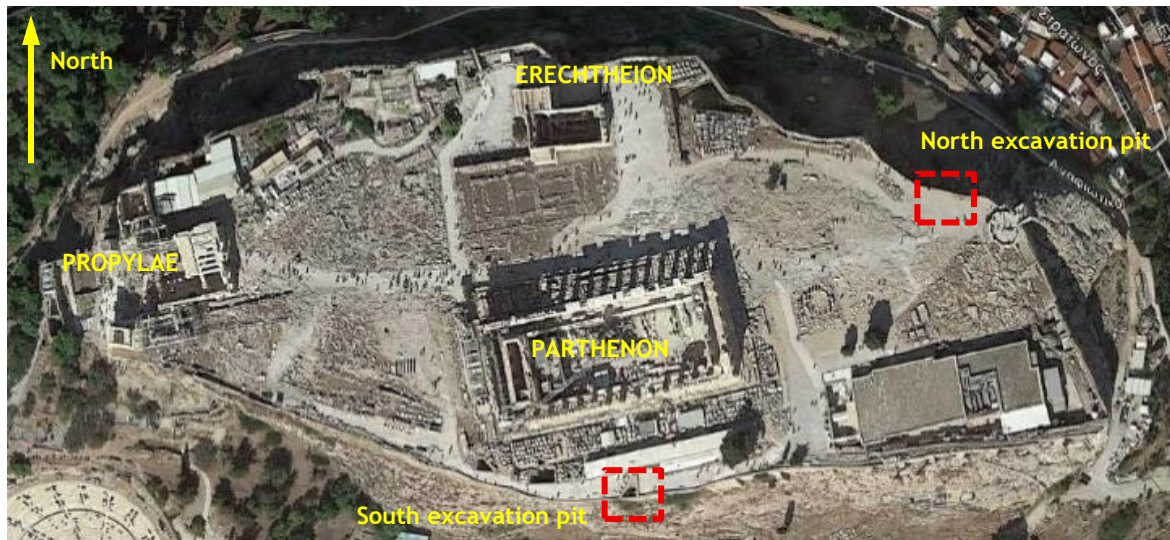
**Figure 2.** Satellite image of the Acropolis of Athens (Google Earth) showing the location of the excavation pits and the major monuments.

This geotechnical investigation was based on two excavation pits, one adjacent to the North part of the wall, and one adjacent to the South part of the wall (Fig. 2) supported by local surface sampling at other locations. These excavation pits were a combination of archaeological and geotechnical investigation, as they were opened by archaeological investigation crews which as soon as they had finished their work at each depth, geotechnical logging and sampling would follow down to the full length of both excavation pits. The progress of excavation was supported by light Dynamic Cone Penetration Testing (as per ASTM D6951, Bardanis & Kokoviadis, 2026). Laboratory testing included soil mechanics classification and compaction tests, mechanical testing focusing on parameter testing to create an understanding of the expected behaviour of the fill under various conditions and testing in large-size devices given the coarse-grained nature of the material. This investigation was supported by field

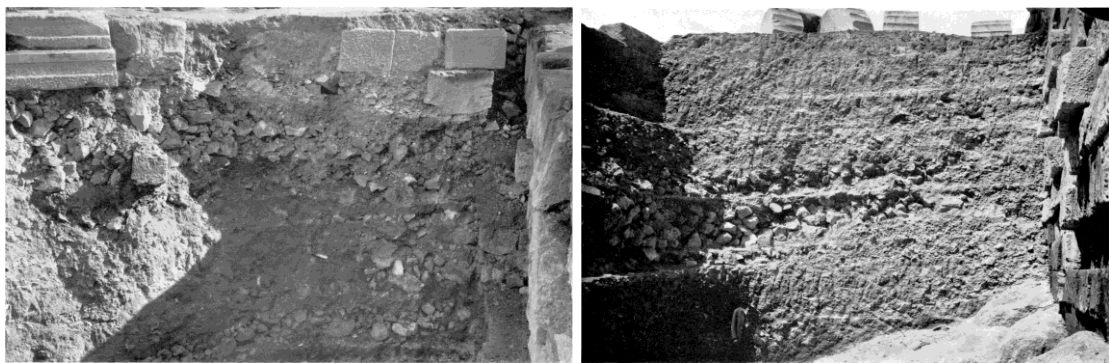
**Figure 3.** Views from the 19th century great excavation demonstrating the macroscopic nature of the earthfill (left) and the big height of the free standing vertical faces of the excavated earthfill (right).

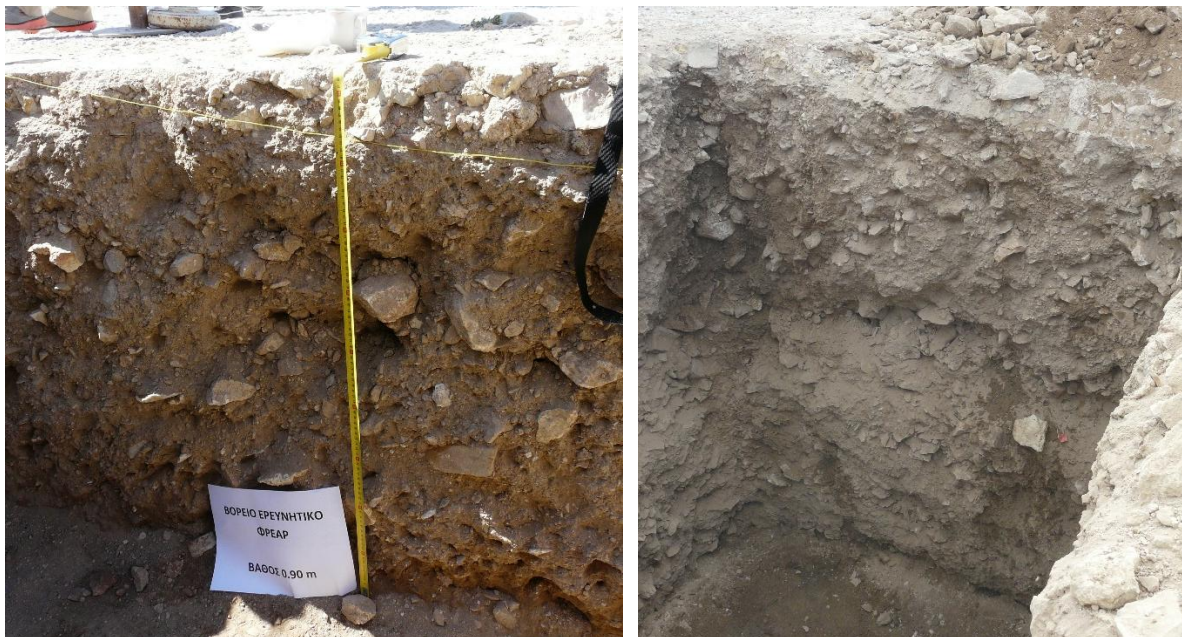
**Figure 4.** Views from the 2015 pit adjacent to the North part of the circuit wall when the depth was 0.90m in April 2015 (left) and during backfilling of the pit in October 2015 with the wall of the pit being 2.00m high (right). Both views of pit walls shown are photographed from north looking south.

The backfill behind the walls is a material that has been practically 'remoulded' (in geotechnical terms) because of the great excavation between 1885 and 1890 (Kavvadias & Kawerau, 1907) that involved moving large volumes of original, historically placed backfill to excavate all the way to the bedrock on the hill. These excavations were combined with various important archaeological findings and as the excavation progressed with backfilling of the excavated back to its place on the hill. The same source reports the material of the backfill as man-made ground of fine-grained to sandy origin with large fraction of gravel, cobbles and fragments from building materials (porous stone of marly origin, marble, limestones and dolomites) which can be observed in the limited photographs of the time (Fig. 3). The same photographic material documents the ability of the excavation faces to stand for considerable height without failing (Fig. 3). Andronopoulos & Koukis (1976) report the backfill behind the walls as *recent* earthfill of fine-grained to sandy origin with gravel, of *low permeability*, with fragments of porous stone of marly and limestone origin towards its base. More recent observations (Egglezos, 2013) seem to verify previous reports, with the backfill material being considered as well compacted, clayey to sandy gravel (GC). All these observations are in agreement with the findings in the 2015 excavation pits (Fig. 4) and in terms of a geotechnical context seem to be summarised as follows:

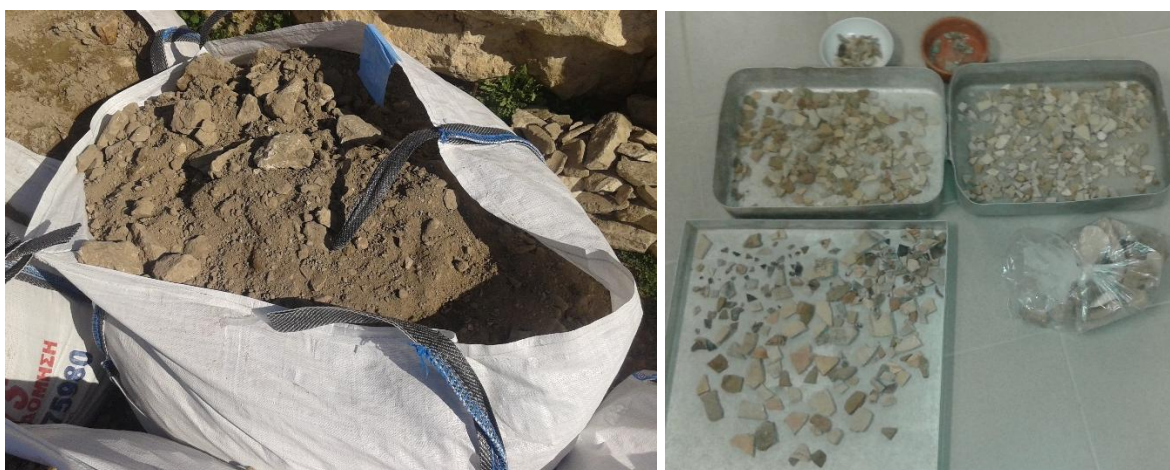
**Figure 6.** Big bag of excavated material from the excavation pit adjacent to the North Wall (left) and findings during the sieving of all of the material in the big bag (right) consisting of marble, limestone, dolomite, marl fragments, ceramics (painted and non-painted) with traces of metallic objects and bones (in the small bowls at the top of the photograph).

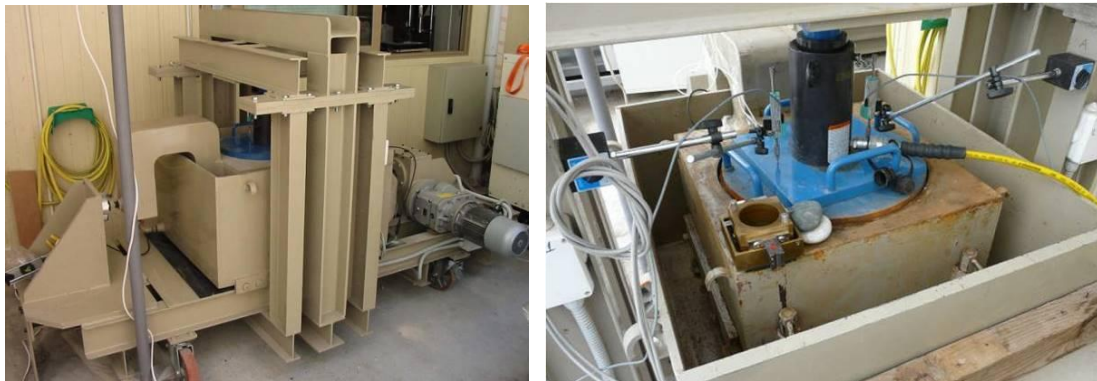
**Figure 9.** A schematic of the EDAFOS S.A. large-size direct shear device (top), and actual views of the large direct shear device: overall view (left), view of direct shear cell (right) -for comparison two cobbles of the largest size that may be included in the sample in this device and the cell of a conventional small-size direct shear device.

passing #75mm. To test this material the EDAFOS S.A. large-size direct shear device was used (Bardanis et al., 2013, Bardanis, 2014, Fig. 9). It is a displacement-controlled device capable of applying as low shear strain rates as 0.1%/min with a 45cm diameter circular shaped cell, generally compliant to ASTM D3080. Vertical load is applied through an oil jack, electronically controlled to counter for pressure changes due to contraction or dilation during the shearing stage and compression during the loading stage. The maximum load applied electronically yields 1500 kPa vertical stress and 3000 kPa when the load is applied by means of manual control of the oil jack. The horizontal load is measured by a load cell measuring a force corresponding to a shear stress of 2000 kPa. This combination of electronically controlled vertical load application and horizontal load measurement allows for measuring values of the angle of shearing resistance considerably larger than 45° even up to the vertical stress of 1500 kPa.

The large size of this device allows samples containing the fraction of material even to that passing #75mm to be tested and in combination with the circular shape of the cell, it allows for measuring the minimum and maximum unit weight. Minimum dry unit weight was found 13.1 kN/m<sup>3</sup> and maximum dry unit weight 20.5-21.0 kN/m<sup>3</sup>. Following this, consolidated, direct shear tests were performed on samples with the minimum dry unit weight, the maximum dry unit weight and an intermediate value of 19 kN/m<sup>3</sup>. Initial water content in all case was selected to be 8% -approx. the average of the water content measured in situ. Fig. 10 summarises the results from the peak values from these tests and the failure envelope of the shear strength after large strain. The latter corresponds to  $c' = 0$  and  $\phi' = 46^\circ$ , with values of shear strength parameters for tests with high initial dry unit weights corresponding to  $\phi' = 42-44^\circ$  and cohesion intercept values of tens of kPa. On top of these tests, using the circular section of the device cell, one-dimensional compression tests were performed on samples with the aforementioned dry unit weight values and total earth pressure cells installed inside them to measure the coefficient of earth pressure at rest,  $K_0$ , along normal compression branches of the tests and unloading-reloading cycles

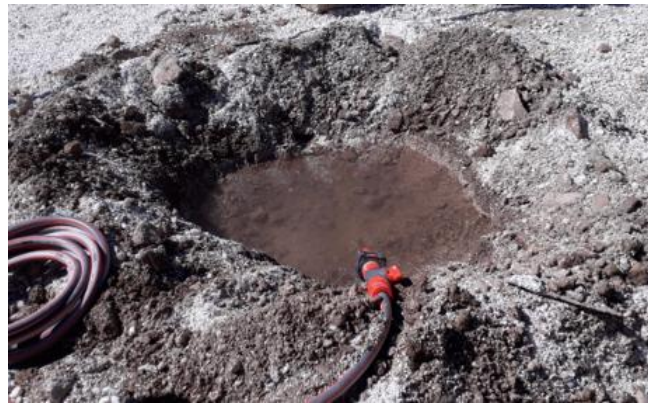
**Figure 14.** The wetting test of March the 22nd 2018 at the Acropolis station.

In this particular station, a wetting test was performed on the 22nd of March 2018 (Fig. 14). It allowed the study of the response of the sensors at the two depths (Fig. 13c) indicating a response within 3.5 hours for the depth of 0.80m (after providing a total of 738lts of water from the surface) but a response after 9 days for the depth of 2.0m (which itself lasted 3 days until suction dropped to zero). The total supply of water reached 2177 lts and was completed in the morning of the 23rd of March 2018. Recovery of “normal” field suction values took approximately 3 months for the depth of 0.80m and 9 months for the depth of 2.0m. The drying stage was used to estimate field evolution of permeability of the material with suction. The water front diameter at the ground surface was 75cm (Fig. 14).
