## Study for the Restoration of the Walls of the Castle of Kalamata

### ABSTRACT

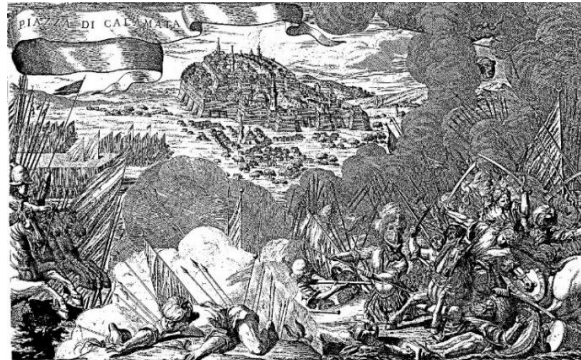
**Figure 2.** *Battle of Kalamata. The Castle at the background, Coronelli, Venice, 1686*

As we can see, Coronelli designed the castle full of buildings, with the walls not fully filled and with a multitude of external and internal buttresses. Of course, it is a serious question whether the illustration is true, even approximately, since the exaggeration is evident in it.

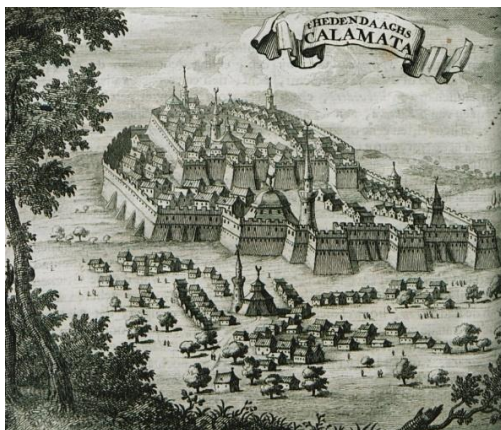
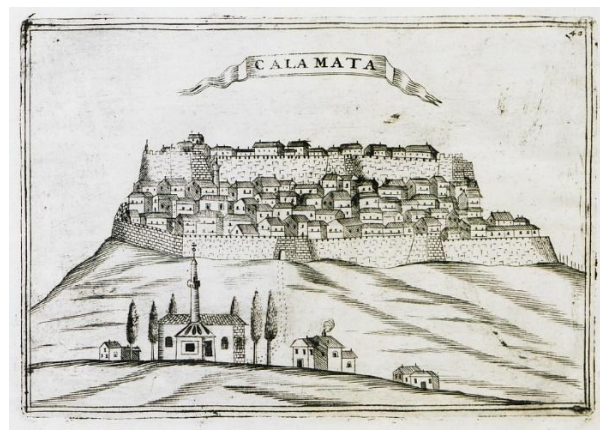
The Dutchman Dapper, apparently copying Coronelli, publishes in 1688 the left illustration. Coronelli himself published in 1708 the right image.

**Figure 3.** *Castle of Kalamata. Left drawing Dapper, 1688. Right drawing Coronelli, 1708.*

By this short review it becomes clear how little credibility can be given to the various depictions of the castle.

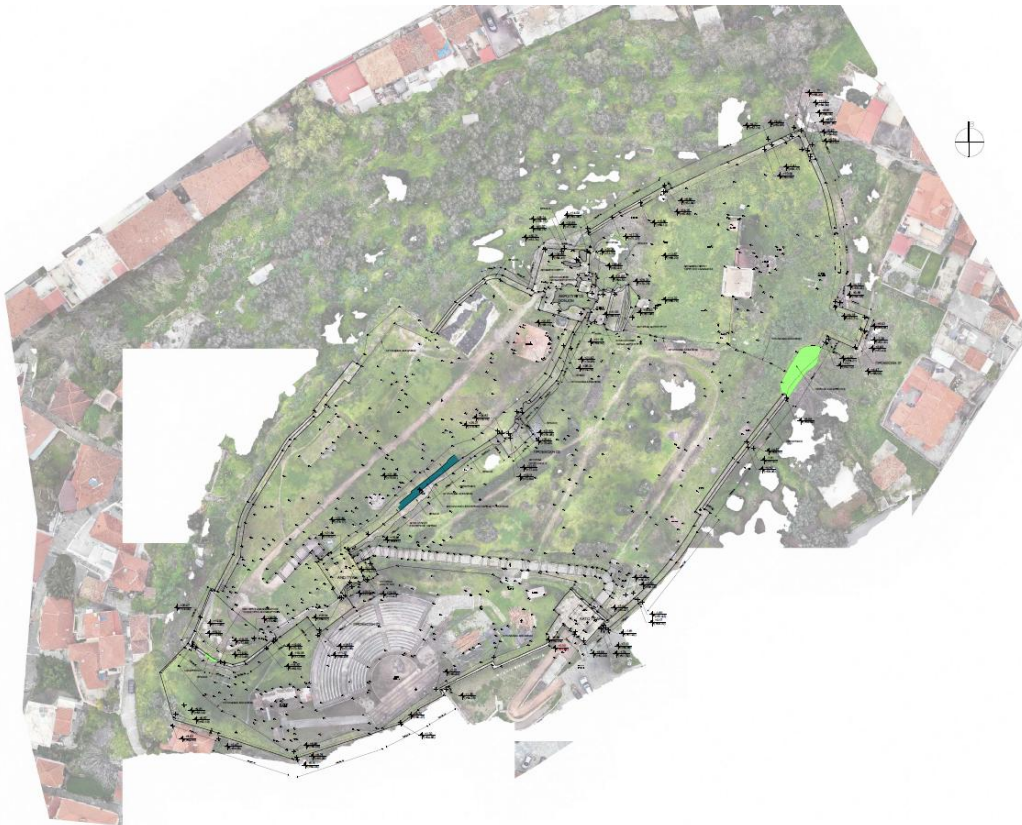
**Figure 4.** Site plan of the Castle

The Castle of Kalamata consists of a fortified area of approximately 1.300m<sup>2</sup>. The walls' height varies from 6 to 9 meters tall, while their thickness is approximately 1.6 meters. The walls do have a soil backfill for their entire length. The castle has several masonry Towers mainly on the south side.

The general thickness of the walls is therefore 1.60 and the quality of the building due to rounded rubble stones is relatively poor. A greater thickness of around 2.0 meters was only seen in a part of the upper wall just after the buttress and just before the donjon. Only around the gates do we see a better quality of construction with large cornerstones, which is natural since the main effort of the attackers was focused on them.

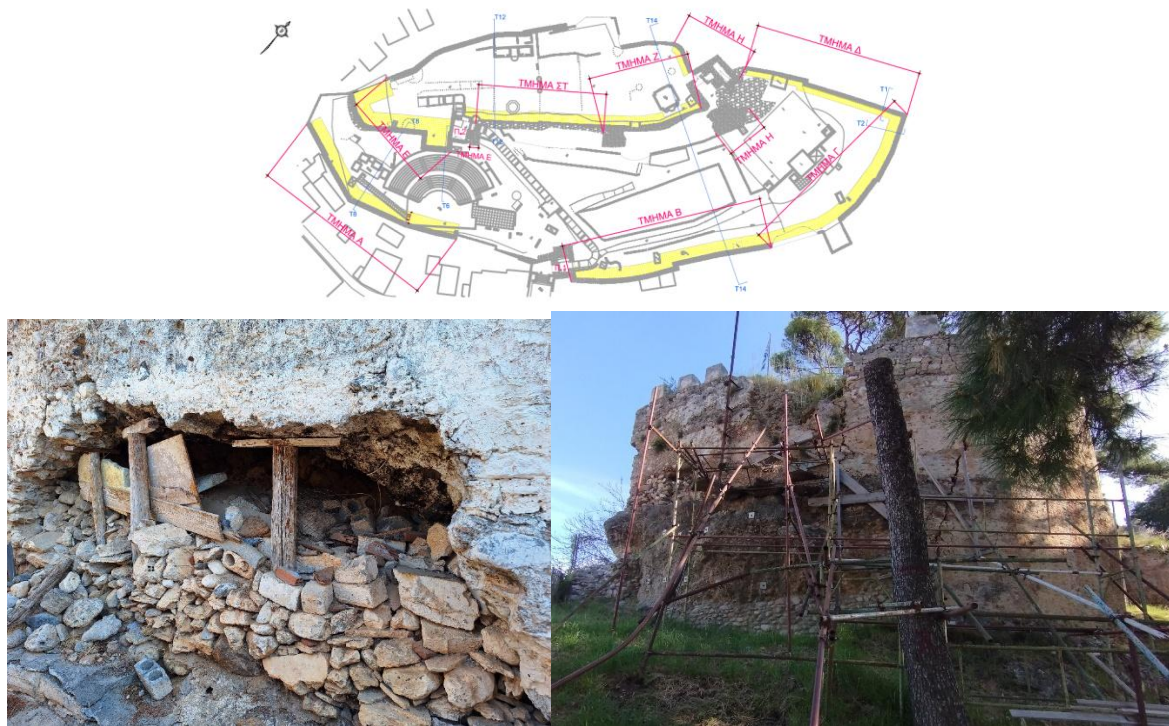
**Figure 5.** Discretization of the Castle into parts. Partial collapse in part A and cracking in part E.

The thickness of the walls is generally insufficient for the current height of embankments, as it is concluded by the findings of this study. It is possible that in an earlier phase the levels of the fills were lower, since the initial construction was Byzantine-medieval. Therefore, cracking of the castle's walls is observed. Besides smaller cracks and partial collapses, there is extensive cracking and partial collapse at the base of the southeast low wallpart A). The walls appear extremely weak in this area, which is problematic since this area bears the small amphitheater of the castle, and is adjacent to the settlement at the base of the wall. This area is perhaps the most prone to collapse part of the castle. Even while the castle rests on a rocky background, the heights of fills made of loose materials make this section precarious.

The next major failure is the disorganization of the area in the southwest curved area of the upper wall (Part E), which has also received a retaining scaffold as a direct measure to avoid collapse.
