## Substructure design of ancient master builders

### ABSTRACT

*Keywords: ancient foundations, ancient water drainage, ancient underground water control*

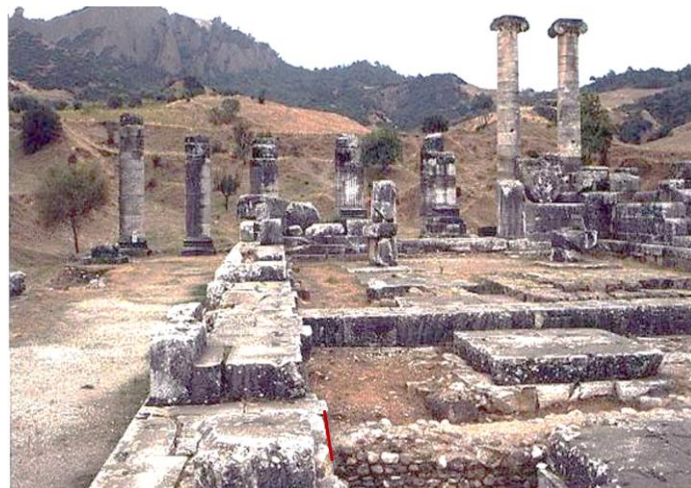
In the organization of building foundation grillage, if different components of a building were not of the same weight and therefore would settle differently, the foundations of these components were not joined (Figure 1). The superstructure of these buildings was also separated as seismic joints. Such practice may be observed in Hagia Eirene Museum and Süleymaniye Mosque at Istanbul, and Double Hamam in Skopje. In Fatih Mosque at Enez, the foundations of the lightweight, wooden-roofed exonarthex to the heavier main block of the building were not bonded, although these different weighing blocks were constructed at the same time [Ousterhoud, 1999].

*Figure 1. Foundation of different weighing parts not bounded in Sardes*

- Provided seismic joints by not connecting the foundations of different weighing components of a building
- Changed the natural frequency of soil by placing a pillow layer of sand or gravel under the foundations,
- Provided flexible base by placing round wood at the foundation base or by carving the rock in the form of a trough and placing the foundation stone on a flexible layer in the trough.

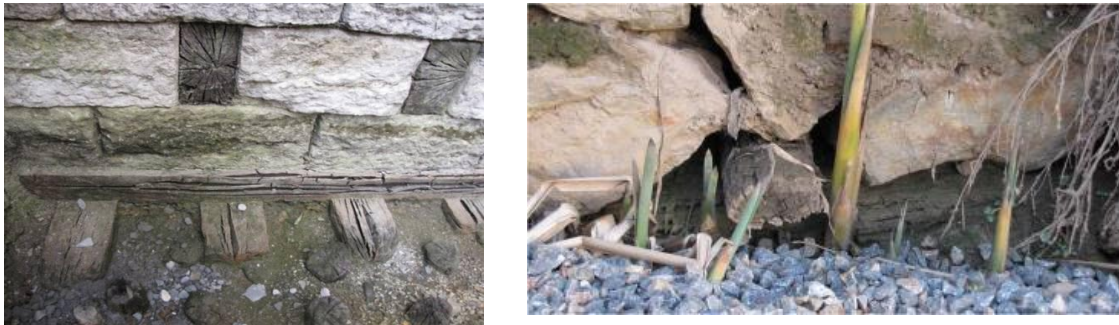
Figure 6. Wooden grillage of a Üsküdar and Sirkeci Byzantine chapels in Istanbul

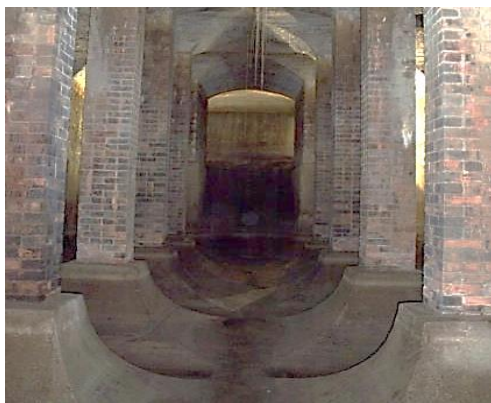
Figure 7. Wooden grillage under the inverted vault foundation of Edirnekapı Cistern

1991]. The foundation of Konjic Bridge constructed in 1682 also rests on two layers of wooden grillage in between dolomite stones [Sert, 2007] (Figure 5). The foundation of the Süleymaniye Mosque rests on a bedrock via wooden grids filled with mortar, with piers that widen as they deepen [Aksoy, 1982]. During metro excavations in Istanbul, two chapels in Sirkeci and Üsküdar resting on two layers of wooden grillage were found (Figure 6). Use of wooden layers provides flexible base for buildings. Edirnekapı Cistern constructed late 19th century has inverted vault foundation resting on a timber grillage placed under the piers (Figure 7).

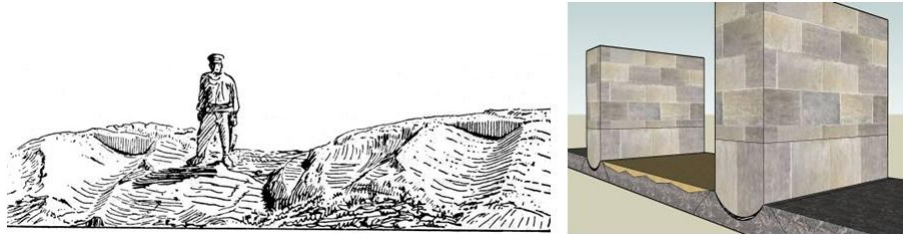
If the rock bed was on the surface, the rock was carved in the form of trough so that each stone of the foundation wall could be placed in the rock as if resting in a cradle [AE Report, 2007, Nauman, 1991] (Figure 8). Here the big, dressed stones of the wall rested on the high edges of the trough, not inside [Ousterhoud, 1999, AE Report, 2007, Nauman, 1991]. In between the rock and the foundation stone briar, pieces of coal or animal skin were placed [Philemon, 1601]. The rock foundations in the form of trough were met in Boğazköy, Temple of Diana at Ephesus in Turkey.].

Figure 8. The rock foundations in the form of trough [Nauman, Arun, 2013]

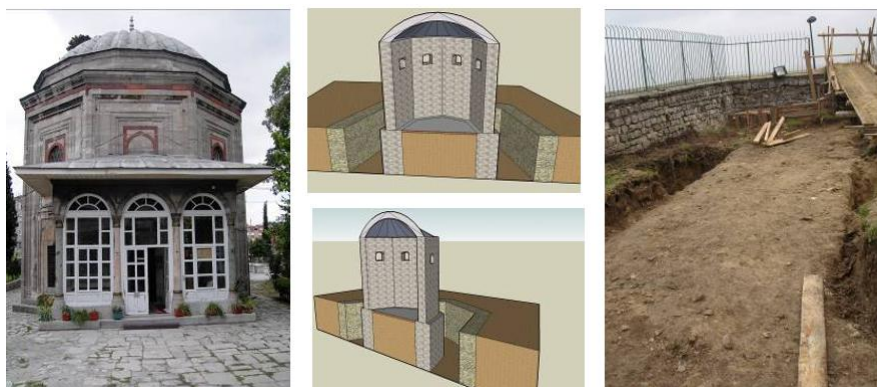
Figure 10. Retaining wall of the tomb at Yavuz Selim Mosque

Octagonal buildings, especially octagonal tombs rested on rectangular foundation systems for octagonal is not an adequate form in EQ areas. The foundation of semihexagonal apsis Küçük Ayasofya Mosque, former church of Sts. Sergius and Bachus was three layers of stone constructed as zigzag (Figure 9). Another different foundation system practice was met at the 16th century octagonal tomb foundation of Yavuz Selim Mosque complex. Around 4m distance away from the octagonal tomb, 2m thick, 6m high buried stone wall in the same octagonal form was found. Since octagonal is not an adequate form in EQ areas was this wall might be constructed as a retaining wall to absorb the first shock of earthquake forces (Figure 10).

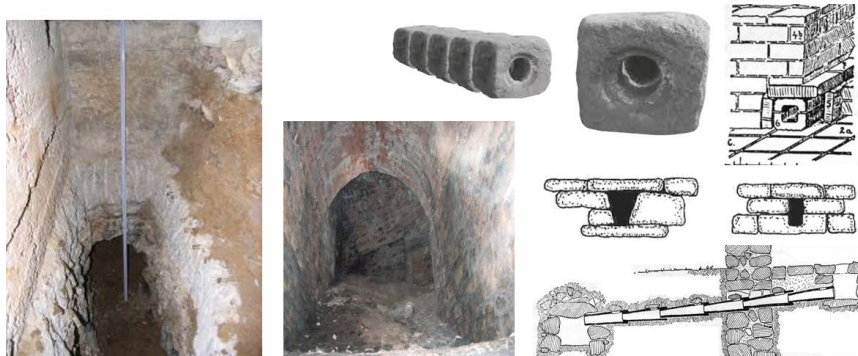
Figure 12. Discharge of underground water

constructed of stones or bricks bound by mortar [Ousterhoud, 1999] (Figure 12). Often, the galleries or channels were constructed within the foundations, just below the foot touch [Bayraktar et al, 2007]. These tunnels served to keep the structure warm in the winter and cold in the summer while removing the moisture from underground water. The size and length of these gates varied according to the need and size of structure and air ventilation of structure. Because this practice is completely forgotten, while constructing new buildings close to historic buildings, the drainage system is often demolished and cause partial settlement of the structure (Figure 13).

Ottoman culture preferred discharging the wells to a nearby fountain tank. In most of the Byzantium buildings in and around Istanbul, the underground water was discharged to a nearby cistern or the foundation of the buildings included cistern [AE Report, 2007]. In the area of Topkapı Palace, more than forty cisterns were found within the substructures of buildings [Tezcan, 1989]. The twelfth-century church of Pammakaristos includes a large colonnaded and vaulted cistern that extends under the naos and parts of the ambulatory, now filled with soil. There is also a cistern near the Fatih Mosque. Yavuz Selim Mosque in Fatih district and Nur-u Osmaniye Mosque in Bayezid district include large gallery heading toward a cistern that is blocked by the foundation of the mosque.

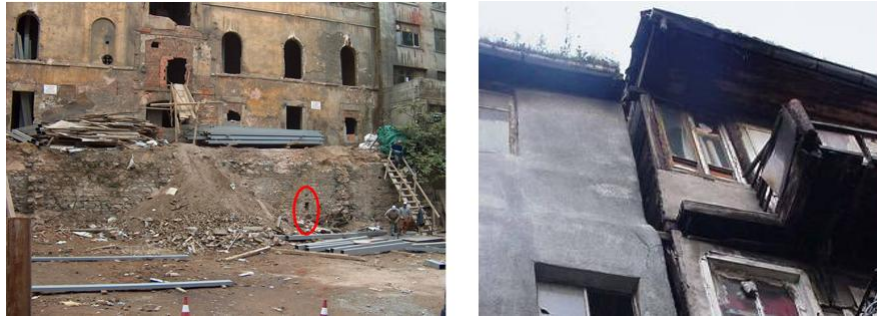
*Figure 13. New construction beside a masonry building*

Several lined masonry houses in Galata district of Istanbul, suffering of moisture and tilting due to the soil settlement, had wells in their basement connected to each other by a channel system through all the settlement. The newly built RC building in between them had blocked the subsurface water control system and water started to rise to the building softening the soil that had led to the building settlement. Inspection of the subsurface drainage works under the district provided important information for the damage evaluation of these historical masonry buildings.

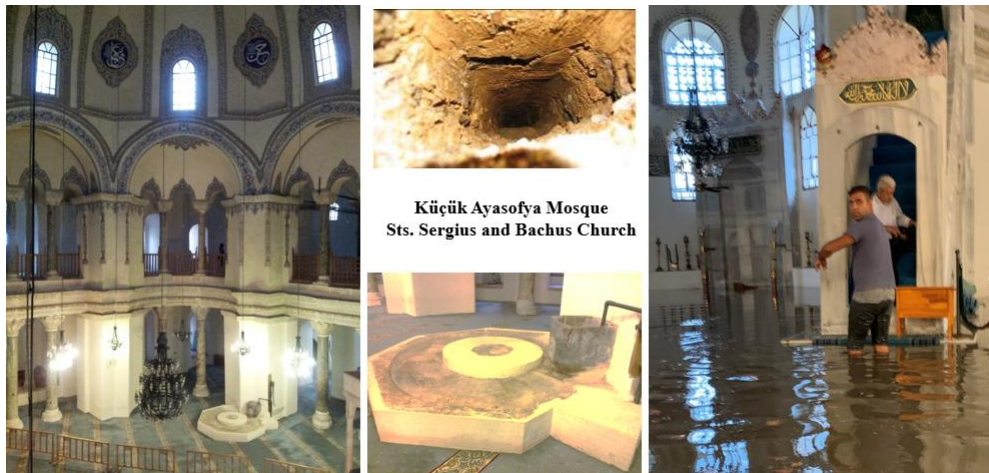
*Figure 14. Küçük Ayasofya Mosque after a heavy rain*

Similarly, the Küçük Ayasofya Mosque, former church of Sts. Sergius and Bachus constructed near South Sea walls of Constantinople had a well underneath its naos. Construction of highway filling the sea in front of the building must have demolished the underground water discharge system that the building was suffering of moisture and partial settlement before its recent restoration. During the building's restoration in 2001, today's master builders decided that this well is of no use today and closed the system filling with concrete. Today, after every heavy rain, the building is suffering from overflow (Figure 14).
