# Investigation, analysis and rehabilitation of the failures of St Dimitrios Bastion in the old city of Chania, Crete

M. Bardanis<sup>1</sup>, G. Dounias<sup>1</sup>

<sup>1</sup>EDAFOS Engineering Consultants S.A., Athens, Greece, email: mbardanis@edafos.gr, gdounias@edafos.gr

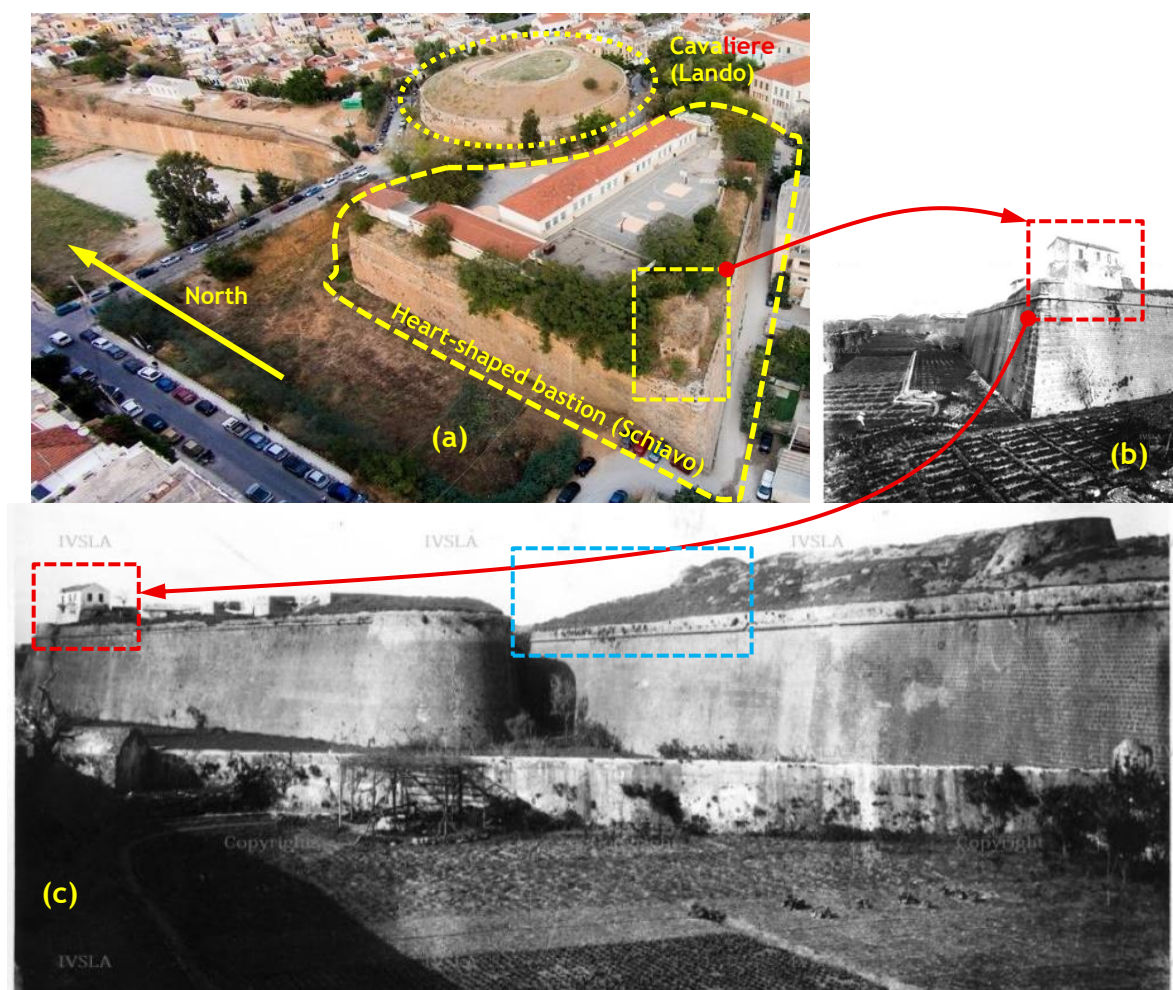
**Figure 3.** a) Aerial view of the southwest part of the Venetian fortifications in the old city of Chania (before the failures of the cavalieri walls) with yellow rectangle indicating the remains of a building at the tip of the heart-shaped bastion, b) historic photo of the early 1910's showing in the red rectangle the same building indicated in Fig. 3a (taken from south-west of the bastion tip), & c) historic photo of the early 1910's showing in the red rectangle the same building indicated in Fig. 3a (taken from south-east of the bastion) and the toe berm of the cavalieri wall in the light blue rectangle.

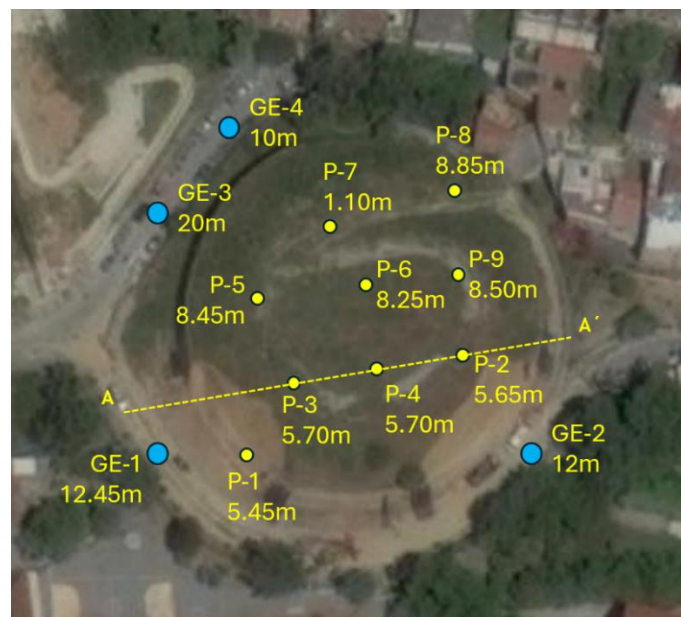
The geotechnical investigations undertaken following the 2017 and 2019 failures comprised four boreholes and nine lightweight dynamic cone penetrometer tests conducted in accordance with ASTM D6951. The Cavaliere has an inclined access ramp extending from its toe on the south-eastern side to its summit on the north-western side. The ramp was narrow and highly uneven, while its entrance at the toe was almost completely obstructed by the base of the eastern steel buttress constructed after the 2017 failure. Consequently, heavy drilling equipment could not reach the top of the Cavaliere. The boreholes were therefore drilled around the perimeter of the Cavaliere at toe level. Boreholes GE-1 to GE-4, ranging from 10 to 20 m in depth, investigated the ground conditions beneath its foundations and within the body of the bastion. The materials forming the Cavaliere itself were investigated using lightweight dynamic cone penetrometer tests, supplemented by samples collected from the exposed faces of the eastern and western failures after removal of the debris. The lightweight dynamic cone penetrometer tests were performed using a manually operated Kessler K100 device equipped with additional rods, enabling penetration to depths of up to 9 m. Personnel carried the equipment to the summit of the Cavaliere on foot. The versatility of this testing method makes it particularly suitable for geotechnical investigations at archaeological sites, where restricted space and difficult access frequently preclude the use of conventional drilling equipment (Bardanis & Kokoviadis, 2026). At the Saint Dimitrios Cavaliere, the penetrometer reached a maximum depth of 8.85 m, which is unusually deep for this method and is seldom achievable because of the penetration resistance of the soil layers encountered. The locations of all boreholes and lightweight DCP tests are shown in Fig. 5.

**Figure 5.** Boreholes (blue circles, denoted GE-n) and lightweight dynamic penetrometer tests (smaller yellow circles, denoted P-n) performed as part of the 2017 and 2019 geotechnical investigation campaigns.

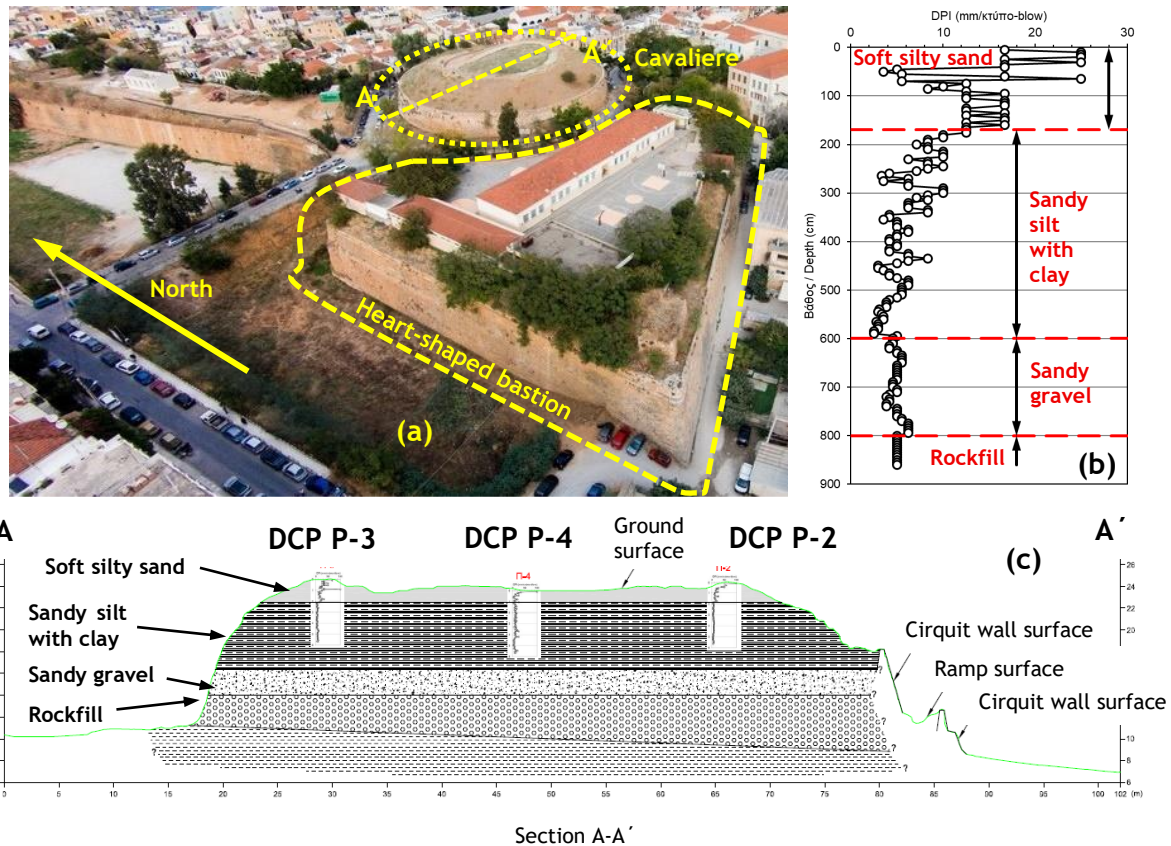
**Figure 6.** a) Aerial view of the southwest part of the Venetian fortifications in the old city of Chania in Crete, Greece (before the failures), b) DPI with depth of DCP test P-9 performed at the crest of the St Dimitrios Cavaliere, & c) cross-section A-A' across the St Dimitrios Cavaliere (indicated in Fig. 5a).
