# Preserving Historical Structures in Urban Tunneling: Diaphragm Walls Embedded in Bedrock

F. Capata<sup>1</sup>, M. Iacorossi<sup>2</sup>, F. De Santis<sup>3</sup>

<sup>1</sup>Engineer, SGS Studio Geotecnico Strutturale srl, Rome, Italy, email: [f.capata@studiosgsroma.com](mailto:f.capata@studiosgsroma.com)

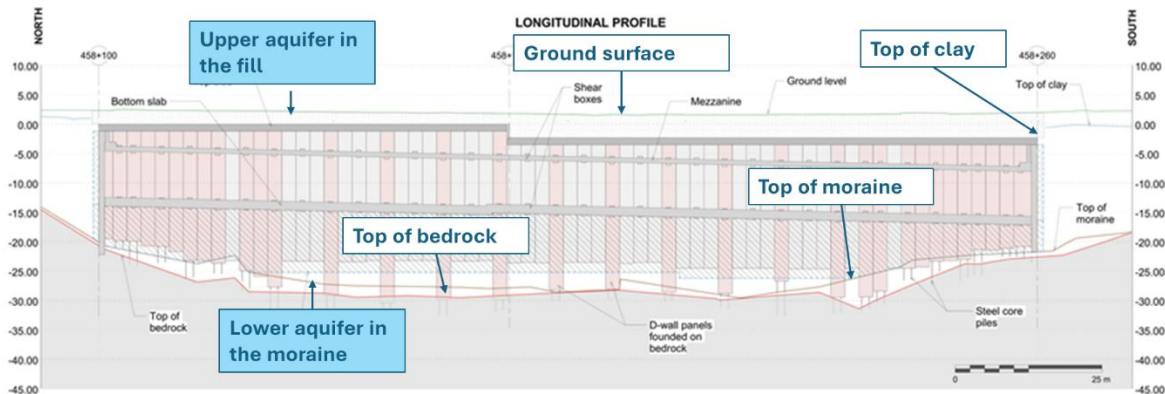
**Figure 2.** Longitudinal geological profile with excavation level, D-walls, moraine and bedrock variability.

The combination of thick soft clay, boulder-rich moraine, an irregular and inclined bedrock surface, and high groundwater pressure creates particularly unfavourable conditions for achieving a reliable and continuous contact between diaphragm wall toes and bedrock, while the tolerance for induced ground movements is extremely limited due to the proximity of sensitive historical buildings.

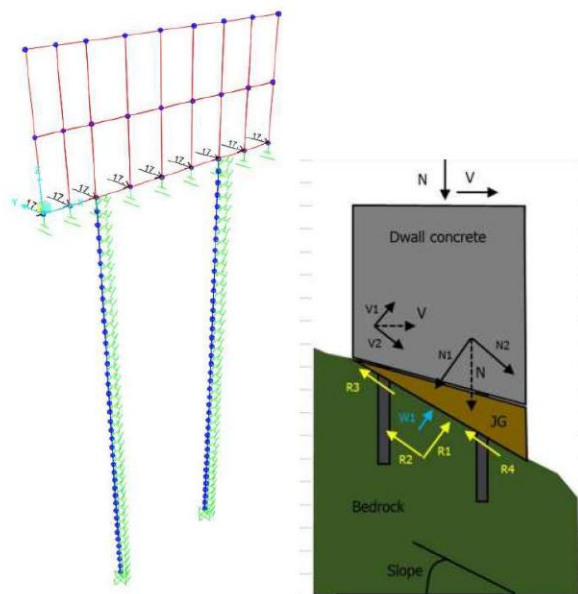
**Figure 6.** Structural model of diaphragm wall toe with steel piles and load transfer mechanism at the wall–pile–rock interface.

Several geometrical configurations were analysed, considering different values of the toe-to-rock gap and different rock inclinations, in order to evaluate the sensitivity of internal forces and displacements to the observed deviations from the design geometry. Particular attention was paid to the axial force and bending moments developing in the steel piles, as well as to the stress transfer mechanisms at the pile–rock and pile–wall interfaces.

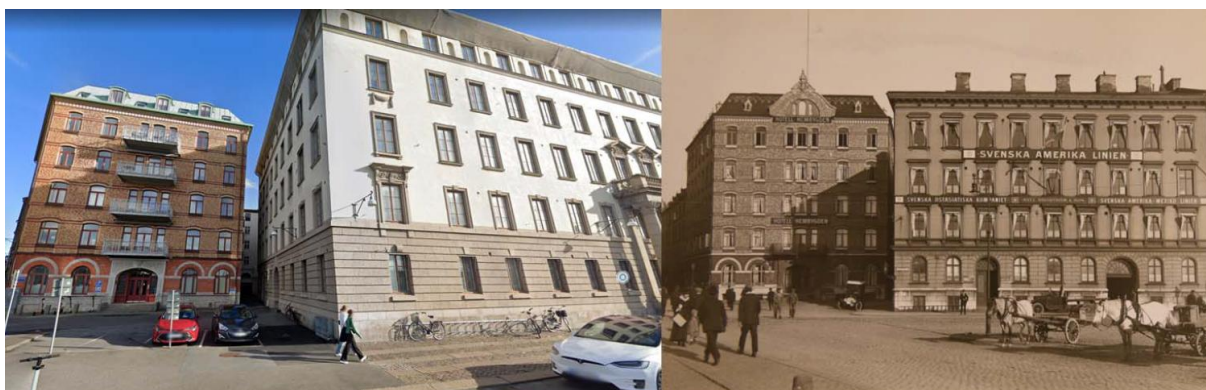
The monitoring focused on the historical buildings Nordstaden 13.12 and Nordstaden 13.7, part of the Nordstaden 13 complex located on reclaimed land in the former harbour area of Göteborg. Building 13.12 was originally constructed in approximately 1850 and later extended in 1926 (Figure 7); the original masonry structure is founded on a traditional timber mattress foundation (“rustbädd”), consisting of horizontal timber layers resting on soft ground, while the later extension is supported by a concrete and steel structure founded on end-bearing piles. Building 13.7 (Figure 8) was constructed in approximately 1882 and is founded on timber friction piles driven in soft cohesive deposits, typical of foundation systems adopted in harbour areas during the nineteenth century. The two buildings are directly adjacent and share a common interface wall, making them particularly sensitive to differential settlements and relative movements.

**Figure 7.** Building 13.12: comparison between recent status (left) and historical status at 1920 (right).

Cracks notified inside Building 13.12 during construction were mainly located along the interface with the adjacent Building 13.7, suggesting a potential interaction mechanism between the two structures. Review of historical documentation and inspection records indicates that similar crack patterns and façade distortions were already present prior to the start of the West Link works, pointing to a pre-existing deformation process.

Analysis of historical settlement trends shows that the two adjacent buildings have experienced markedly different long-term settlement behaviour. Building 13.7 exhibits a significantly higher cumulative settlement than Building 13.12, likely related to differences in foundation typology and structural history. This differential behaviour may generate restraint effects along the common interface, leading to stress concentration and cracking even in the absence of external perturbations.

These elements support the interpretation that the observed damage is predominantly associated with long-term differential settlements between the adjacent buildings rather than with excavation-induced effects.

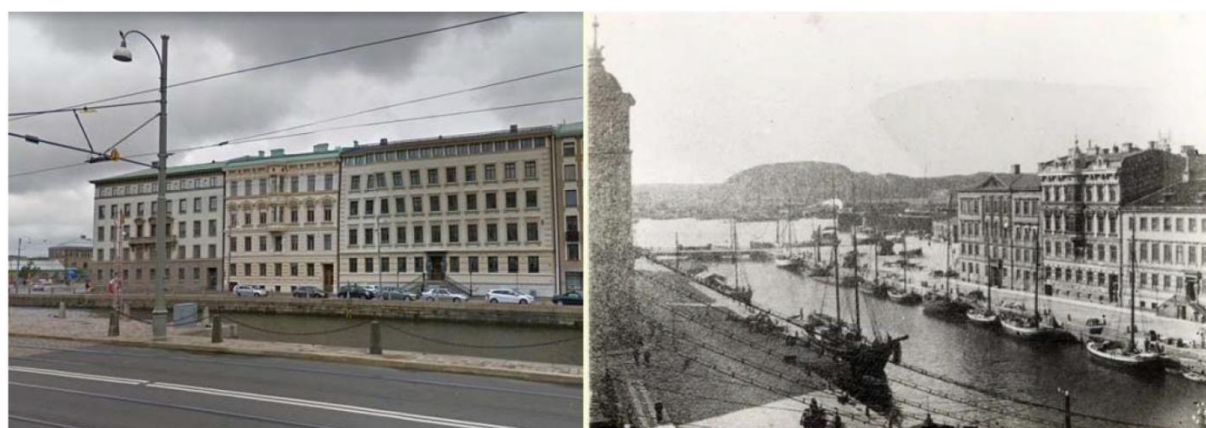
**Figure 8.** Building 13.12 and 13.7: comparison between recent status (left) and historical status at 1920 (right).

The construction-phase monitoring data show that vertical and horizontal displacements in the vicinity of the crack locations remained limited to a few millimetres and did not display any systematic increase associated with excavation stages. In particular, no acceleration of movements was detected during diaphragm wall installation, Deep Soil Mixing or early excavation phases. Visual inspections carried out before and after the notified event confirmed the absence of significant crack propagation or widening.
