## Underground Church of Saint-Emilion : Geotechnical challenges in light of heritage issues

N. Carpentier<sup>1</sup>, E. Antoinet<sup>2</sup> and A. Esnault Filet<sup>3</sup>

<sup>1</sup>Senior geotechnical engineer in heritage structures, Antea Group, Bordeaux, France, email: [nicolas.carpentier@anteagroup.fr](mailto:nicolas.carpentier@anteagroup.fr)

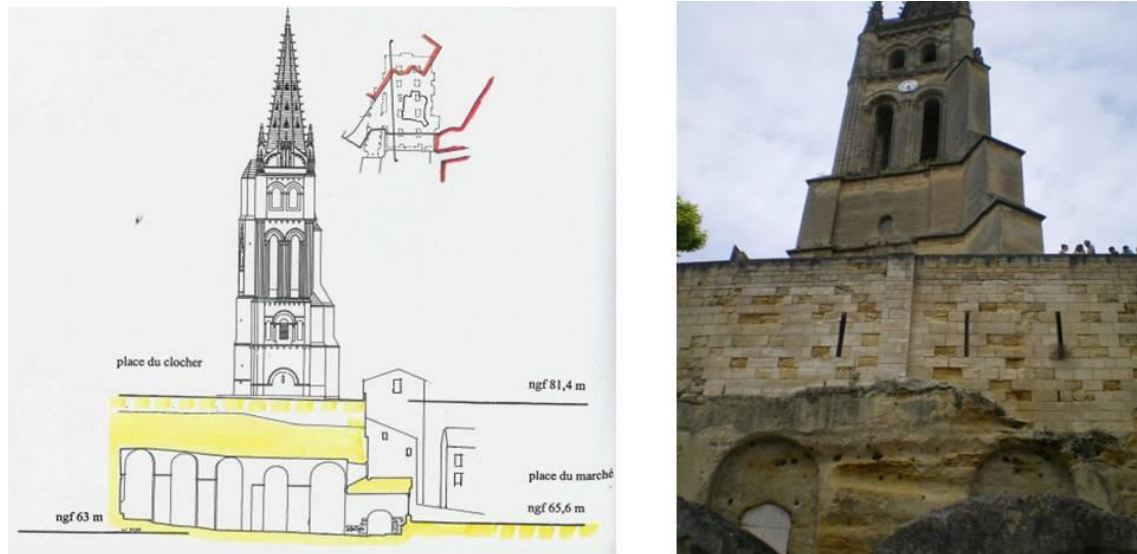
**Figure 2.** Elevation view of the monolithic church of Saint-Emilion (Goutal M., 1999) (left). Photo from the lower forecourt (Antea Group, 2018) (right)

The bell tower square forms a terrace which constitutes the "roof" of the underground church which is connected to the bell tower by a shaft dug through the rock about 5 to 6m thick. This bell tower, representing an overload of more than 5,000 tons, was built later, between the 15th and 16th centuries, on the upper square above the church (see Figure 2).
