# A Multidisciplinary Approach to the Restoration of the Pyli Arch Bridge: Integrating Seismic, Geotechnical, and Hydraulic Analyses

D. Egglezos<sup>1</sup>, and C. Giannelos<sup>2</sup>

## ABSTRACT

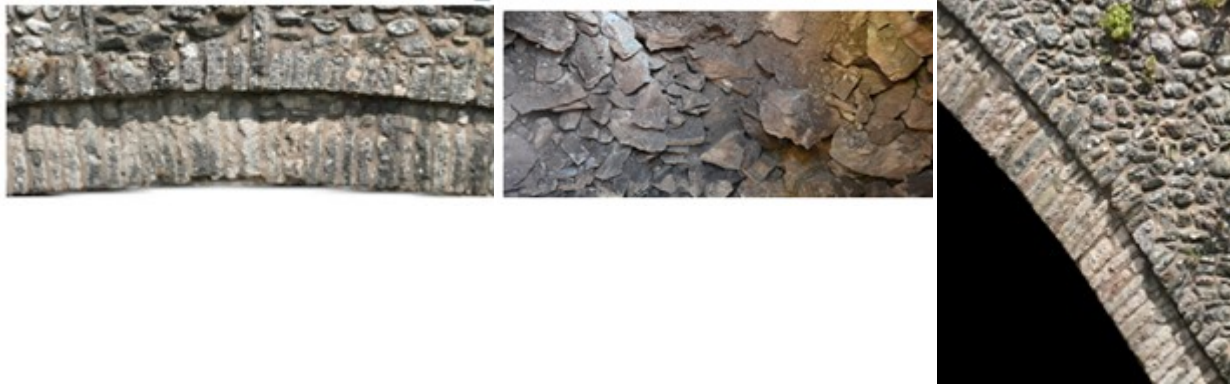
During architectural documentation, the construction methodology of each component—arch, piers, and parapets—was identified (Figure 5), along with indications of later repair phases. Material sampling provided detailed information on the composition and physical–mechanical properties of the masonry units and mortar. Laboratory tests revealed that the historical lime-based mortar exhibits low tensile and shear strength, which significantly affects the global mechanical behavior of the masonry.

**Figure 5.** Characteristic segments of the Pyli Bridge: arch, fill, and spandrel drum.
