# A Multidisciplinary Approach to the Restoration of the Pyli Arch Bridge: Integrating Seismic, Geotechnical, and Hydraulic Analyses

D. Egglezos<sup>1</sup>, and C. Giannelos<sup>2</sup>

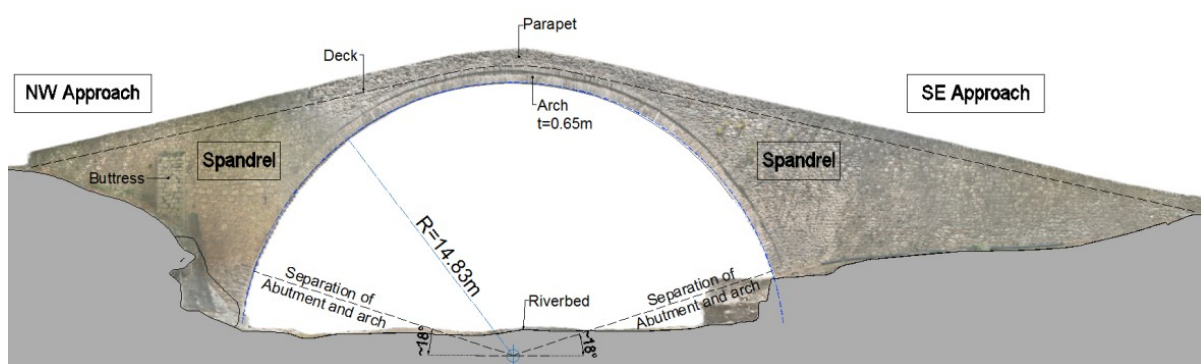
**Figure 1.** Upstream view of the stone bridge of Pyli.
